**Runway excursion, Eastern Air Lines, Inc., Boeing 727-225, N8838E,  
Raleigh, North Carolina, November 12, 1975**

**EASTERN AIR LINES, INC.  
BOEING 727, N8838E**

**REPORT NUMBER: NTSB-AAR-76-15**

EASTERN AIR LINES, INC.  
BOEING 727-225, N8838E  
RALEIGH, NORTH CAROLINA  
NOVEMBER 12, 1975

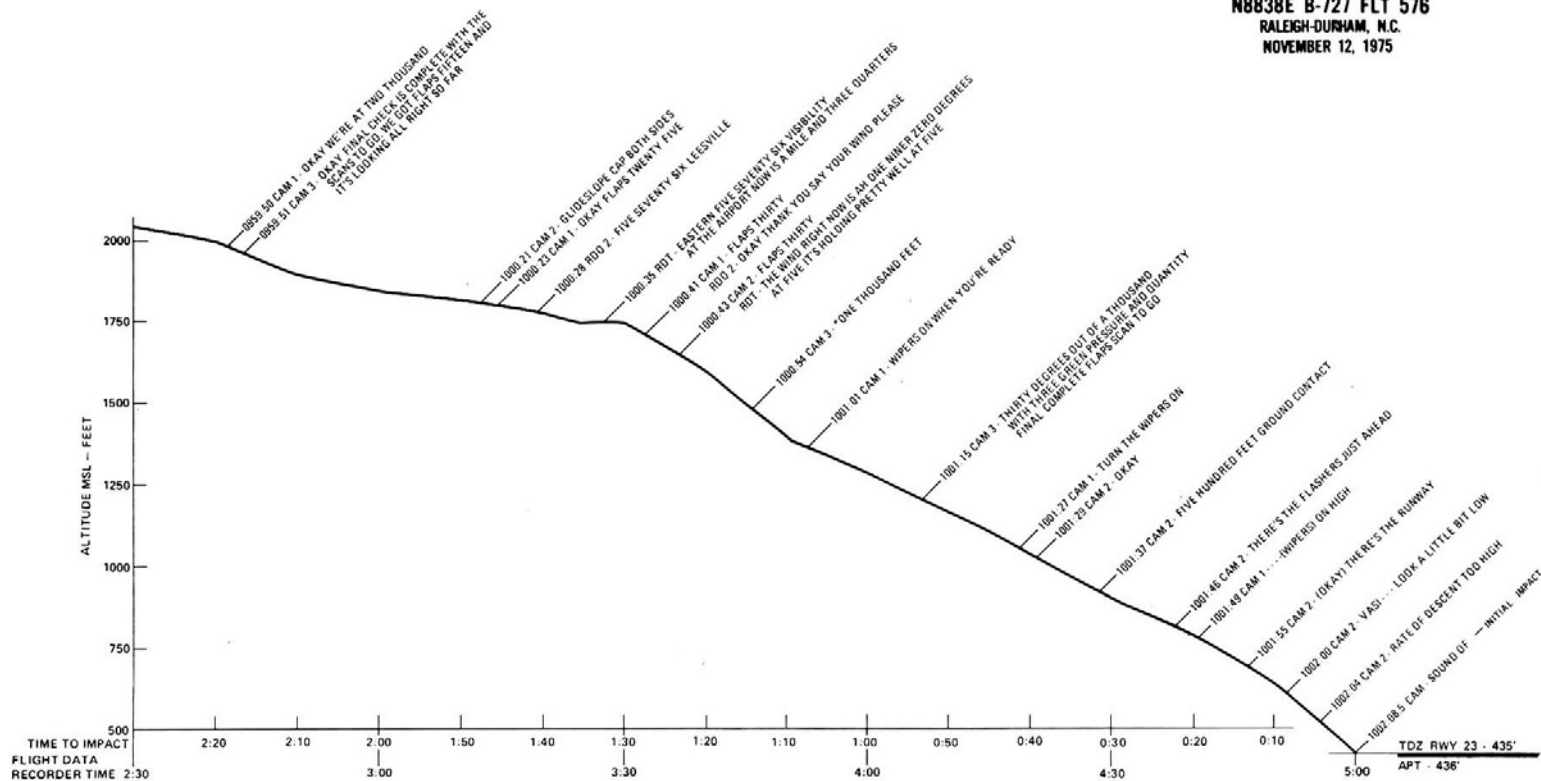
DESCENT PROFILE  
EASTERN AIRLINES  
N8838E B-727 FLT 576  
RALEIGH-DURHAM, N.C.  
NOVEMBER 12, 1975

The FDR showed that the airspeed on the final approach varied from 140 kn to 145 kn until about 300 feet where it increased to about 147 kn at initial impact. The rate of descent remained fairly constant at between 650 fpm and 700 fpm until about 100 feet where it increased to 1,250 fpm. At 3.6 seconds before touchdown, the descent rate increased to an average of 1,400 fpm.

The flightcrew recalled that the rate of descent was about 700 fpm during the approach; however, the FDR trace shows rates as high as 1,400 fpm during the last 3.6 seconds of flight. About 4 seconds before the initial impact, the first officer made the descent rate callout "rate of descent too high." He did not specify the numerical rate as required. Had he done so, the captain may have been alerted and consequently may have considered a missed approach. Because of the low voice volume of the callout and the high noise level caused by the operation of the windshield wipers and the rain striking the aircraft, the captain did not understand the first officer's alerting call. This callout was the only rate-of-descent call made during the approach.

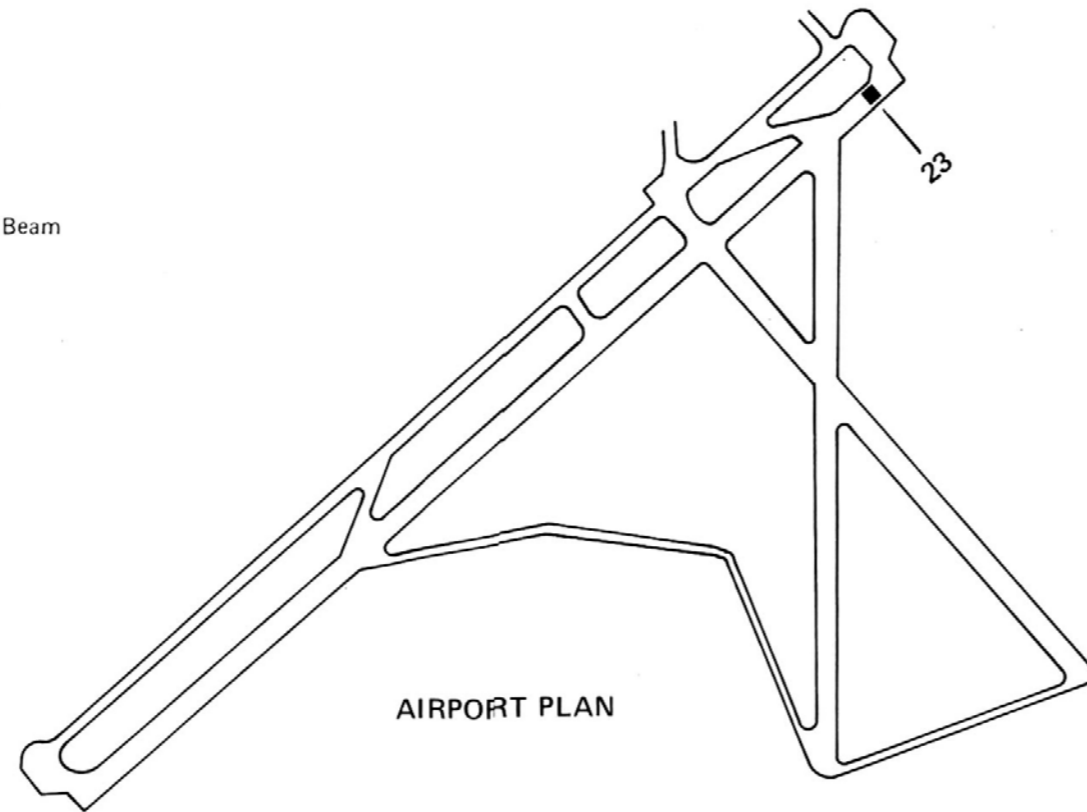
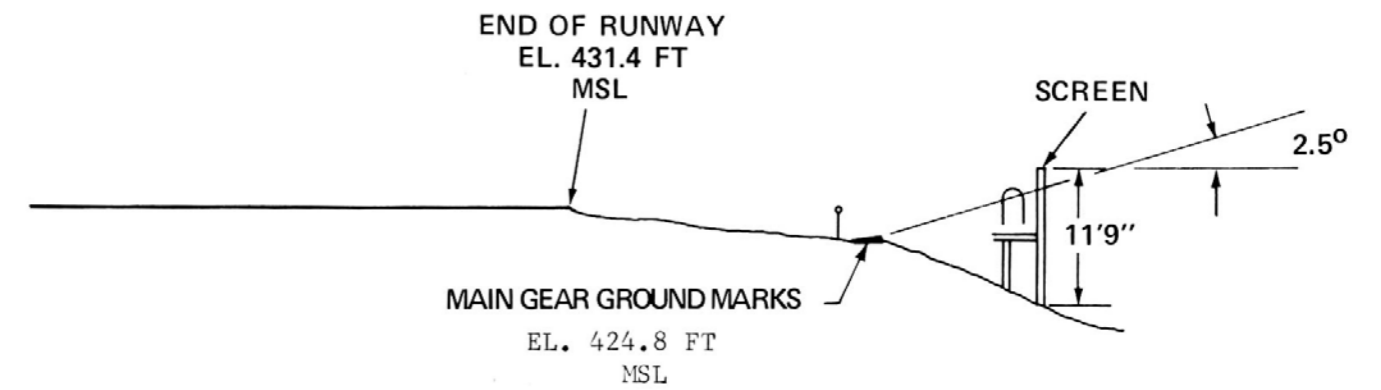
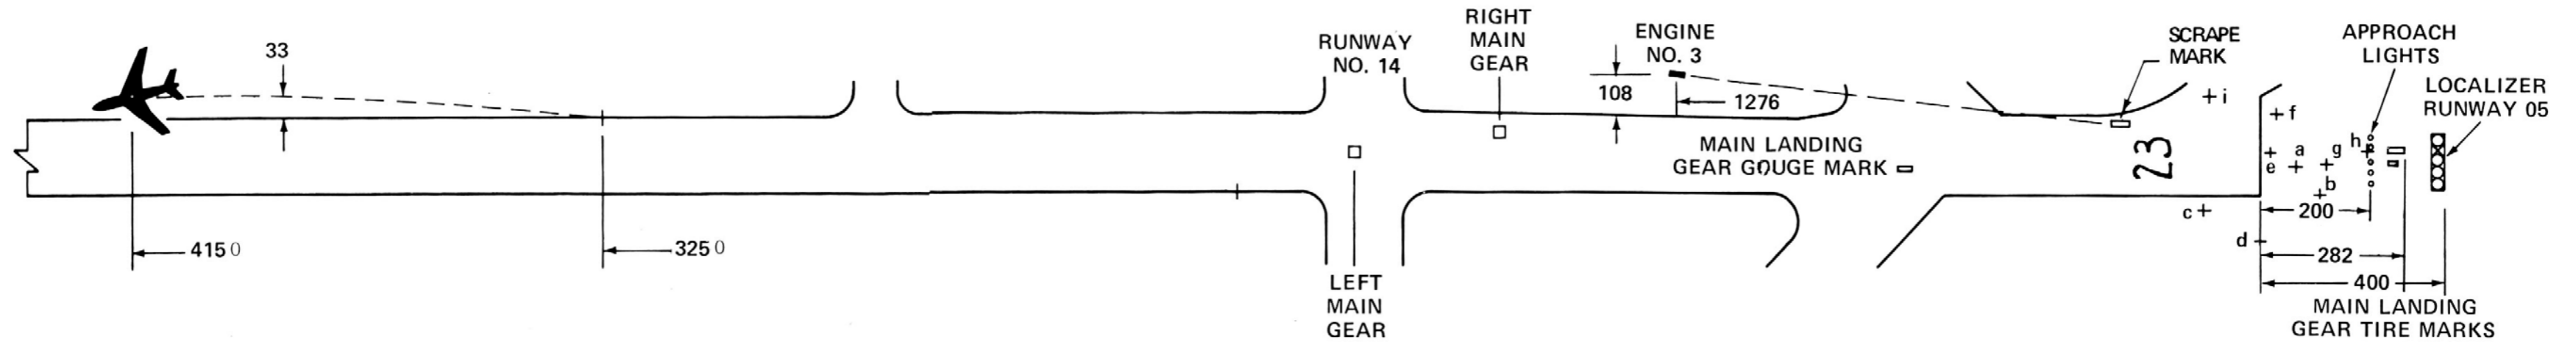
WRECKAGE DISTRIBUTION CHART  
EASTERN AIRLINES FLIGHT 576  
Raleigh-Durham N.C.  
12 November 1975

The aircraft first struck the ILS localizer antenna screen for runway 05, which is located 400 feet before the threshold of runway 23. The top 2 feet of the parallel antenna screen wires were severed. The elevation of the top wire was about 430 feet m.s.l., about 1.5 feet below the runway threshold elevation and about 5 feet below the touch-down zone elevation. An antenna dome was also damaged. (See Appendix E.)

The main landing gear tires hit the ground first--about 282 feet short of the runway 23 threshold. The elevation of the ground marks was about 425 feet m.s.l., about 3.5 feet below the elevation of the runway threshold, and about 6 feet below the elevation of the touch-down zone. The aircraft's angle of descent between the broken ILS localizer antenna domes and the ground marks was about 2.5°.

The nose landing gear remained on the aircraft; the tires were flat. Portions of both main landing gear support structures, the left inboard, mid-inboard, and the mid-trailing edge flaps; the airstair handrails; and airstair control access panel were found between the point of the first ground contact and the runway threshold.
