Near Midair Collision, Hughes Airwest, Douglas DC-9, N9333, and Northwest Airlines, Inc., Douglas DC-10, N148US, Spokane International Airport, Spokane, Washington, April 1, 1976

AIRCRAFT INCIDENT REPORT

**NEAR MIDAIR COLLISION,
HUGHES AIRWEST,
DOUGLAS DC-9, N9333
AND
NORTHWEST AIRLINES, INC.,
DOUGLAS DC-10, N148US
SPOKANE INTERNATIONAL AIRPORT**

REPORT NUMBER: NTSB-AAR-76-18

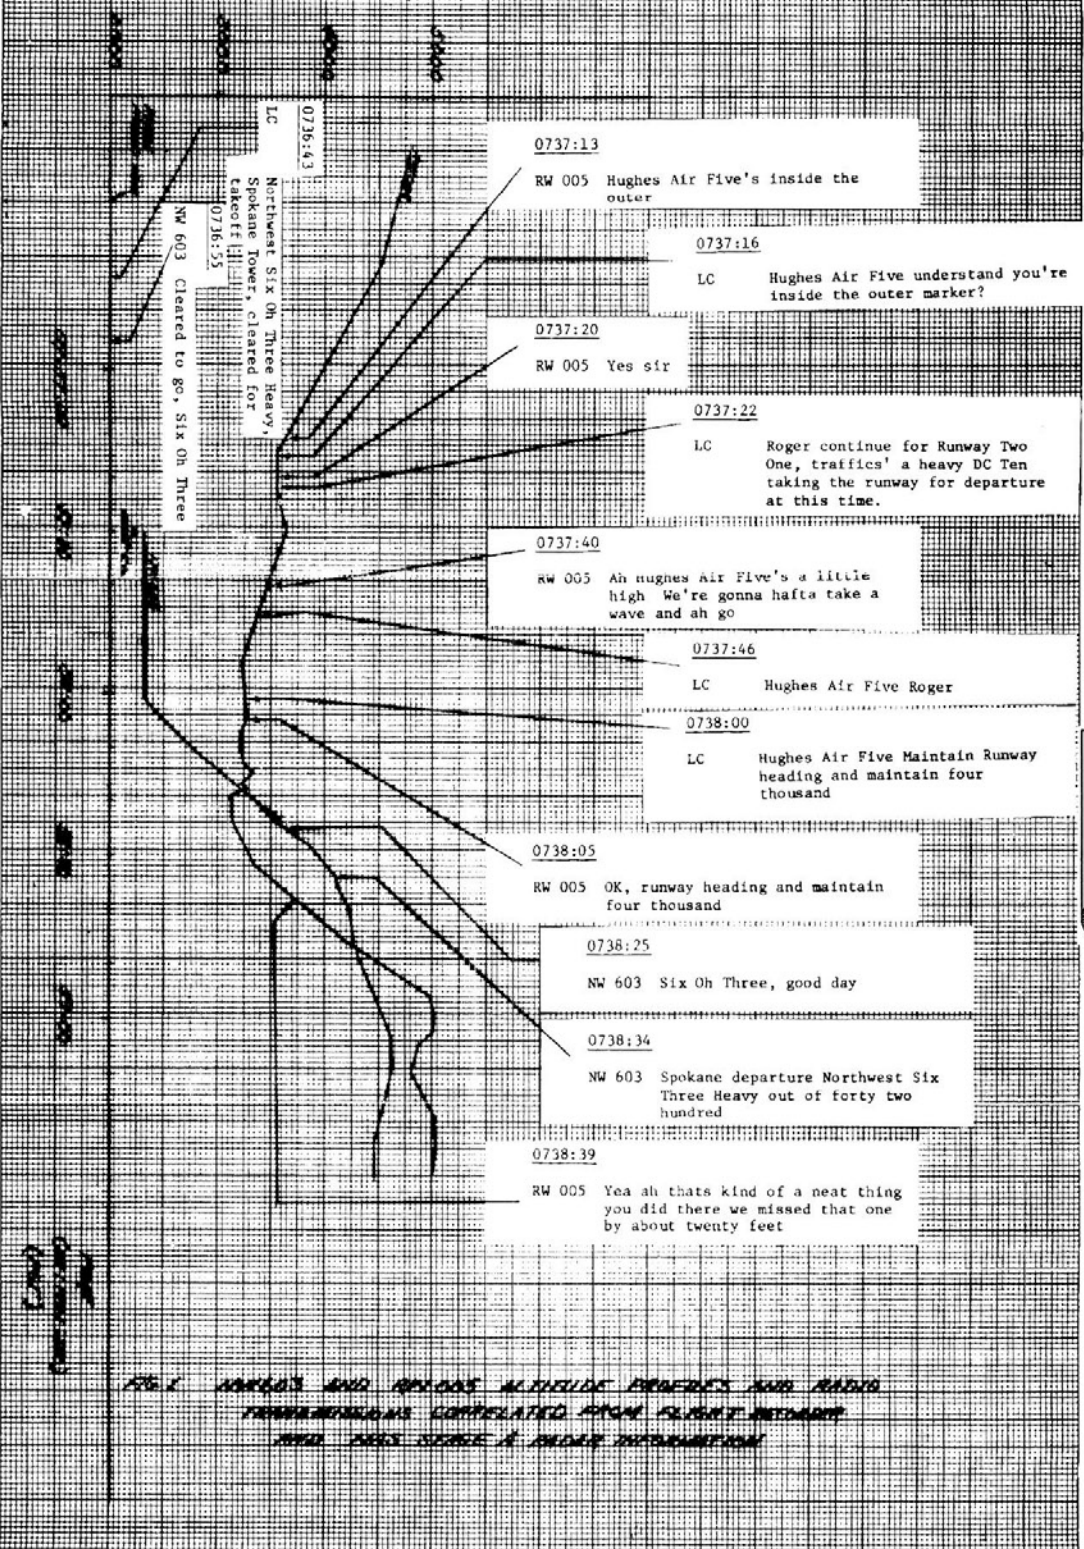
FIG. 1. APPROX AND POSITIONS AT FIELD, PROFILES AND RADIOS FROM RECONSTRUCTION CORRELATED FROM FLIGHT RECORDS AND THIS SOURCE A PHOTO RECONSTRUCTION

Data from the Seattle Center National Airspace System (NAS) Stage A digitized radar system were retrieved and processed. These data were used to verify the FDR information from both aircraft and to establish a common time base correlation. (See Appendix D.) NAS Stage A radar coordinate data showed that Airwest 5 passed the OM for runway 21 about 0736:30. At that time, Airwest 5's FDR showed an airspeed of 224 kn at an altitude of about 4,700 feet.

The FDR information from Airwest 5 indicated that between 0738:13 and 0738:15, the aircraft rolled rapidly to the right. During that 2-second period, the aircraft's altitude was about 3,225 feet, its indicated airspeed was about 180 kn, and its heading was 205°. During this same time period, Northwest 603's altitude increased from 3,450 feet to 3,550 feet; its airspeed was about 165 kn and its heading was 203°.

During the 10-second period which preceded Airwest 5's roll, Airwest 5's altitude varied slightly between 3,250 feet and 3,225 feet. Its airspeed increased from about 156 kn to 180 kn, and its heading changed from about 200° to 205°. During this period, Northwest 603's altitude increased from 2,900 feet to 3,450 feet, and its airspeed increased from about 160 kn to 165 kn. Its heading was constant at about 203°.

During the 10-second period after the roll, Airwest 5's altitude decreased to about 3,125 feet (the lowest altitude recorded throughout the approach and missed approach) and the airspeed increased to about 210 kn. The aircraft's heading changed from 205° to 213°. During this period, Northwest 603's altitude changed from 3,550 feet to 4,200 feet, and its airspeed decreased from 165 kn to 160 kn. Its heading was constant at 205°.

A calculator was programmed with ground-related position rates-of-change which were derived from the FDR information from both aircraft, the NAS Stage A radar data, and an assumption about wind velocity distribution for the period of time between 0737:56 and 0738:25. The shortest, nominal three-dimensional distance between the two aircraft was computed to have been 291 feet at 0738:21. This distance is within the range of the resolution of the radar equipment which is specified accurate to 1/8 nmi., and 1/10° in azimuth. The actual distance between the two aircraft could have been greater or less than the nominal 291 feet, because of the tolerances involved in the recording systems which must be applied to nominal values. The exact tolerance to be applied to the computed separation distance is unknown because the tolerances related to the assumptions made for the wind model and time correlation cannot be determined, and because the position on the aircraft from which the separation distance is measured is not known.
