## Wing Failure Of Boeing 747-131, near Madrid, Spain, May 9, 1976

## **SPECIAL INVESTIGATION REPORT**

**WING FAILURE OF BOEING 747-131  
NEAR MADRID, SPAIN  
MAY 9, 1976**

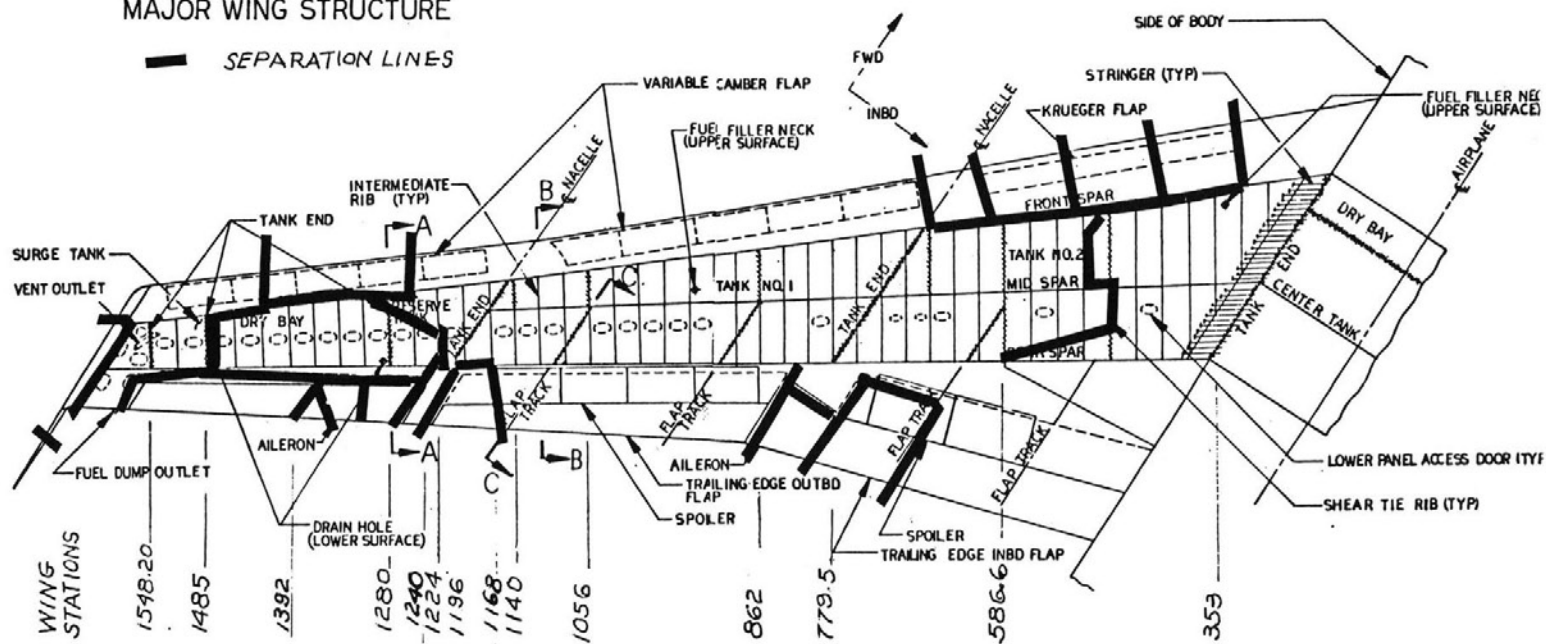
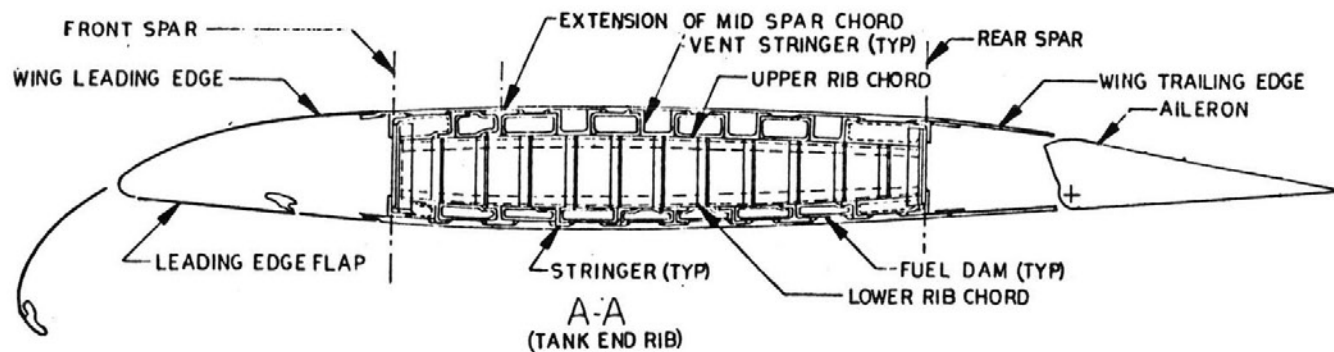
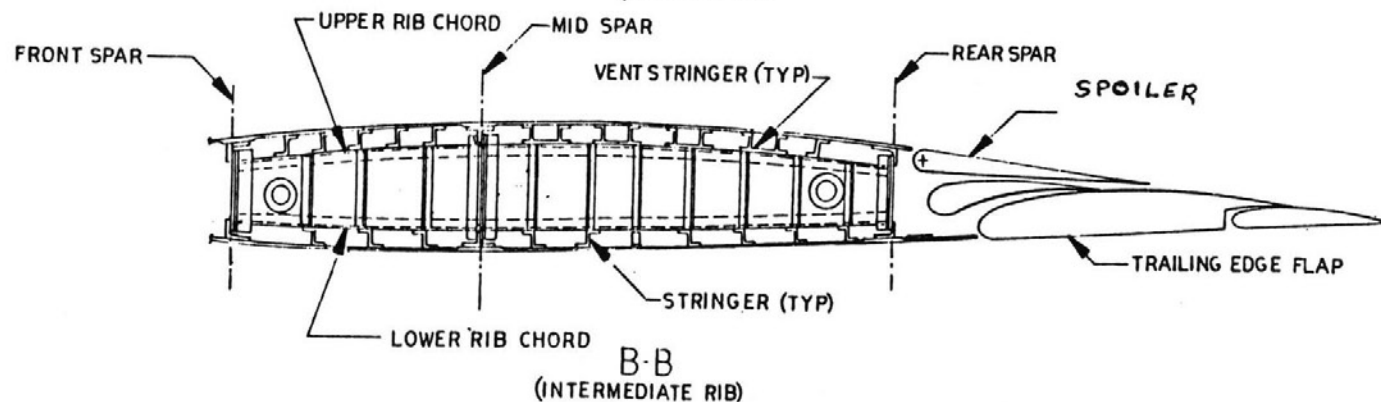
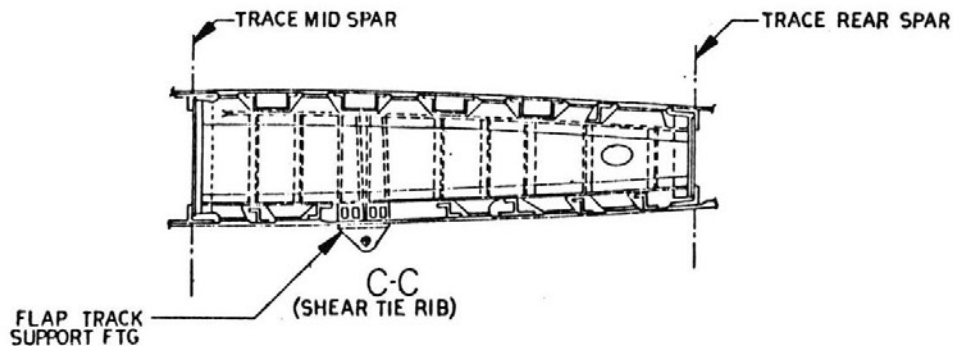
# MAJOR WING STRUCTURE

Pitting and localized burn areas typical of lightning attachment damage were found on the left wingtip and on the vertical fin at the VOR antenna. The left wing had separated into 15 major pieces before ground impact and parts of it were found at each location of wreckage. (See drawing on page 31.)

The left wing outboard of the No. 1 engine position separated in three major pieces and along three lines of fracture. The left wingtip, a piece about 20 ft long, separated on a line parallel to the fuselage centerline and roughly halfway between the end of the wing and the No. 1 engine. A second line of separation was just outboard of the No. 1 engine and ran parallel to the rib centerlines. The third line of separation spanned between the first two and ran along the front spar. The wingtip, consisting of the high frequency antenna and coupler, also separated from the wing.
