Runway overrun, Texas International Airlines, Inc., Douglas DC-9-14, N9104, Stapleton International Airport, Denver, Colorado, November 16, 1976

AIRCRAFT ACCIDENT REPORT

**TEXAS INTERNATIONAL AIRLINES, INC.,
DOUGLAS DC-9-14, N9104
STAPLETON INTERNATIONAL AIRPORT**

REPORT NUMBER: NTSB-AAR-77-10

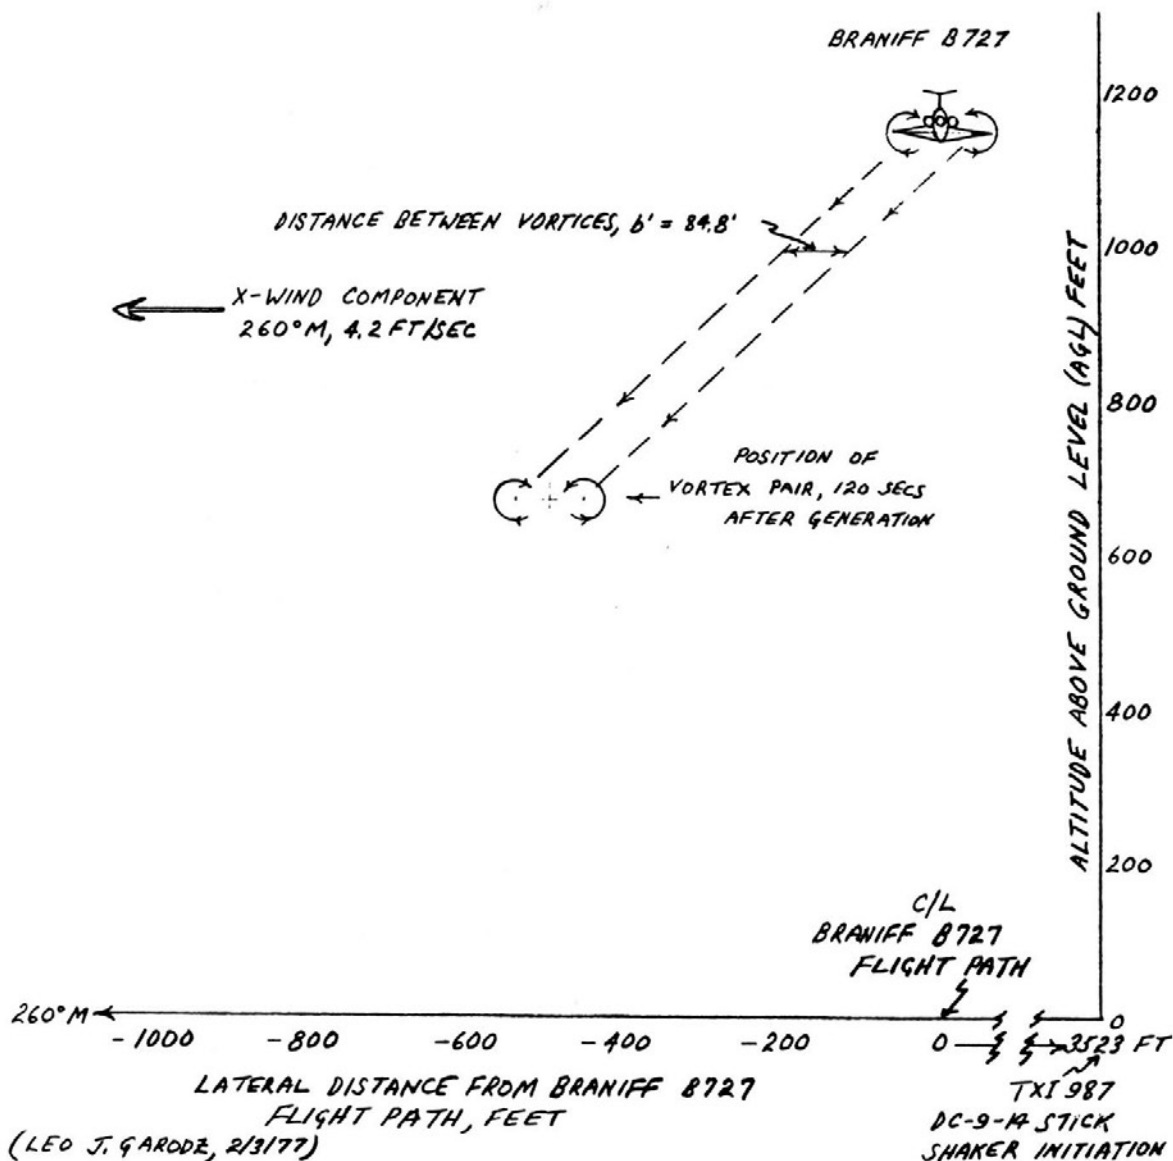
FIGURE 1
 BRANIFF FLIGHT 928 - B727-100 - VORTEX TRAJECTORY - NOV 16, 1976
 RELATED TO RWY 8R-26L, COMMON FLIGHT PATH POINT
 B727 & TXI DC9-14 (B727 PROJECTED TO GROUND)
 STAPLETON INTL AIRPORT

Summary: The probability is extremely low that the Braniff B-727 vortices could have impinged upon the Texas International DC-9 because: (1) based on the best available data to date, it has been found that the B-727 vortices persist at lower altitudes for less than 120 seconds which is less than the separation time between the flight path intersection for the two aircraft; (2) even if they did, for whatever reason, it is extremely unlikely that they would have descended to the level of the DC-9 airplane taking off or create a problem; and (3) regardless of the separation time interval between the two aircraft, assuming valid assumptions on wind speed and direction from the B-727's flight altitude to the surface, the B-727 vortices are drifting downwind of the projected flight path intersection of the two airplanes which is another 3,523 feet downwind of the DC-9 stick shaker initiation position.

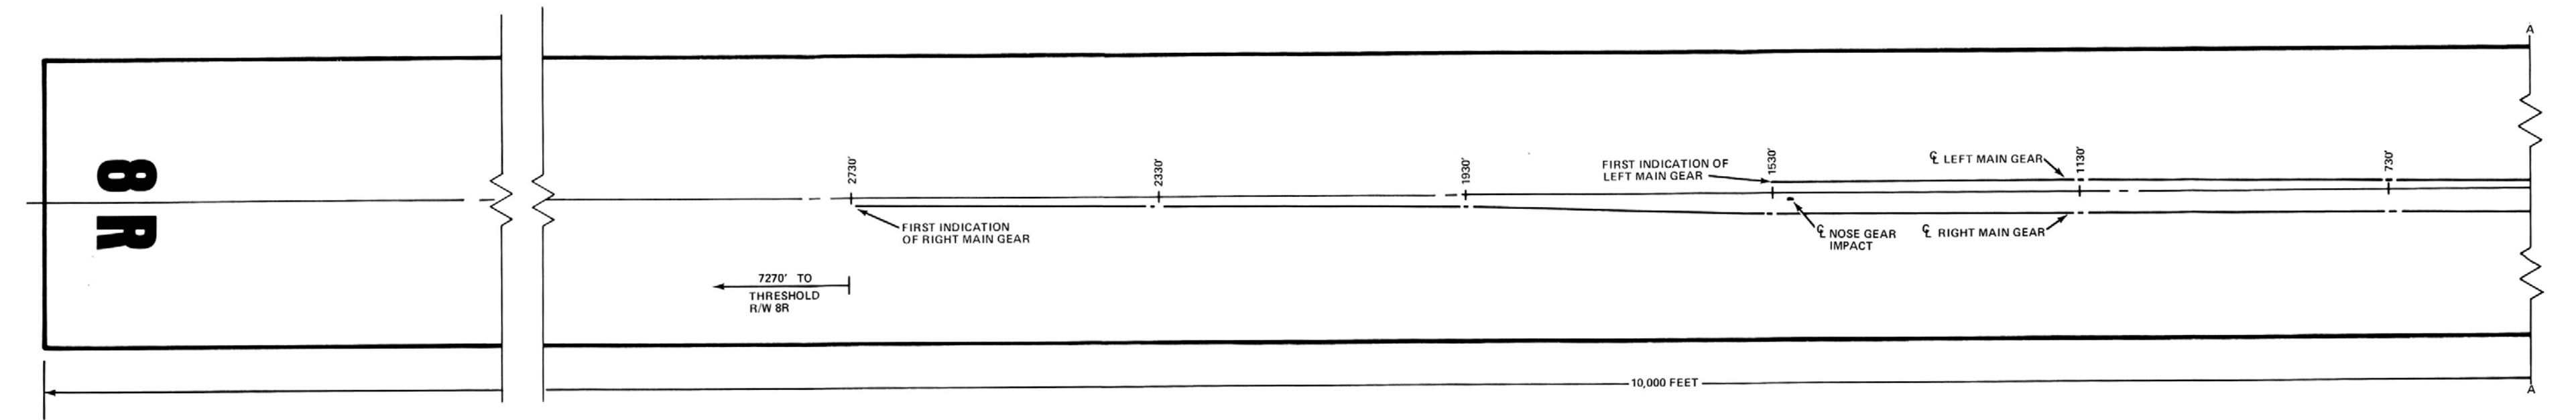
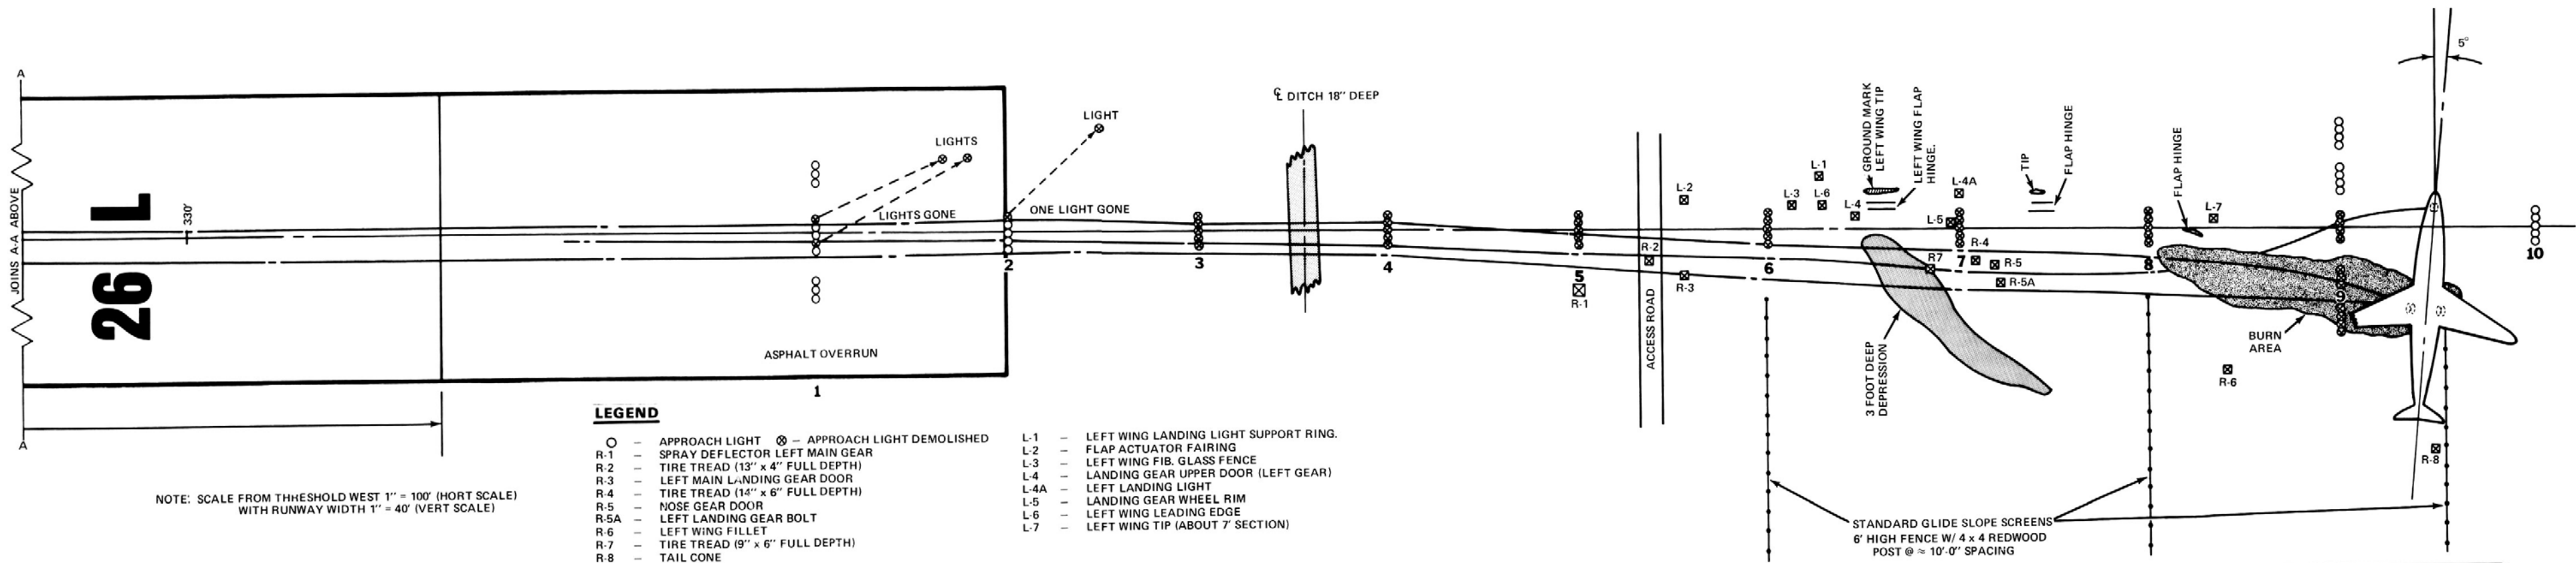
WRECKAGE DISTRIBUTION CHART
TEXAS INTERNATIONAL AIRLINES, INC.
MCDONNELL - DOUGLAS DC-9-14, N 9104
STAPLETON INTERNATIONAL AIRPORT
DENVER, COLORADO
NOVEMBER 16, 1976

After a postcrash fire, the fuselage was found tilted 15° to the left. The wings, engines, and entire empennage remained attached

to the fuselage. The lower fuselage structure from the radome to the nose gear was damaged heavily. The fuselage was burned through on the left side in the area of the left wing root. The nose gear failed rearward and the wheels came to rest in the electrical and electronics compartment. The left main landing gear supporting structure failed, allowing the gear to trail aft from its normal down position. The right main landing gear remained attached and extended. The left wing was on the ground; the wingtip separated. The left aileron and flaps remained attached to the wing; the left wing root and fairing were burned.

All flight control surfaces were in place. The fuselage structure around the main cabin entry door was deformed. The left side of the fuselage was burned through except for stringers and frames between FS 390 and FS 584. The fire damage extended vertically from the top of the left wing up to fuselage stringer No. 19. The right side of the fuselage between FS 256 and FS 718 had been punctured in several places; orange paint smears were found around the punctures and in other locations on the fuselage.
