Landing gear collapse, Aircraft Accident Report, New York Airways, Inc. Sikorsky S-61L, N619PA, Pan Am Building Heliport, New York, New York, May 16, 1977

**NEW YORK AIRWAYS, INC.,
SIKORSKY S-61L, N619PA**

PAN AM BUILDING HELIPORT

REPORT NUMBER: NTSB-AAR-77-9

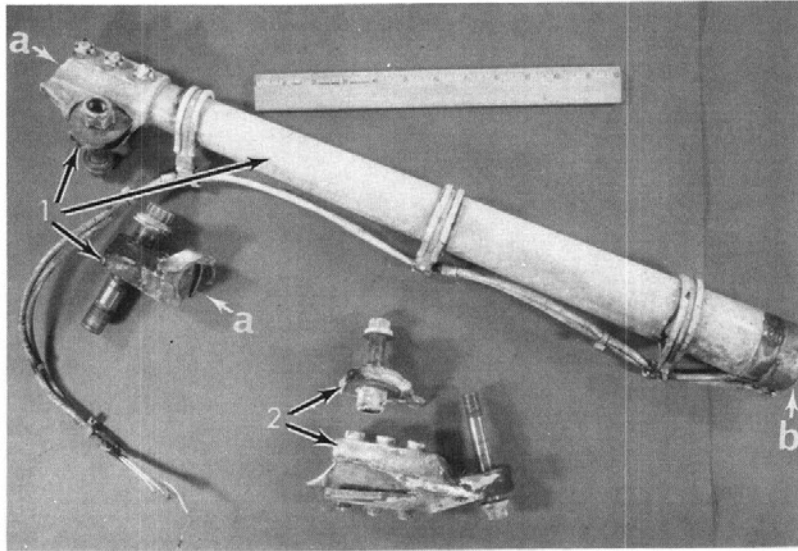
Figure 1. Overall view of the components, as received.
1.) Forward main landing gear fitting and tube assembly.
2.) Aft main landing gear inboard fitting with portion of tube.

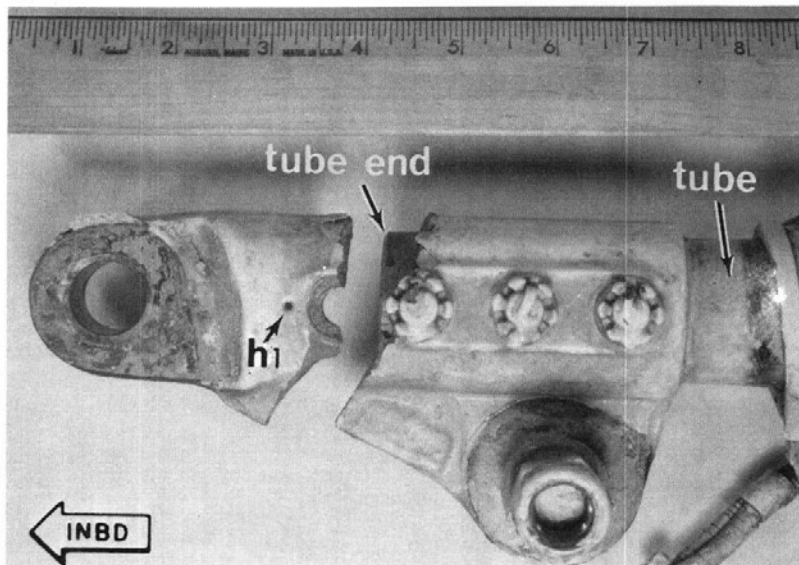
Examination of the right forward main landing gear P/N S6125-50333-22 fitting showed that it fractured near where the end of the tube assembly is located within the fitting (See figure 2, Appendix F). This was near the bottom of a 1.498/1.500-inch diameter hole which is drilled in the fitting to accommodate the tube. Fractography of the fractured features indicated that a fatigue crack had begun along the 0.12-inch radius near the bottom of the hole where the hole changes from a cylindrical to a conical shaped section. (See figure 4, Appendix F.)

Figure 2. Right hand main landing gear fitting (P/N S6125-50333-2) with the fractures (arrows "a" figure 1) placed relative to each other as if intact. Inboard attachment bolt was removed from the hole.

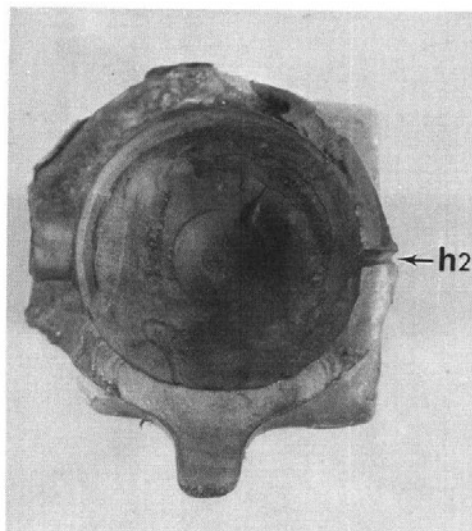
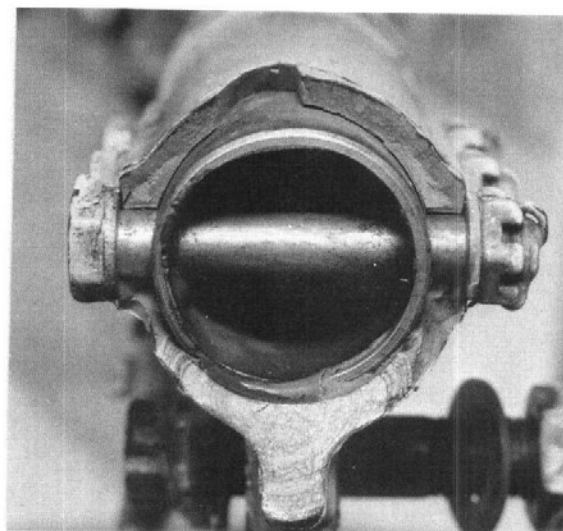
The missing area on the forward side was seen by comparing the mating fracture halves and noting that the fracture on the inboard half went through the small hole used to locate the tube in the fitting while on the outboard half the fracture in the same area progressed through the bolt hole. (See Figure 3, Appendix F.)

Figure 3. Mating fracture surfaces on the P/N S6125-50333-2 fitting. Both photographs approximately X1 1/4

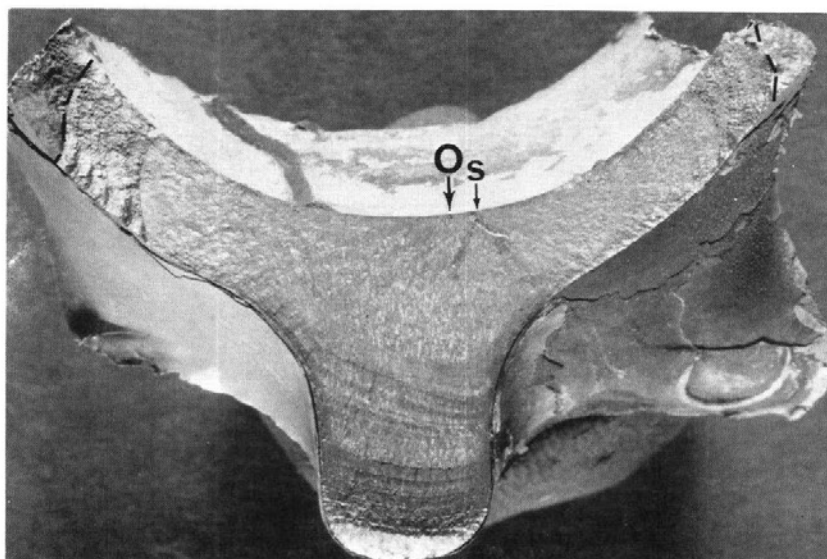
Figure 4. Portion of inboard fracture surface removed for detailed fractographic examination. Arrow "O" denotes main origin and arrow "S" locates secondary origin while dashed lines indicate approximate extent of fatigue propagation from these origins.

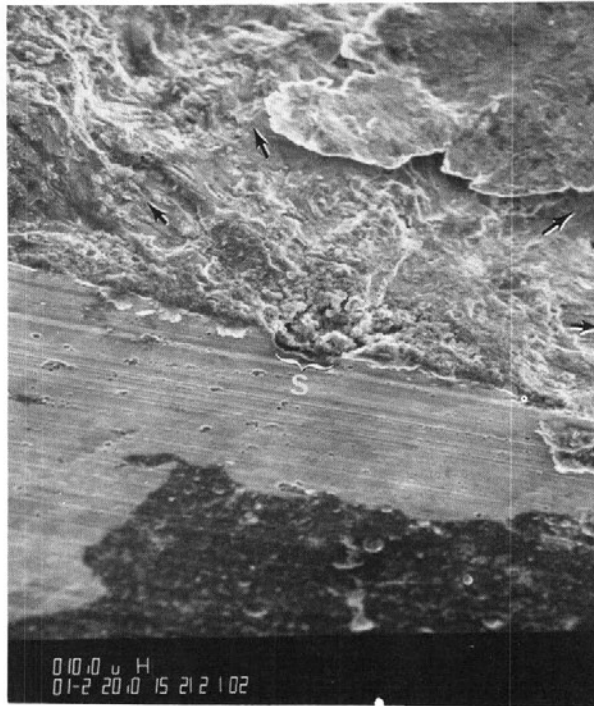
Detailed examination of the fracture origin area disclosed two origin sites, both of which appeared to be at discontinuities in the radius (See Figures 5 and 6, Appendix F). The two origins produced two planes of fatigue fracture slightly offset from one another. The two fatigue cracks grew into one large crack a short distance out from the radius. Because of the extent and symmetry of the crack arrest markings and the locations of the origins with respect to a ratchet mark (step-like portion of the fracture connecting the fatigue planes), one origin was considered secondary and the other was considered the main origin. A substance was found which completely filled the discontinuity at the secondary origin and partially filled the discontinuity at the main origin. (See Figures 5 and 6, Appendix F.) Energy dispersive X-ray analysis of the substance at the main origin area disclosed elements normally associated with the fitting alloy system along with an appreciable amount of sulfur and small amounts of calcium and potassium all of which are foreign elements. The silicon energy peak was strong indicating silicon as a primary element of the substance; the fitting alloy normally contains less than 0.4 by percent weight of silicon.

Figure 5. SEM photograph showing secondary origin bracket "S" (see arrow "S" in figure 4 for location). Fracture surface is above origin and hole radius is below. Arrowheads depict fatigue propagation direction. X100

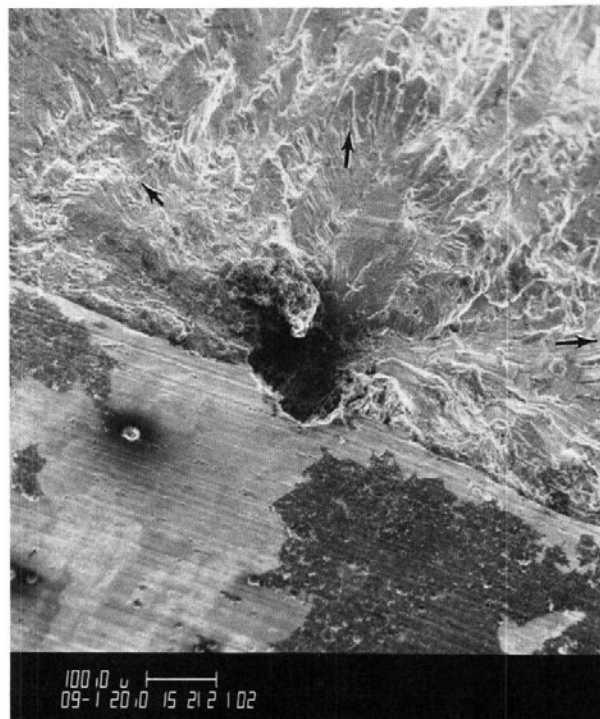
Figure 6. SEM photograph of main fatigue origin area (see arrow "O" figure 4 for location). Arrowheads indicate fatigue propagation directions. X90

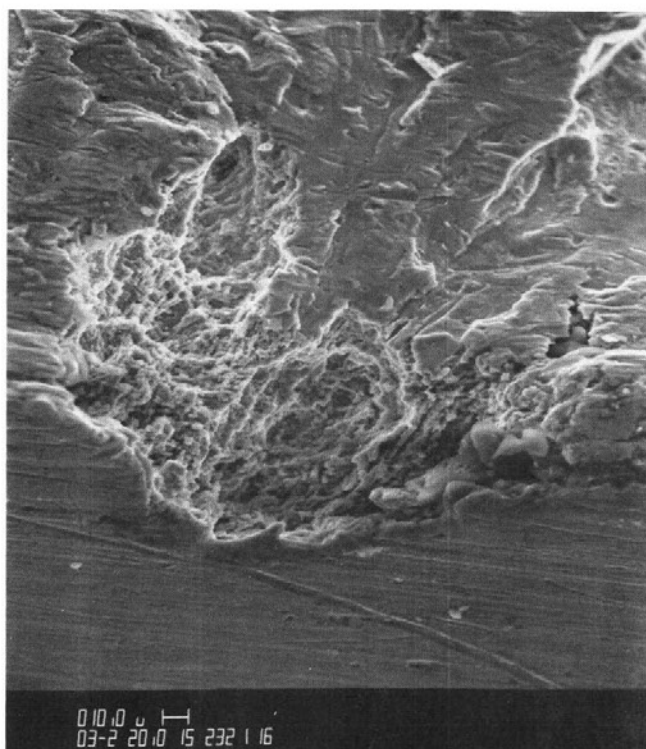
Figure 7 Main origin area shown in figure 6 after extensive cleaning by replication. X300

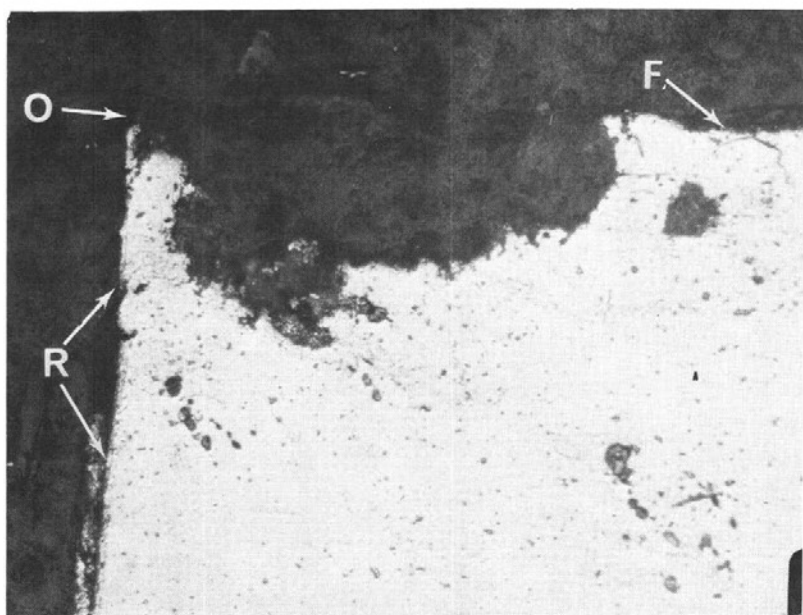
Figure 8. Longitudinal metallographic microsection through the main origin area showing the discontinuity in profile. Arrows "R" and "F" indicate the radius and fracture profile respectively. X375 Kellers etch

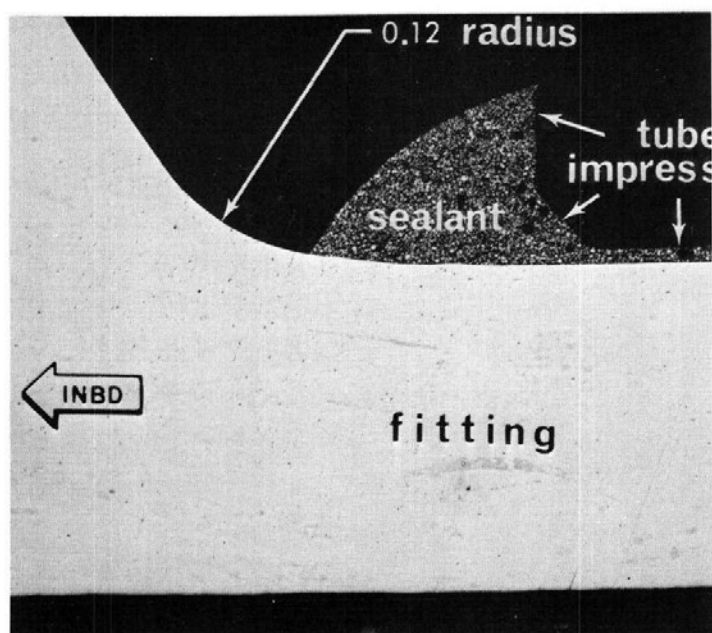
Figure 9. Longitudinal section through the fitting radius at a location diametrically opposite the fatigue origin. X10 unetched

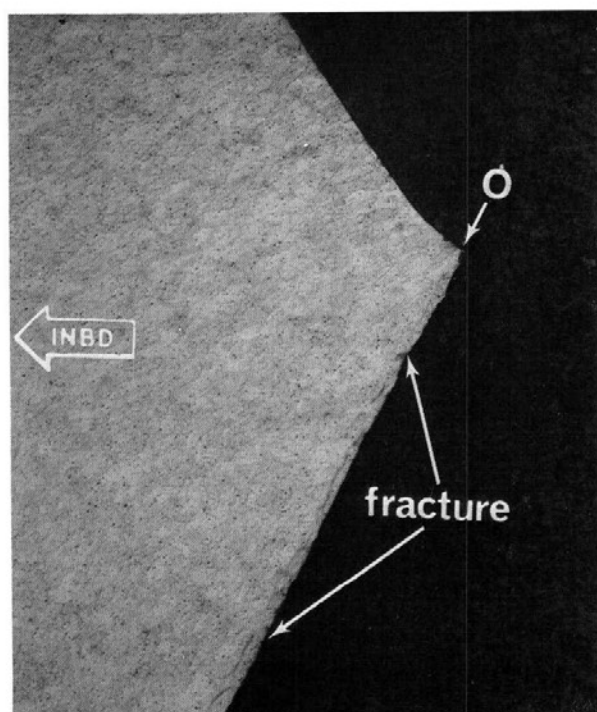
Figure 10. Longitudinal section through the main fatigue origin area. Arrow "O" indicates same area depicted by arrow "O" in figure 8. X10 nital etched
