Runway overrun, Continental Air Lines, Inc., McDonnell-Douglas DC-10-10, N68045, Los Angeles, California, March 1, 1978

AIRCRAFT ACCIDENT REPORT

**CONTINENTAL AIR LINES, INC.,
McDONNELL-DOUGLAS DC-10-10, N68045
LOS ANGELES, CALIFORNIA
MARCH 1, 1978**

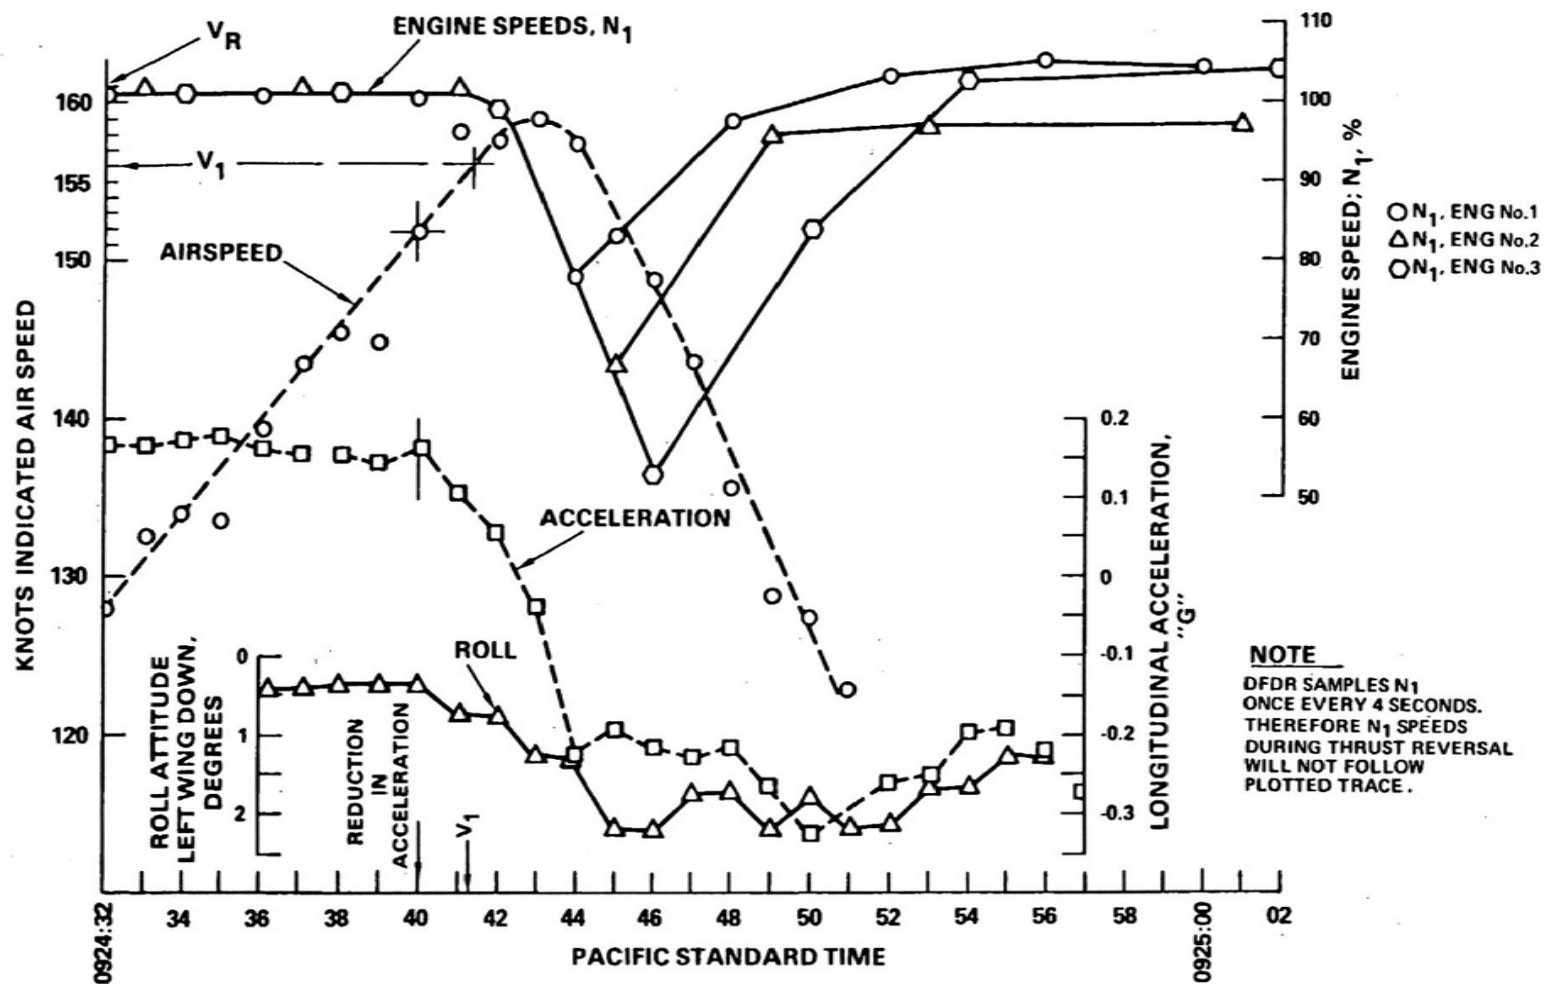
Figure 2. Aircraft performance before, after RTO initiation.

The DFDR data showed that the takeoff roll began from a static position on runway 6R at 0923:54. (See figure 2.) The wing flaps were set at 5°. Takeoff thrust was established at 101-percent N_1 on all engines as the aircraft accelerated through 37 kns. At 152 kns, 46 sec into the takeoff roll and 4 kns below V_1 , the longitudinal accelerometer began recording a marked decrease in the aircraft's acceleration although takeoff thrust was being maintained on all engines. No indications of tire failure were evidenced below 152 kns by the DFDR. At 152 kns, the DFDR roll attitude parameter began to record a gradual lowering of the left wing. V_1 speed, 156 kns, was reached 1.2 sec later, or 47.2 sec after the start of the takeoff roll. Engine thrust began to be reduced less than 0.5 sec after V_1 speed. A maximum speed of 159 kns, 2 kns below V_R , was recorded 1.8 sec after V_1 and 0.5 sec after longitudinal acceleration had changed from positive (acceleration) to negative (deceleration) values. Thrust reversers unlocked while the airspeed was decelerating through 157 kns at a peak deceleration rate of $-0.23g$. About 1.2 sec later, the thrust reversers were deployed at 152 kns as the engines were spooling down for thrust reversal and as the left wing reached its maximum down attitude of 2.1°. The engines began to spool up for thrust reversal 4.8 sec after V_1 ; maximum reverse thrust values were attained in 3 sec on the center engine, in 6 sec on the left engine, and in 8 sec on the right engine. Aircraft heading began to deviate to the right of the runway centerline as full reverse thrust was being attained. The heading reached 079°, the maximum deviation from the centerline, as the aircraft's speed decelerated through 58 kns.

A peak vertical acceleration value of 1.22g was recorded 20.8 sec after V_1 indicating the end of the runway. The airspeed at this time was decelerating through 68 kns with reverse thrust being maintained at 104- to 105-percent N_1 speed on the wing engines and at 100-percent N_1 speed on the center engine. Three sec later, the aircraft heading began a rapid turn to the left simultaneous with a sudden 10° lowering of the left wing. The left engine speed also decreased suddenly. Peak engine speeds for the center and right engines were recorded 1 sec later. Engine speeds began to decrease on the center and right engines at airspeeds of 57 kns and 30 kns, respectively. The last recorded airspeed was 30 kns.

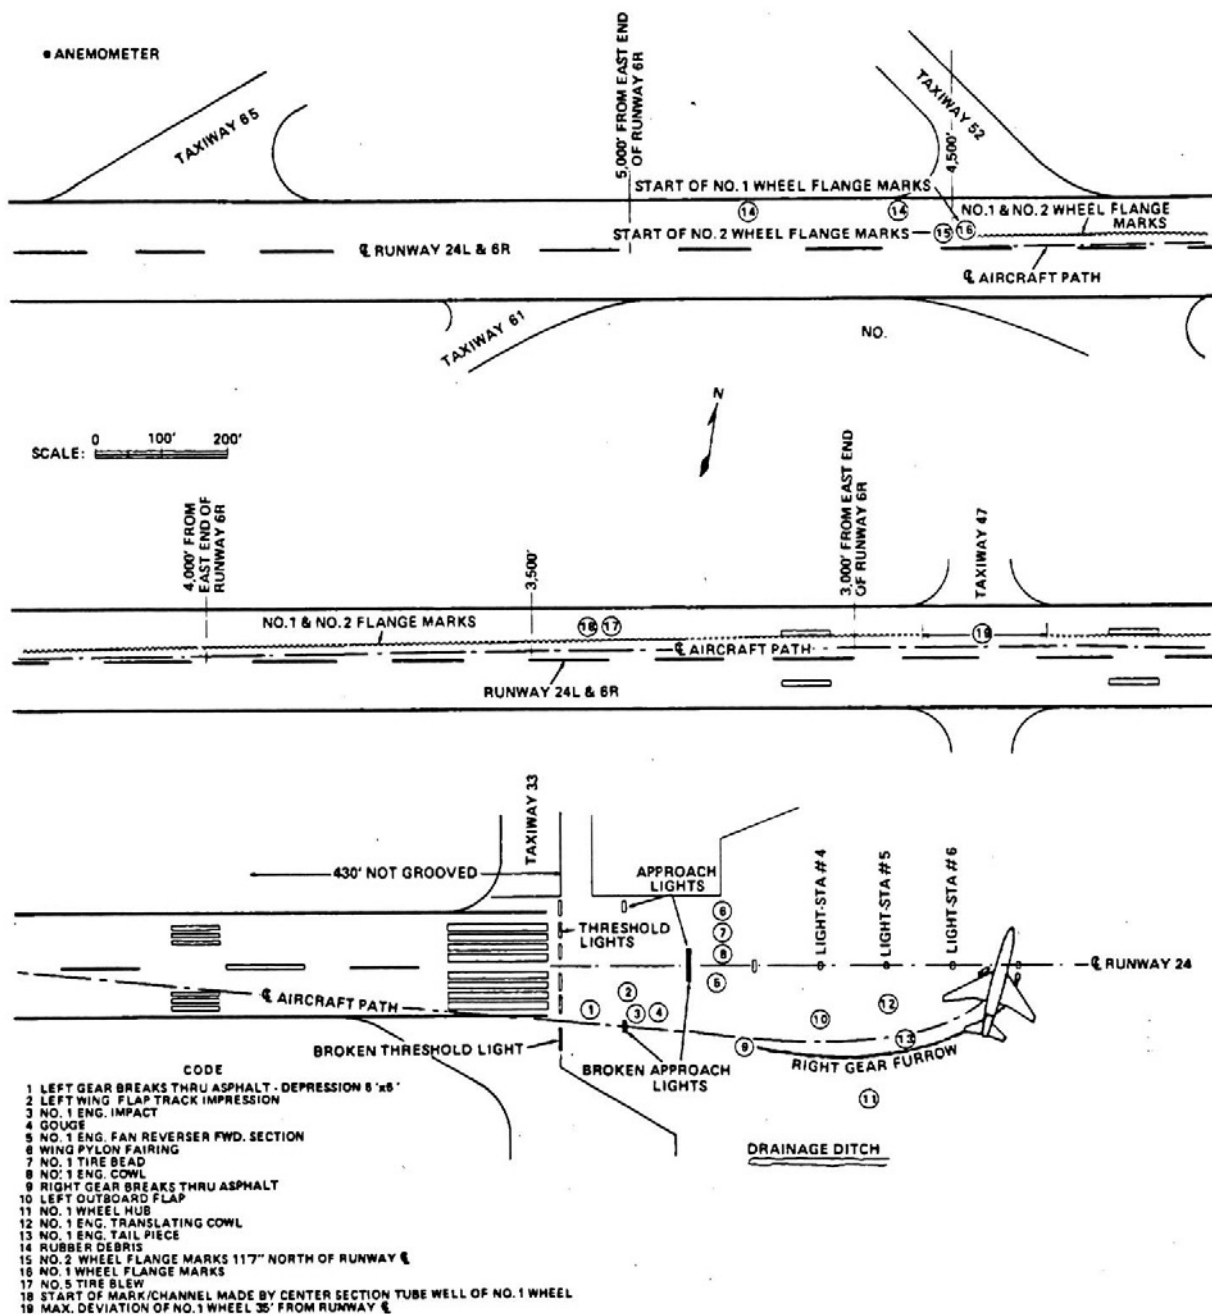
Figure 3. Aircraft wreckage distribution chart.

About 100 ft after the aircraft left the runway surface, the remains of the left main landing gear wheel and tire assemblies broke through the tarmac surface of the nonload-bearing area and the landing gear structure failed aft. The left-main landing gear strut was found trailing behind the wing; the lower end of the strut was supported by the No. 1 wheel and two brake assemblies, which were resting on the ground. The upper end of the strut was not deformed and was connected to the main landing gear support fitting. The support fitting was not connected structurally to the wing box. Extensions of the wing upper skin, upper doubler, lower skin, and lower doubler aft of the wing rear spar connecting the gear support fitting to the wing box had failed. The upper skin had torn off along the rear spar. The lower skin had torn off aft of the rear spar. The lower doubler was torn off aft of the skin fracture.

The upper and lower auxiliary spar was torn off at the flap hinge fitting. Major fasteners connecting the support fitting to the wing box failed, except for the lower outboard 1 1/2-in.-diameter bolt connecting the support fitting to the wing box internal bulkhead, directly forward of the support fitting.

A trapazoidal portion of the wing rear spar web (about 3 1/2 sq ft) remained attached to the landing support fitting. This opened up the No. 1 fuel tank. The rear spar shear web and doubler had failed. A length of the vertical tang of the rear spar lower cap and a portion of the lower outboard cap of the wing chordwise internal bulkhead also remained attached to the landing gear support fitting. The wing bulkhead upper 1-in. bolts failed 1 in. aft of the rear spar web. The lower inboard 1 1/2-in.-diameter bolt was missing from its hole. A portion of the lower bulkhead cap remained on the lower outboard 1 1/2-in.-diameter bolt. A section of the rear spar web and vertical tang of the lower cap had broken loose at the outboard end of the landing gear fitting, which created a 1-sq-ft hole in the aft wall of the left compartment of the No. 2 fuel tank.

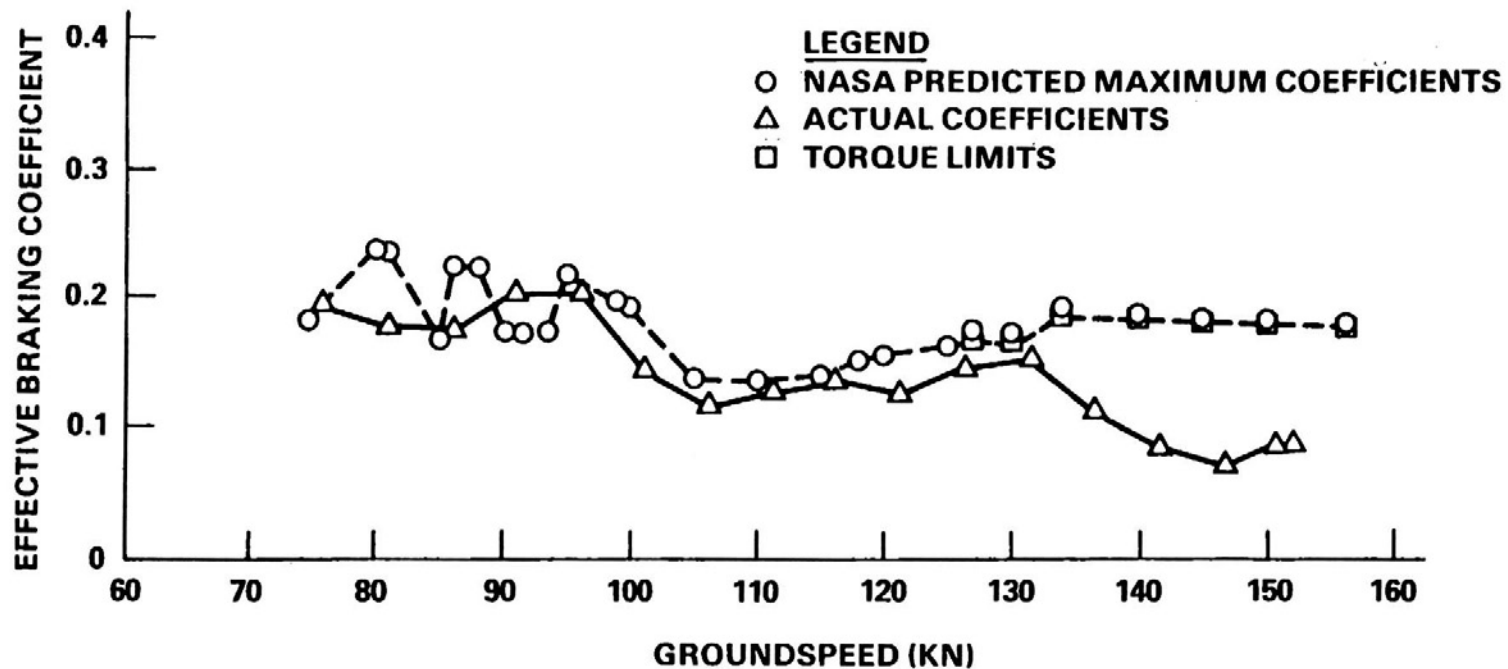
Figure 4. Comparison of actual and predicted maximum braking capabilities.

The effective tire to pavement frictional coefficients available to the failed left main landing gear tires and wheels during deceleration from 156 kns to 74 kns were 42 percent less than those available to the four unfailed right main landing gear tires over the same speed range. Douglas Aircraft Company estimated that the surface contaminants increased the aircraft stopping distance by 300 to 400 ft. By similar analyses, an uncontaminated, wet, and grooved surface was estimated to provide at least a 2,000-ft stopping distance advantage over an ungrooved, clean surface. NASA analysis confirmed these calculations.

The actual rejected takeoff braking performance for the Continental DC-10 was calculated using DFDR data and aerodynamic data. These calculations produced a relationship between effective tire-to-pavement frictional coefficients and aircraft groundspeed. When these results were compared to the NASA-predicted maximum braking coefficients over the same speed range, substantial differences were found in the 153 kns to 132 kns groundspeed range, during which the aircraft traveled about 1,200 ft in the initial portion of the takeoff. For groundspeeds between 132 kns and 68 kns (the end of runway speed), the Douglas and NASA braking values substantially agreed, indicating that maximum braking was being achieved over the last 2,250 ft of runway. (See figure 4.) Three possible reasons for the disagreement above 132 kns are: (1) The values predicted by NASA could have been excessive, (2) temporary loss or delay in antiskid system operation, and (3) the crew could have applied less than maximum brake pressure. If the predicted braking levels above 132 kns had been achieved, the aircraft might have stopped intact about 200 ft beyond the departure end of the runway. The Safety Board was not able to quantify the actual amount of braking effort applied by the crew or to accurately determine why the full braking values predicted by the NASA theory were not achieved.
