Midair collision, Pacific Southwest Airlines, Inc., Boeing 727-214, N533PS, Flight 182, Gibbs Flite Center, Inc., Cessna 172, N7711G, San Diego, California, September 25, 1978

AIRCRAFT ACCIDENT REPORT

**PACIFIC SOUTHWEST AIRLINES, INC.,
B-727, N533PS AND**

**GIBBS FLITE CENTER, INC.,
CESSNA 172, N7711G**

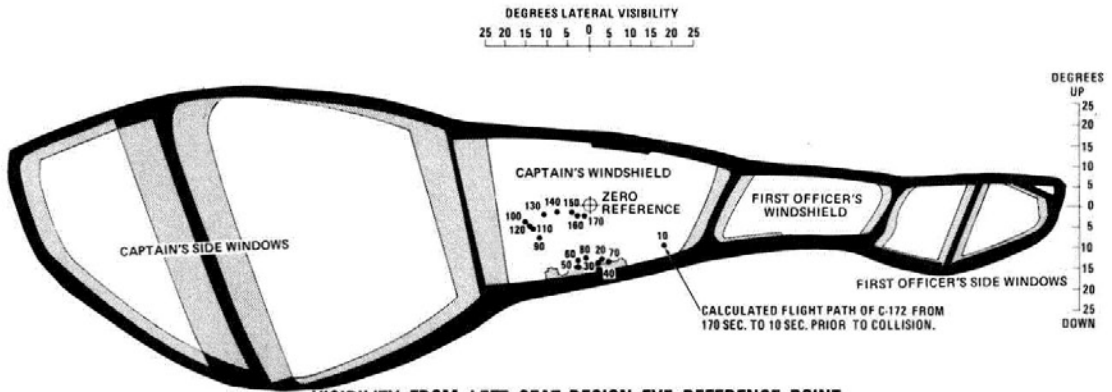
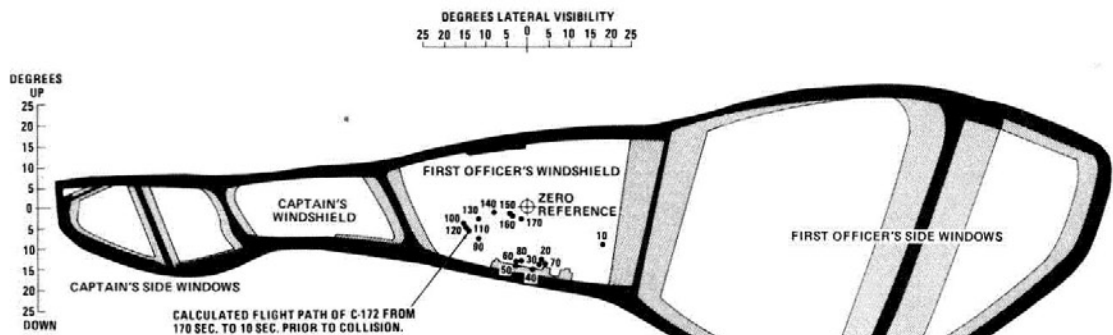
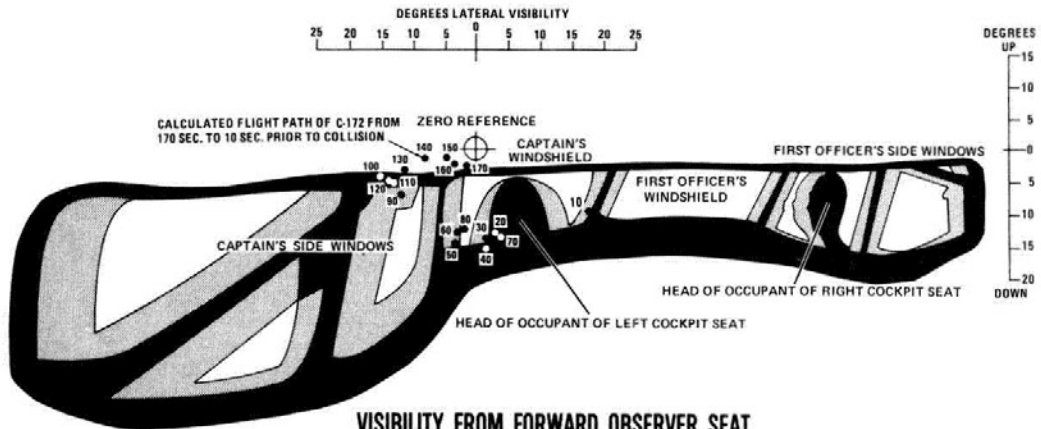
COCKPIT VISIBILITY - BOEING 727

3. The Cessna pilot failed to maintain the assigned heading contained in his ATC instruction.
4. The cockpit visibility study shows that if the eyes of the Boeing 727 pilot were located at the aircraft's design eye reference point, the Cessna's target would have been visible.
