Aircraft Accident Report, Near Collision of Delta Air Lines, Inc. Boeing 727-200, N467DA, and Flying Tiger, Inc. Boeing 747-F, N804FT, O'Hare International Airport, Chicago, Illinois, February 15, 1979

**NEAR COLLISION OF
DELTA AIR LINES, INC.
BOEING 727-200, N467DA,
AND FLYING TIGER, INC.
BOEING 747-F, N804FT
O'HARE INTERNATIONAL AIRPORT
CHICAGO, ILLINOIS
FEBRUARY 15, 1979**

NTSB-AAR-79-11

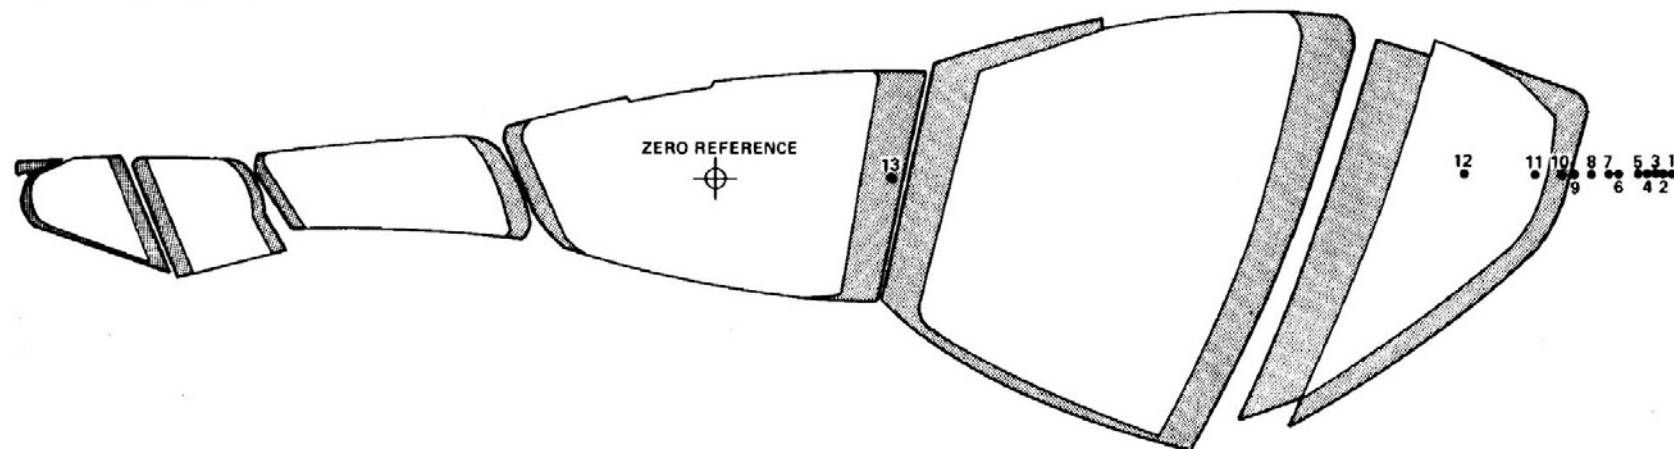
FIGURE 1

NUMBERS DENOTE TIME AND POSITION OF B-747
AS REFERENCED APPENDIX D

BOEING 727-200 QD326
 AIRCRAFT POSITION: LEVEL
 CAPTAIN'S NORMAL EYE REFERENCE POINT
 CAMERA POSITION:
 27.22" AFT OF INSTRUMENT PANEL LOWER EDGE
 20" LEFT BUTT LINE
 46" ABOVE DECK

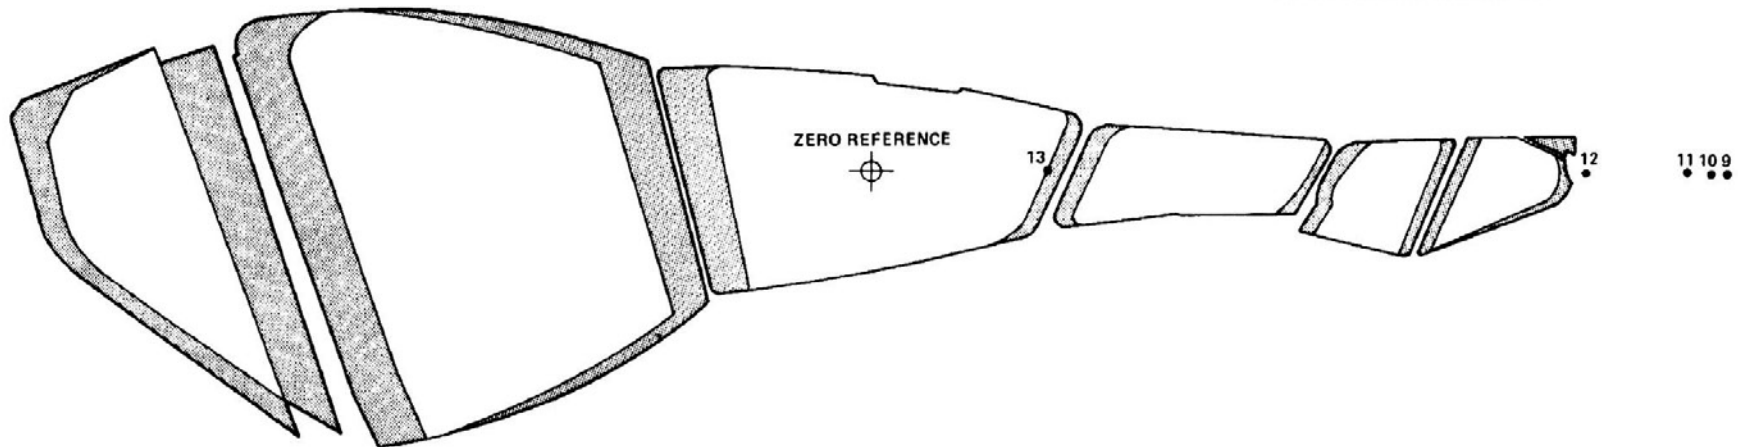
FIGURE 2

NUMBERS DENOTE TIME AND POSITION OF B-747
 AS REFERENCED APPENDIX D
