## **In-flight upset, Trans World Airlines, Inc., Boeing 727-31, N840TW, near Saginaw, Michigan, April 4, 1979**

**TRANS WORLD AIRLINES, INC.,  
BOEING 727-31, N840TW  
NEAR SAGINAW, MICHIGAN  
APRIL 4, 1979**

**NTSB-AAR-81-8**

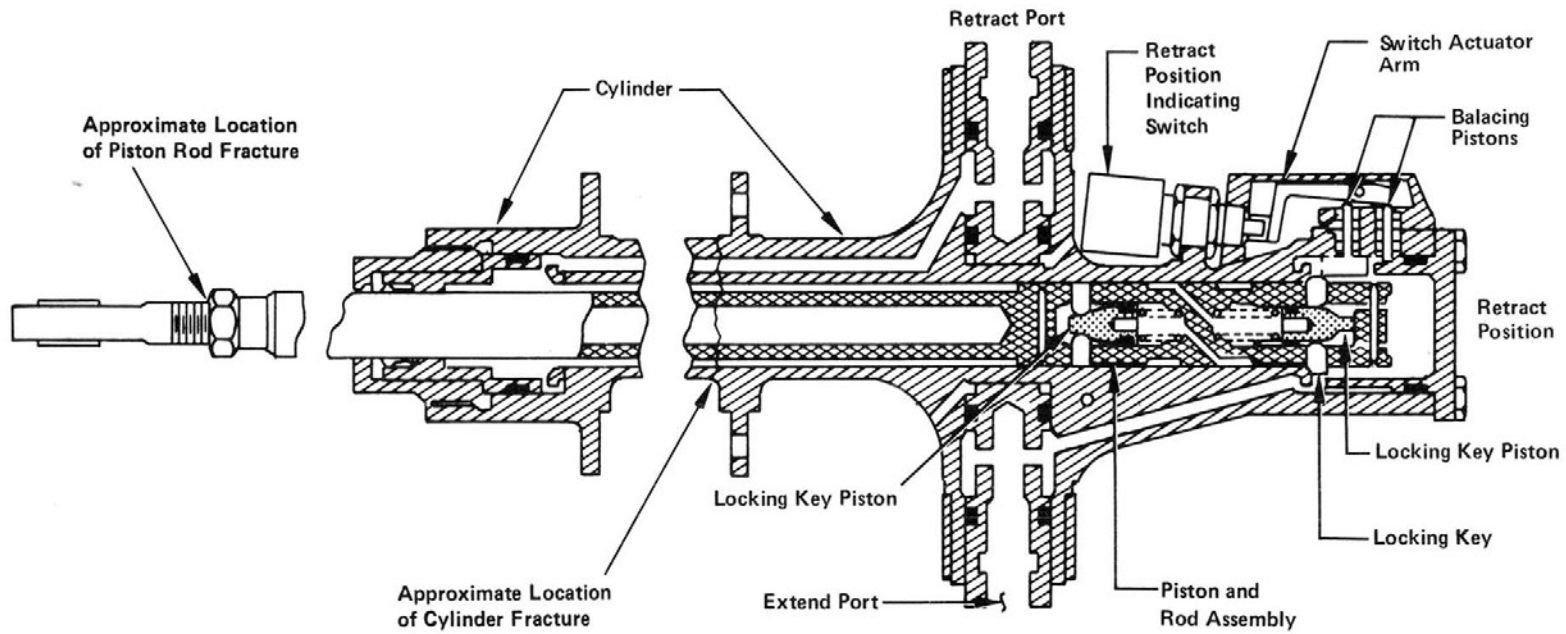
Figure 3.--Leading edge slat actuator.

A metallurgical examination of the No. 7 slat inboard T-bolt indicated that the cross section of the bolt had fatigue fracture characteristics. There was considerable smearing of the fracture face.

The No. 4 and No. 10 spoiler actuators were tested and they functioned satisfactorily. The remaining portion of the No. 7 slat actuator, including the switch mechanism, one lockring, and the shuttle valve, was examined. A production piston assembly could not be inserted into the broken end of the cylinder bore, but after removal of the end cap, it could be inserted into the opposite end of the bore and into the normal retracted position. However, the piston could not be moved past the retracted position through the broken end of the bore. Dimensional analysis of the bore disclosed that it was distorted near the broken end. The actuator bore was not scored, scraped, or marked.

The forward two-thirds of the actuator cylinder, the actuator piston, the piston rod, the locking pistons, and the locking pins were missing; therefore, the condition of the piston, its seals, and the piston rod could not be verified. However, as described above, it is not likely that even a massive failure of either or both piston seals would have nullified the mechanical lock.

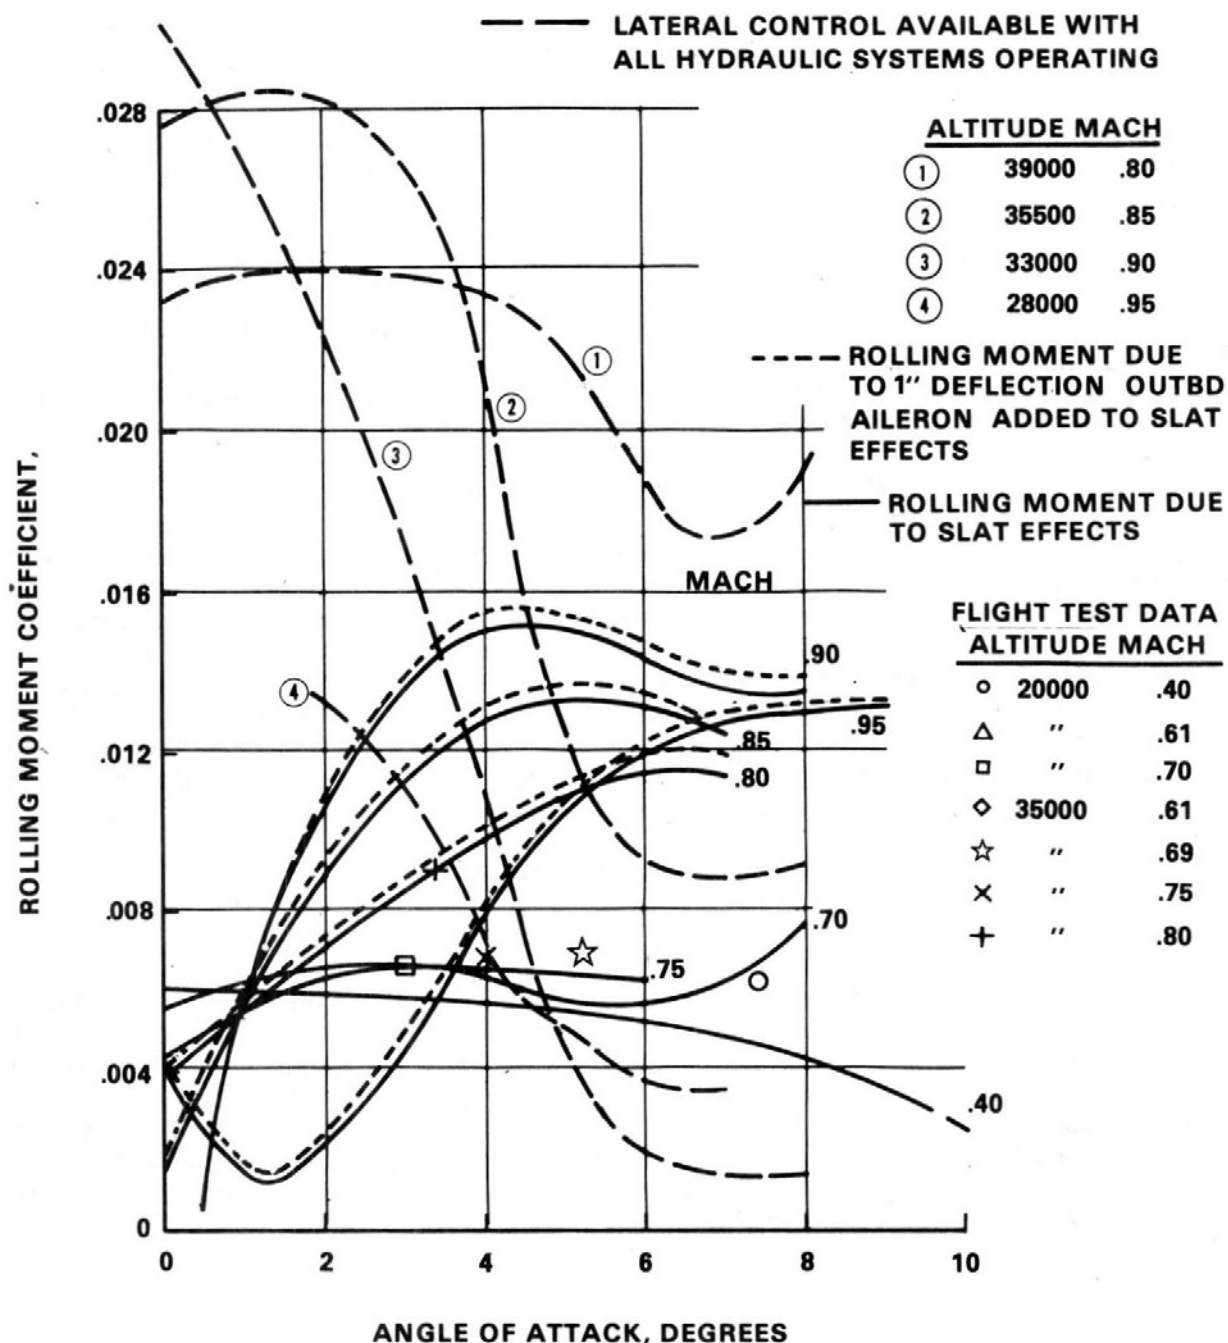
Figure 4.—Rolling moments from extended No. 7 leading edge slat — adjusted to flight test data points.

The rolling moment coefficients caused by the extension of the No. 7 leading edge slat were supplied by the aircraft manufacturer from wind tunnel and flight test data developed in 1975. These coefficients were compared to the lateral rolling moments available from aileron and spoiler controls at various mach numbers and altitudes as a function of wing angle of attack. The comparison showed that at Flight 841's cruise altitude of 39,000 feet and at a cruise angle of attack of 4°, the rolling moment available from lateral controls at mach 0.80 exceeded the rolling moment caused by the extended slat by a factor of about 2. At 37,000 feet, mach 0.85, and an angle of attack of 5°, the rolling moments were approximately equal. Further increases in the angle of attack or

Using the adjusted rolling moment data, a dynamic analysis of Flight 841's maneuver was performed. This analysis showed that 12.5 seconds after development of the roll to the right caused by the extended No. 7 slat, the simulated aircraft reached an attitude such that lateral control could not be regained by full deflection of lateral and yaw controls.

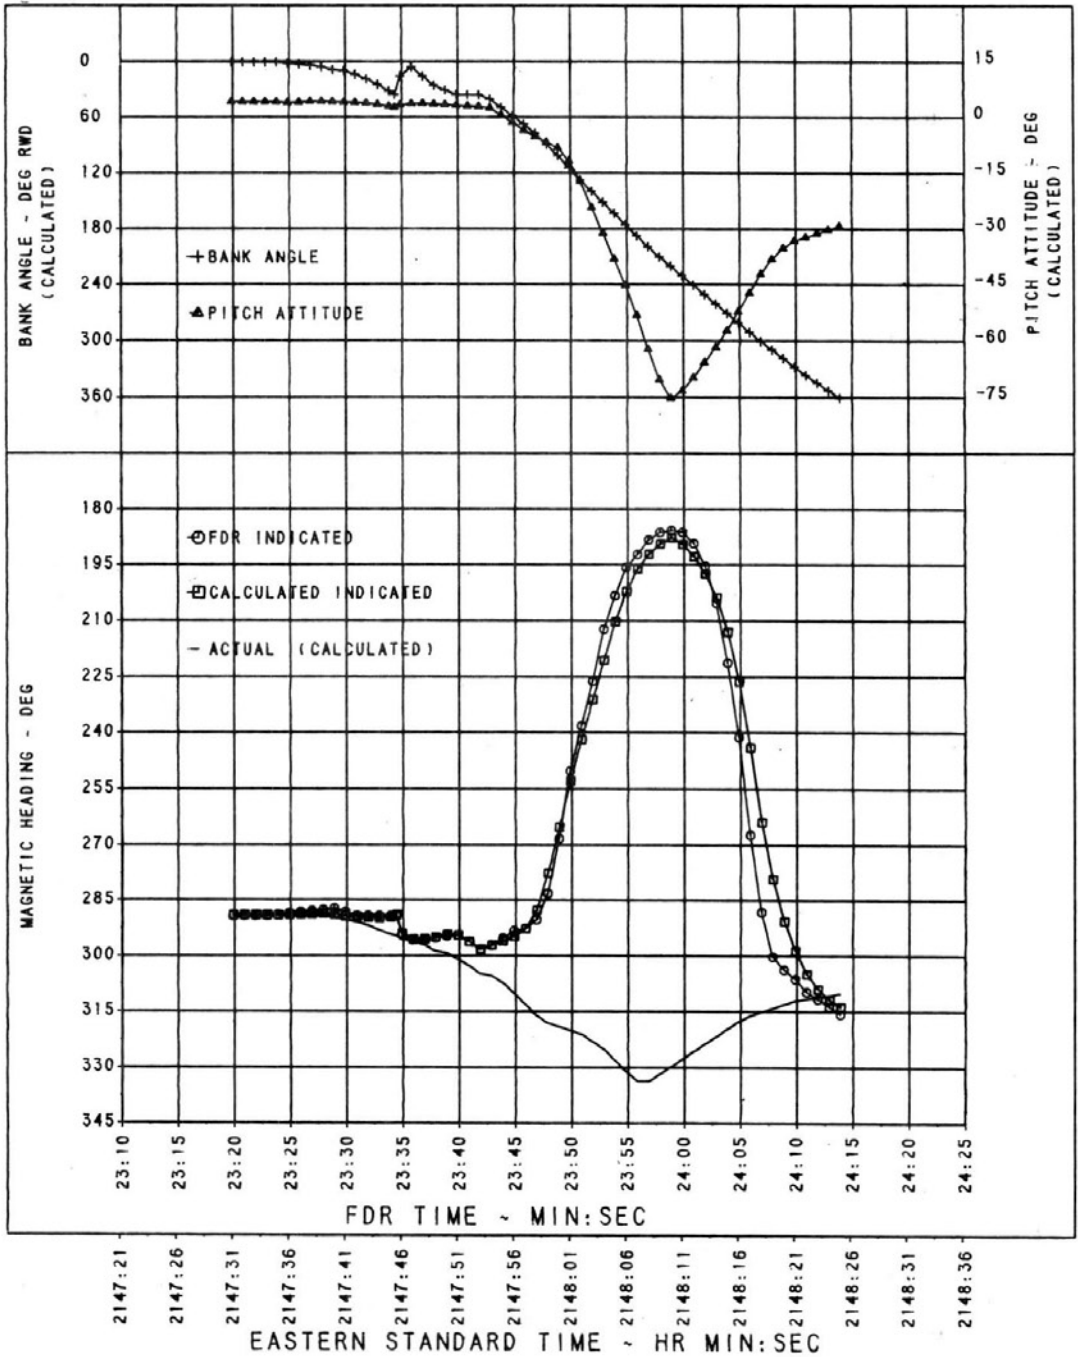
Figure 5.—Comparison of calculated and FDR headings.

As shown in figure 5, the calculated indicated heading trace for these heading, pitch, and bank angles compares almost exactly with the accident aircraft's FDR heading trace with the time shift removed. Beginning about 2147:34, the aircraft began to roll slowly to the right, and about 6 seconds later, the rate of roll began to increase. At 2147:45, the aircraft was in a right bank of about  $35^\circ$ , after which it was rolled rapidly to the left to near a wings-level attitude. About 2147:47, the aircraft began to roll again to the right, and the roll was arrested briefly at 2147:51 near  $35^\circ$  of right bank. At 2147:53, the aircraft resumed its roll to the right and about 2148:07, the aircraft was inverted with a pitch attitude about  $45^\circ$  below the horizontal. As shown in figure 5, the aircraft's actual heading (calculated) changed comparatively little during the  $360^\circ$  of roll.
