Tailcone loss in climb, Air Canada, McDonnell Douglas DC-9-32 (CF-TLU), East Of Boston, Massachusetts, September 17, 1979

AIRCRAFT ACCIDENT REPORT

**AIR CANADA
McDONNELL-DOUGLAS DC-9-32 (CF-TLU)
EAST OF BOSTON, MASSACHUSETTS
SEPTEMBER 17, 1979**

NTSB-AAR-80-13

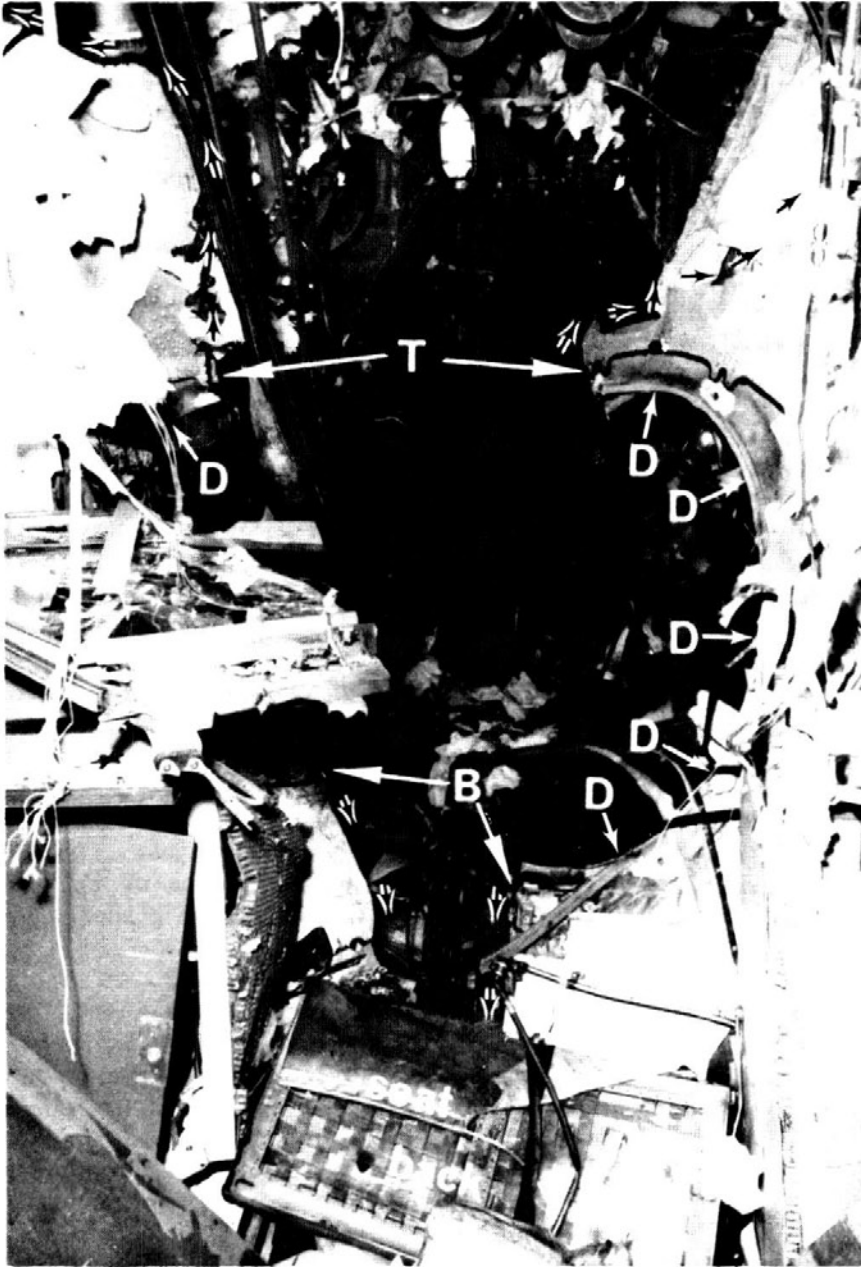
Figure 1.--Overall view looking aft on aft pressure bulkhead as first viewed in Boston. Arrows "D" outline the aft access door frame that is visible in this photograph. Mating areas at the top of the door jamb are denoted by arrows "T" and mating areas at the bottom of the door jamb are indicated by arrows "B". Unmarked arrows show principal fracture directions.

Fracture of the aft pressure bulkhead initiated from a large preexisting crack below the access door area. Primary crack initiation was by low-load,

high-cycle fatigue originating at a mechanical gouge in the lockbolt fastener hole that most likely occurred during assembly of the bulkhead. Cyclic loading of the bulkhead was produced by cabin pressure fluctuations, each of which correlated to one complete cycle per flight. The density of fatigue striations in the access doorjamb and the magnitude of the fatigue crack extension suggests that the fatigue crack began upon initial pressurization of the aircraft. The aircraft had 26,816 landings recorded at the time of the accident, and it is possible that each of the service cycles (equated to landings) produced a striation or incremental crack extension. The loads producing fatigue crack extension in the doorjamb would have been distributed to the door web when the jamb cracks extended to the location corresponding to the top of the web. Low-load, high-cycle fatigue cracking in the web most likely was occurring simultaneously with that in the jamb as the crack extended downward below the web interface. The web most probably tore downward incrementally to about 10 in from the lower rivet hole used to attach the web to the jamb. From this point, the failure appeared to progress catastrophically without further stoppage.

4. Separation of the aft bulkhead below the access door stemmed from a large fatigue crack in the doorjamb which originated in areas of preexisting mechanical damage in a lockbolt fastener hole.
