Midair Collision, United States Air Force, F111-D, Building Contractors Inc., Cessna TU-206G, Clovis, New Mexico, February 6, 1980

Investigative Body: National Transportation Safety Board (NTSB), USA

**MIDAIR COLLISION
UNITED STATES AIR FORCE, F111-D,
BUILDING CONTRACTORS, INC., CESSNA TU-206G,
CLOVIS, NEW MEXICO
FEBRUARY 6, 1980**

NTSB-AAR-82-10

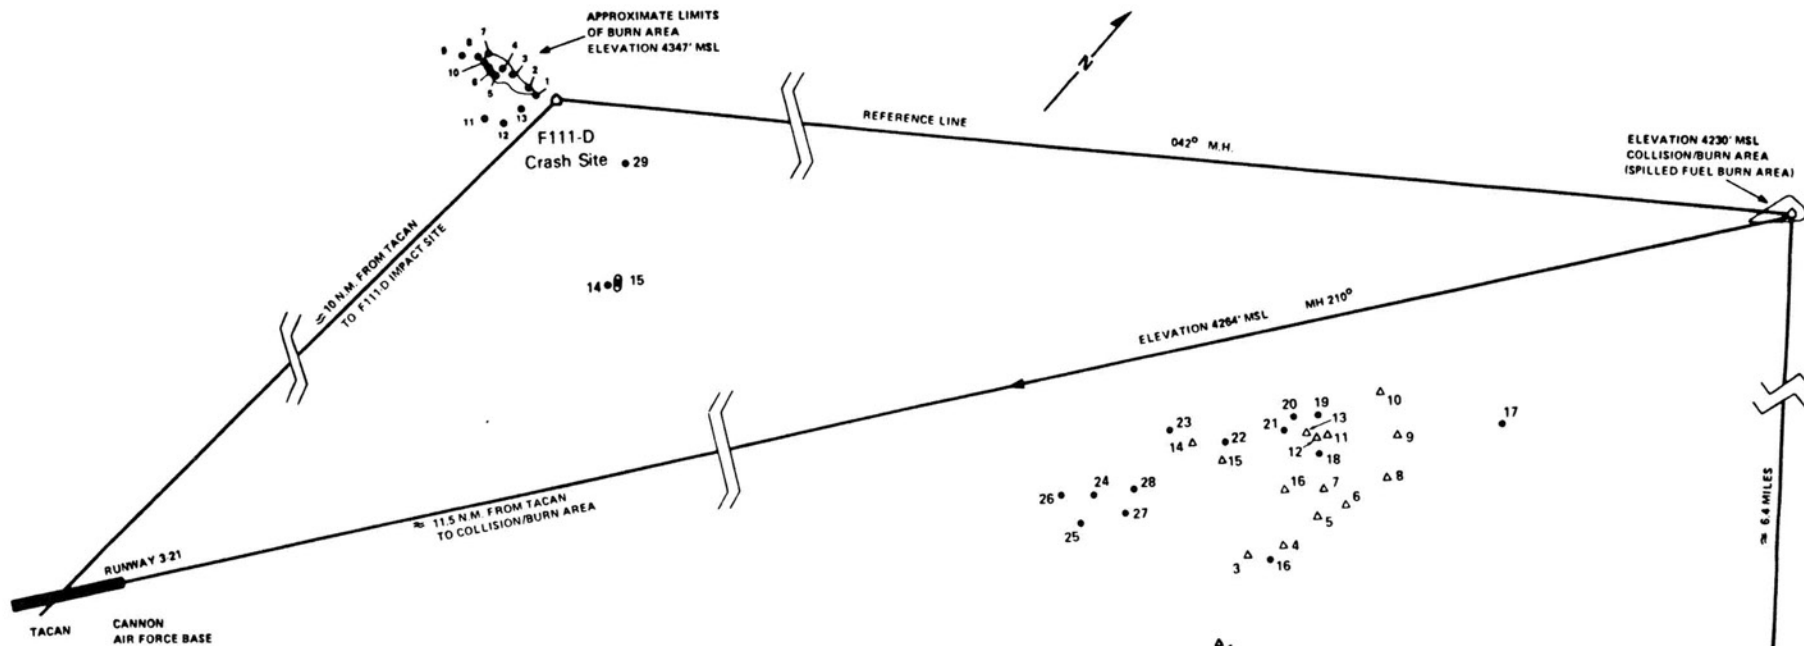
Wreckage Distribution Chart

The F-111D impacted the ground about 9,480 feet from the Cessna wreckage site. It was relatively intact prior to ground impact. Several parts separated from the aircraft during the in-flight collision and were found along the wreckage path. These parts showed evidence of fire damage as a result of the explosion during in-flight impact. At the time of collision, the aircraft's spoilers, flaps, slats, and landing gear were in the retracted position; the inlet spike system was in the full open position; and the speed brake was in the full extended position.

The right wing bomb rack unit, which was installed on the wing outboard pylon, had separated from the aircraft and was found along the wreckage path. The right bomb rack fairing was separated from the bomb rack and was found in the area of the Cessna wreckage. The right outboard side of the bomb rack body displayed heavy white scuff and scratch marks from the forward end running aft for 11 feet. Blue paint and scratch marks were noted on the rear aerodynamic fairing and rear bomb release mechanism. The inner barrel of the bomb rack unit contained numerous pieces of aircraft structure which were identified as being parts of the Cessna. These pieces consisted of wing stringers, wing spar and cap, wing access inspection plates, and a piece of the wing tank refueling cap.

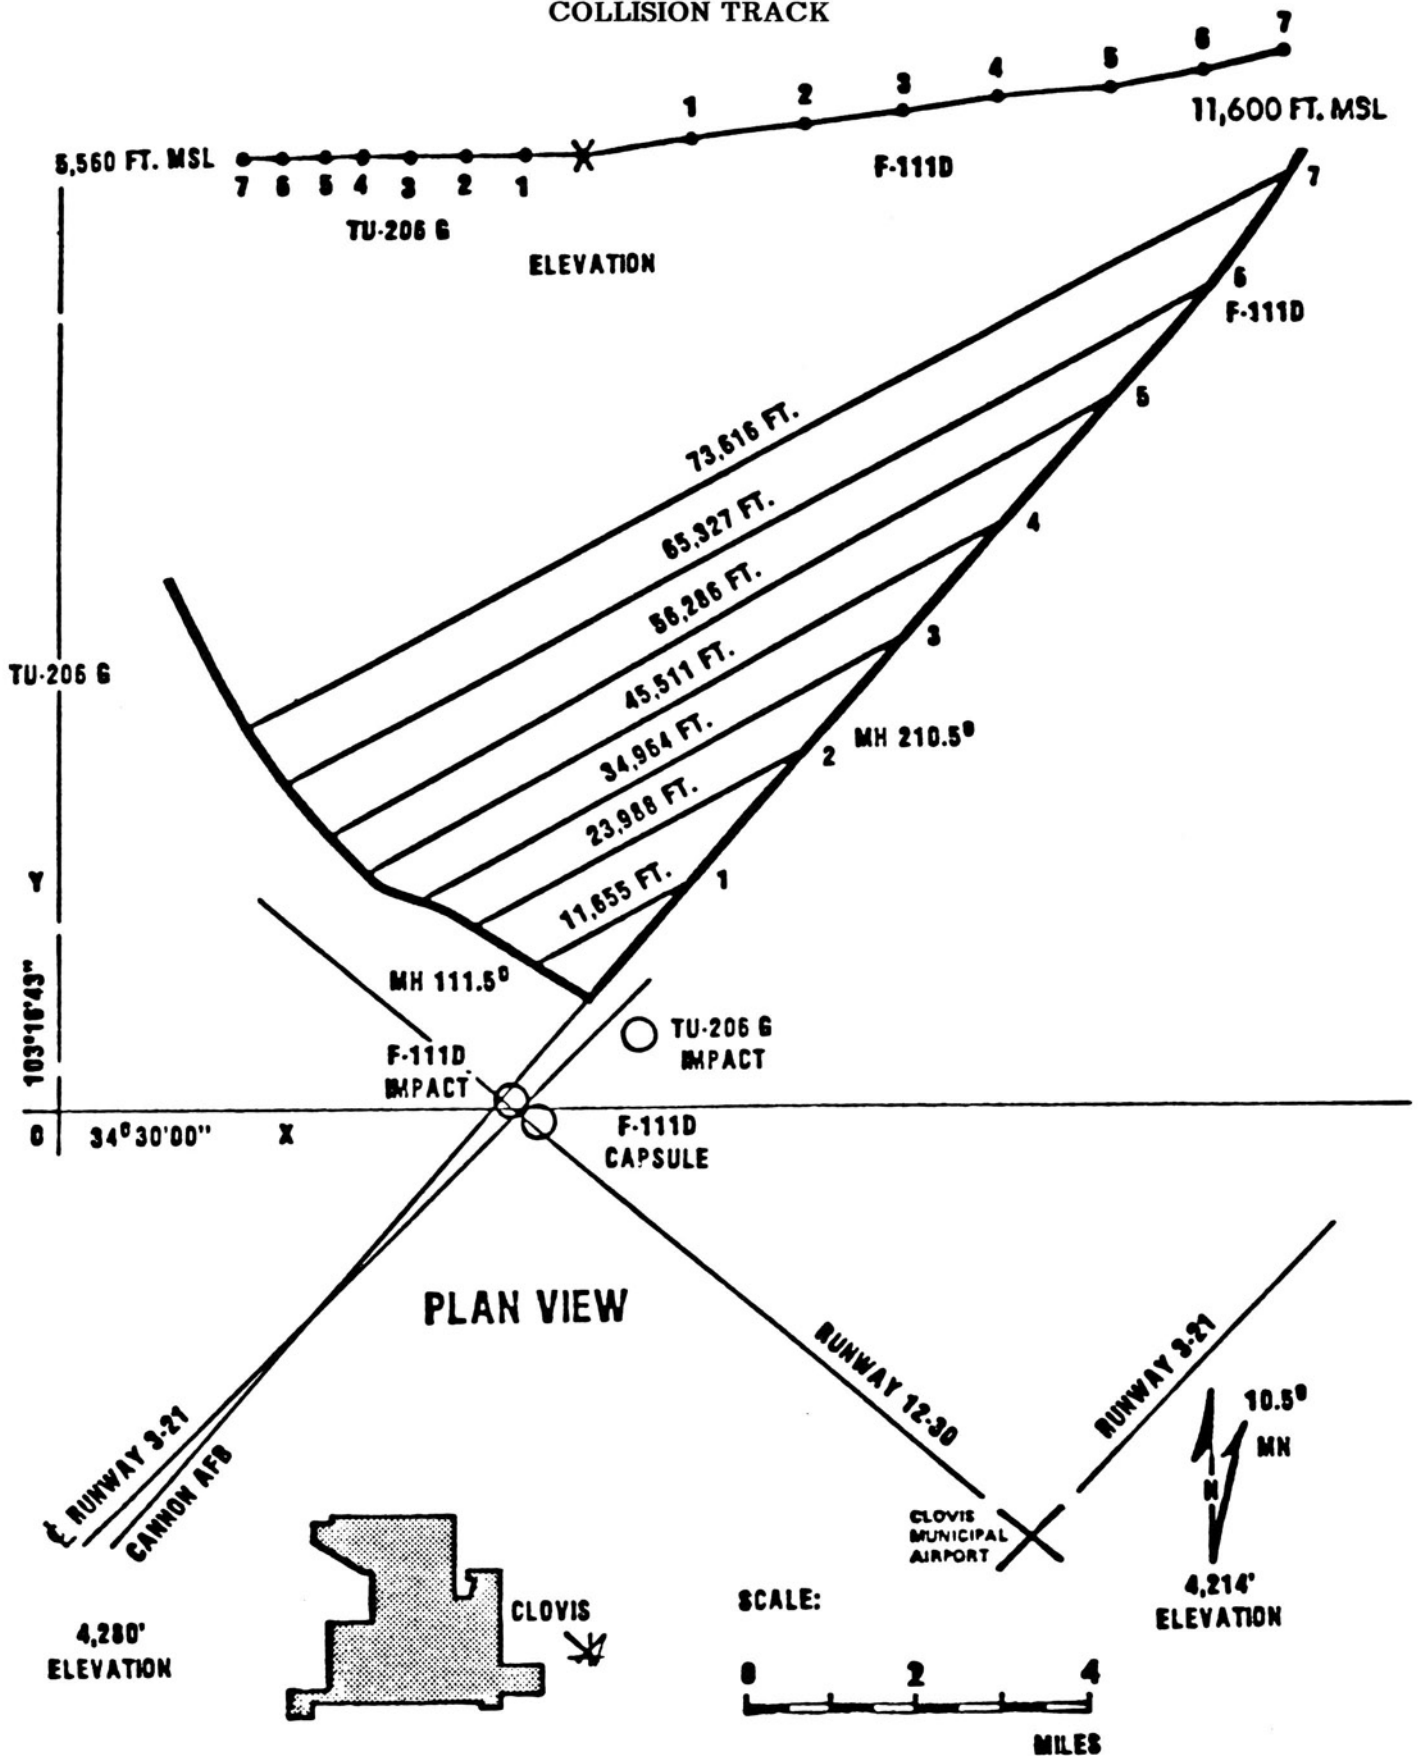
APPENDIX D
COLLISION TRACK

airspeed. The collision geometry and slant range between the two aircraft for the 105-second period before the collision have been calculated and plotted on binocular photographs. (See appendix D.) It is to be noted that the accuracy of a photo depiction of visibility is inherently limited because of the basic assumptions necessary in its construction.

The ABQ ATC radar track recording was smoothed to provide the average ground speed during the last 105-second period before the collision. This information in combination with the collision angles determined from impact markings provided an average closure rate. Further, as the radar track recording did not provide information below 6,400 feet and after the aircraft descended below 6,400 feet, and the collision occurred 14 seconds later, the recommended AILA approach profile and the instrument readings from the crew escape module at the time of module ejection were used to estimate the altitude and indicated airspeed at the time of collision.

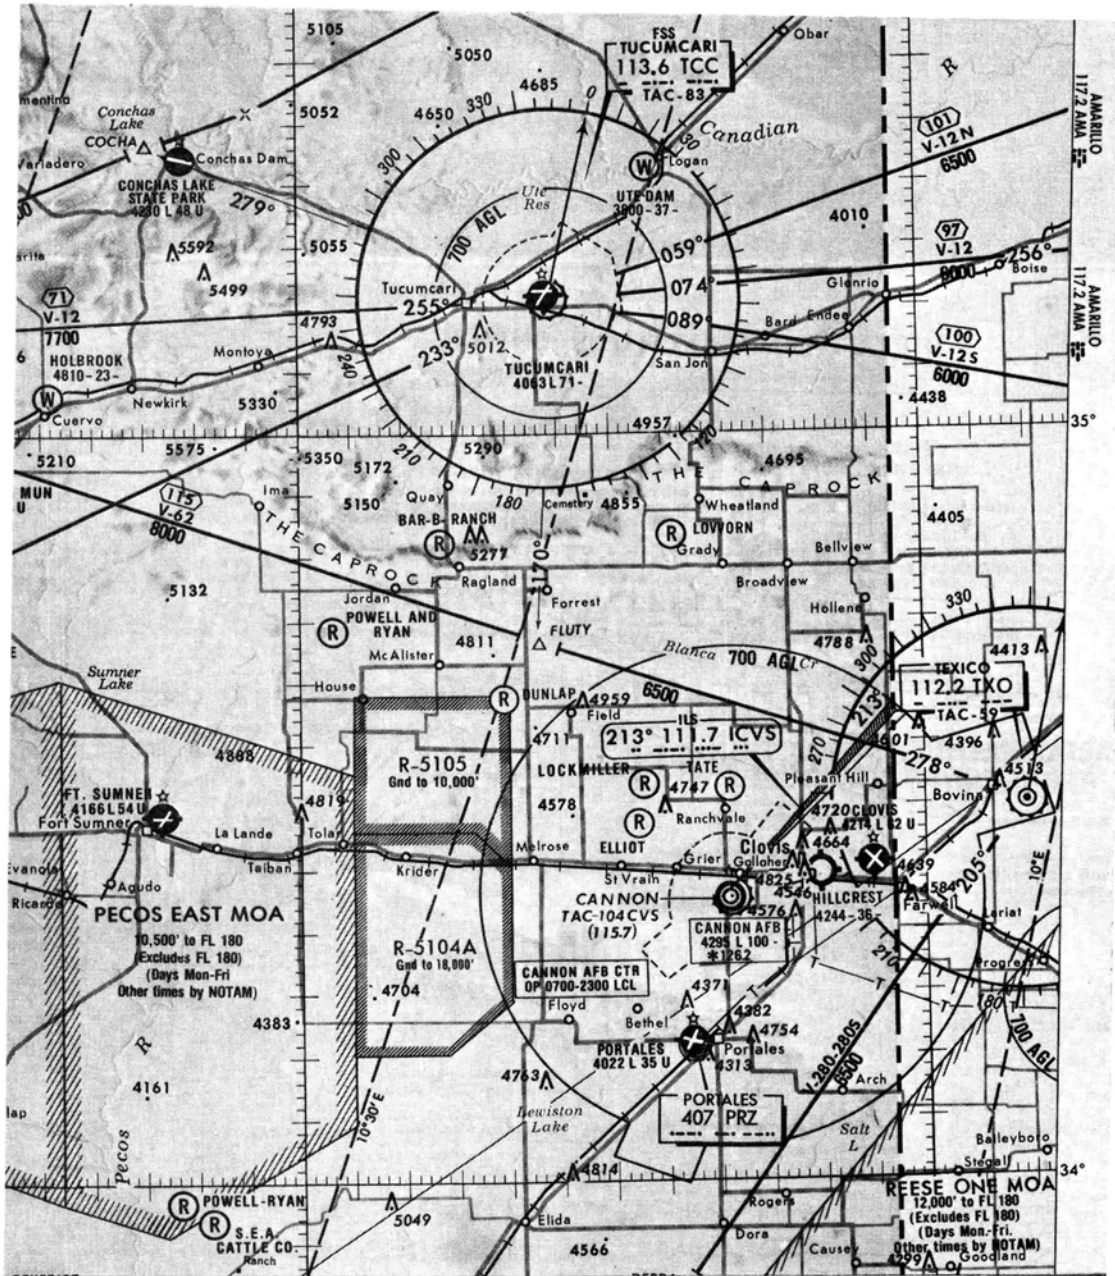
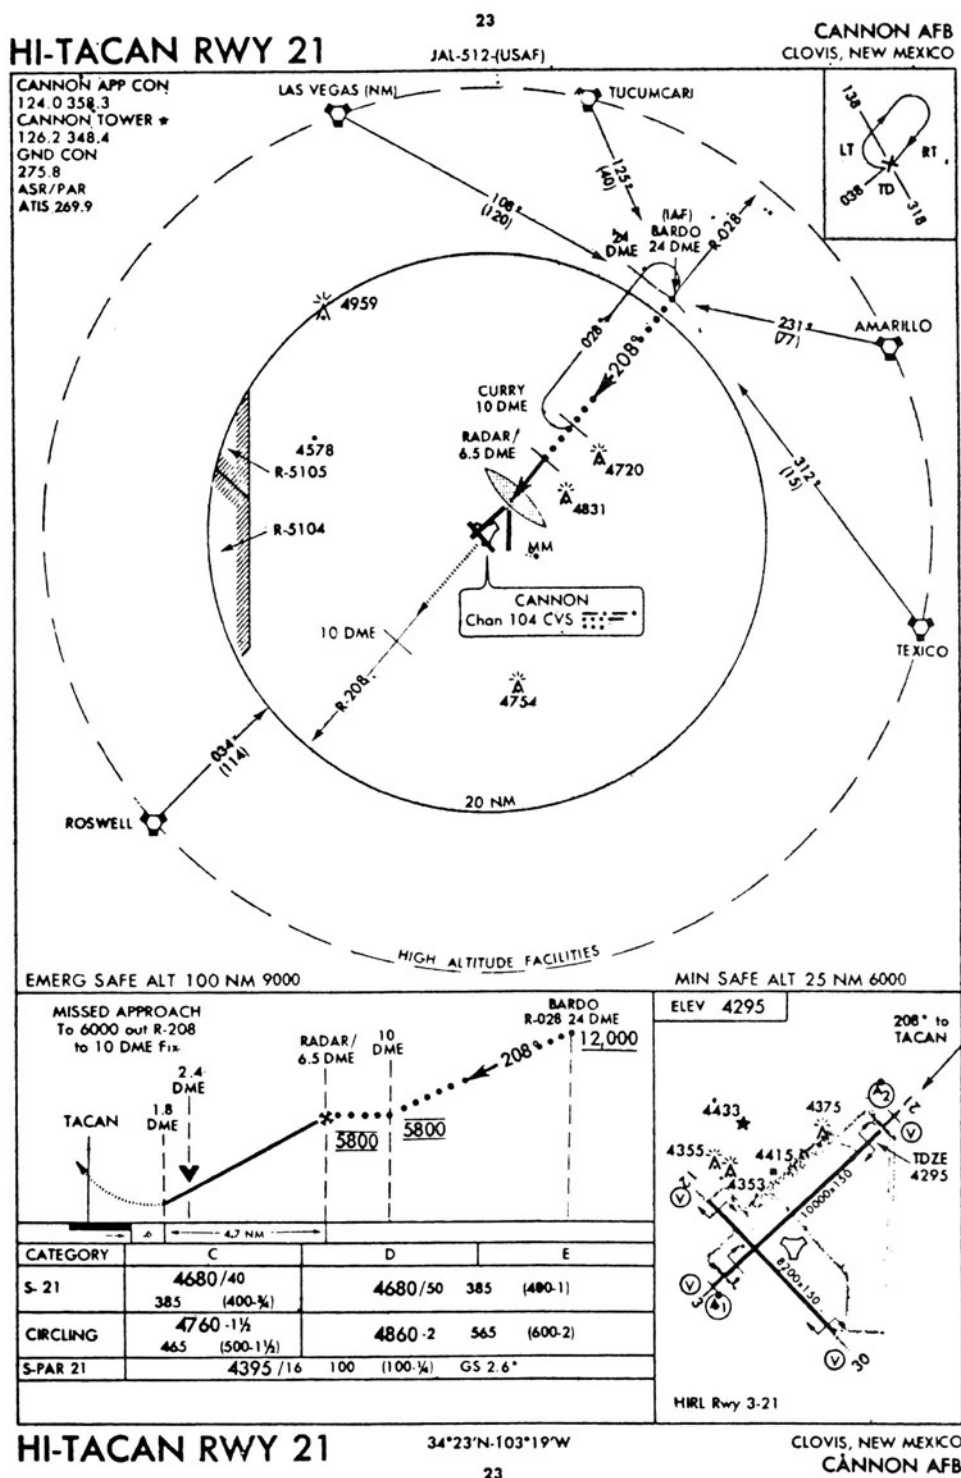
AERONAUTICAL CHART, STATE OF NEW MEXICO

The State of New Mexico publishes the New Mexico Aeronautical Chart.^{7/} The features are illustrated on this chart in a manner similar to the Federal Sectional Chart series. It depicts the Cannon AFB control zone and controlled airspace within a 19-nmi radius; however, radio frequencies for the Cannon Tower are included but not for the RAPCON. A copy of the New Mexico Aeronautical Chart was found in the Cessna wreckage.

A State of New Mexico Aeronautical Chart was found in the Cessna wreckage. This chart displayed the Cannon AFB control zone and the airspace controlled by the Cannon AT facilities. The features of this chart are illustrated in a manner similar to the U.S. ABQ Sectional Aeronautical Chart. Neither contained notations to caution pilots of heavy concentrations of low-altitude jet traffic in the Clovis area, to advise that Cannon AFB provided Stage II radar service, or to advise pilots to consult the publication "Graphic Notices and Supplemental Data" when flight is planned in the Clovis area.

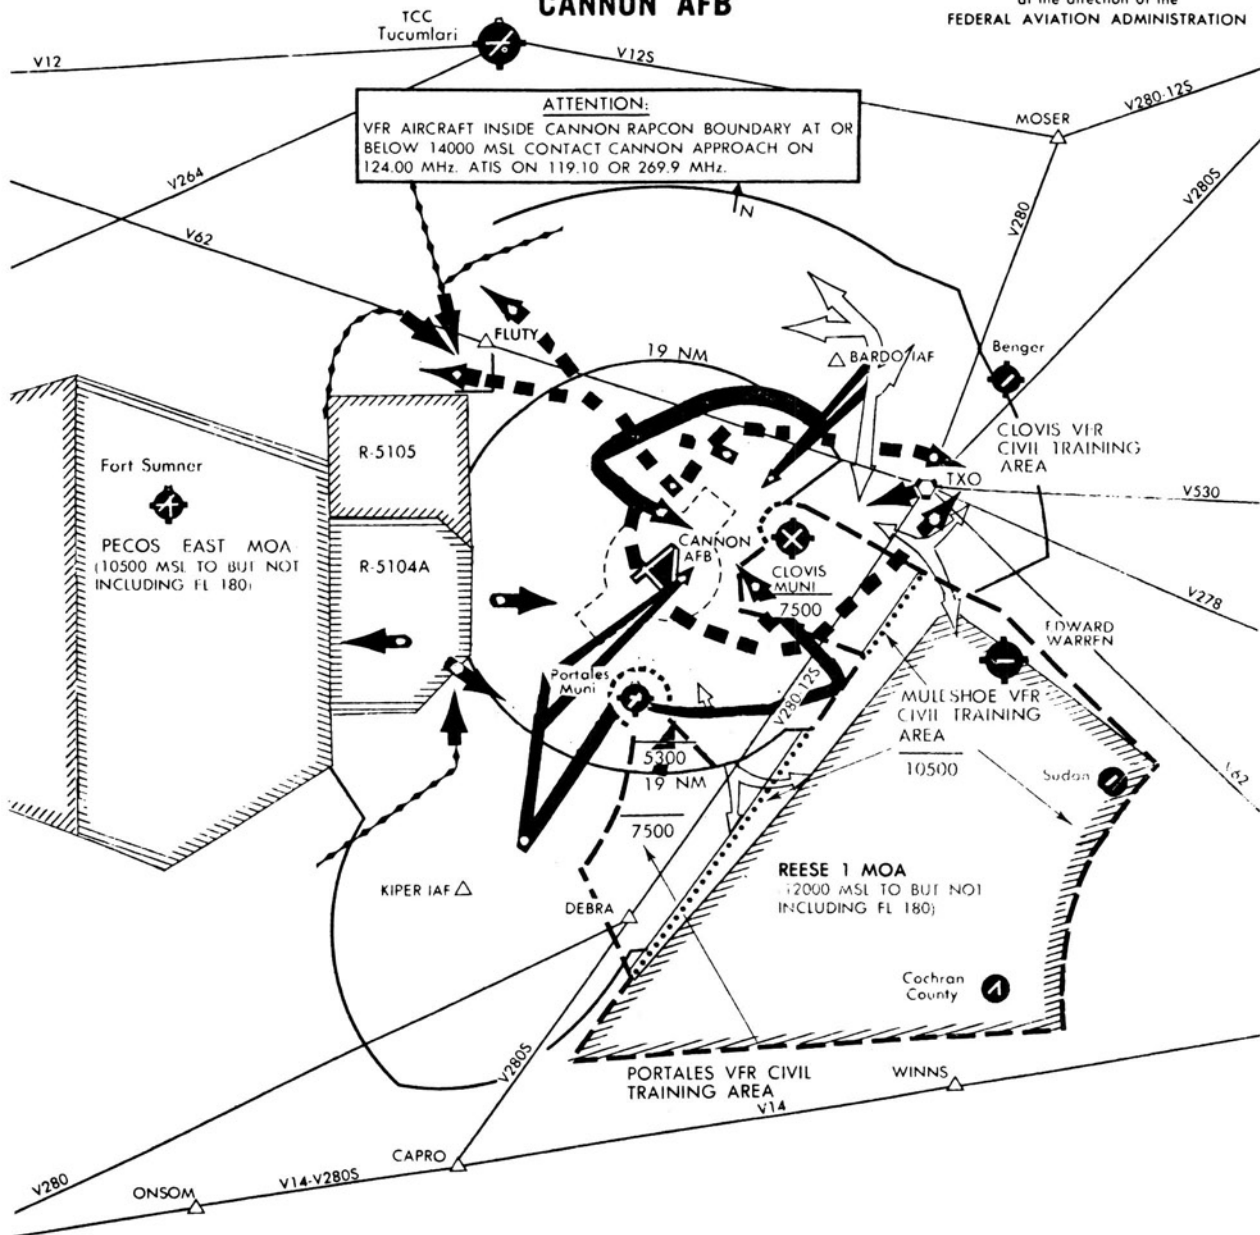
TERMINAL AREA GRAPHIC NOTICE, CHART DATED MARCH 9, 1981

The geometric outline in the northeast sector of the 15-nmi cautionary area of the chart, which relates to a VFR corridor but cannot be readily identified as a VFR corridor, does not appear in the legend although there is an unrelated symbol described in the legend as "Recommended VFR corridors". A numerical symbol which appears outside the cautionary area is intended to indicate that the maximum altitude to be flown in that area is 5,300 feet. This symbol, which is used on instrument approach charts, is not described in the legend of the subject graphic notice. The meaning of the geometric outline and the numerical symbols might not be known to a noninstrument rated pilot.

12. The terminal area graphic chart for Clovis-Cannon AFB, which was published in the January 1980 issue of "Graphic Notices and Supplemental Data," contained symbols not depicted in the legend and notations not clearly defined on the chart. The Cessna pilot may not have understood that he was flying at an unsafe altitude even if he had consulted the chart.
