Power loss in thunderstorm, Air Wisconsin, Swearingen SA-226 Metro, N650S, Valley, Nebraska, June 12, 1980

**AIR WISCONSIN, INC.,
SWEARINGEN SA-226 METRO, N650S
VALLEY, NEBRASKA
JUNE 12, 1980**

NTSB-AAR-80-15

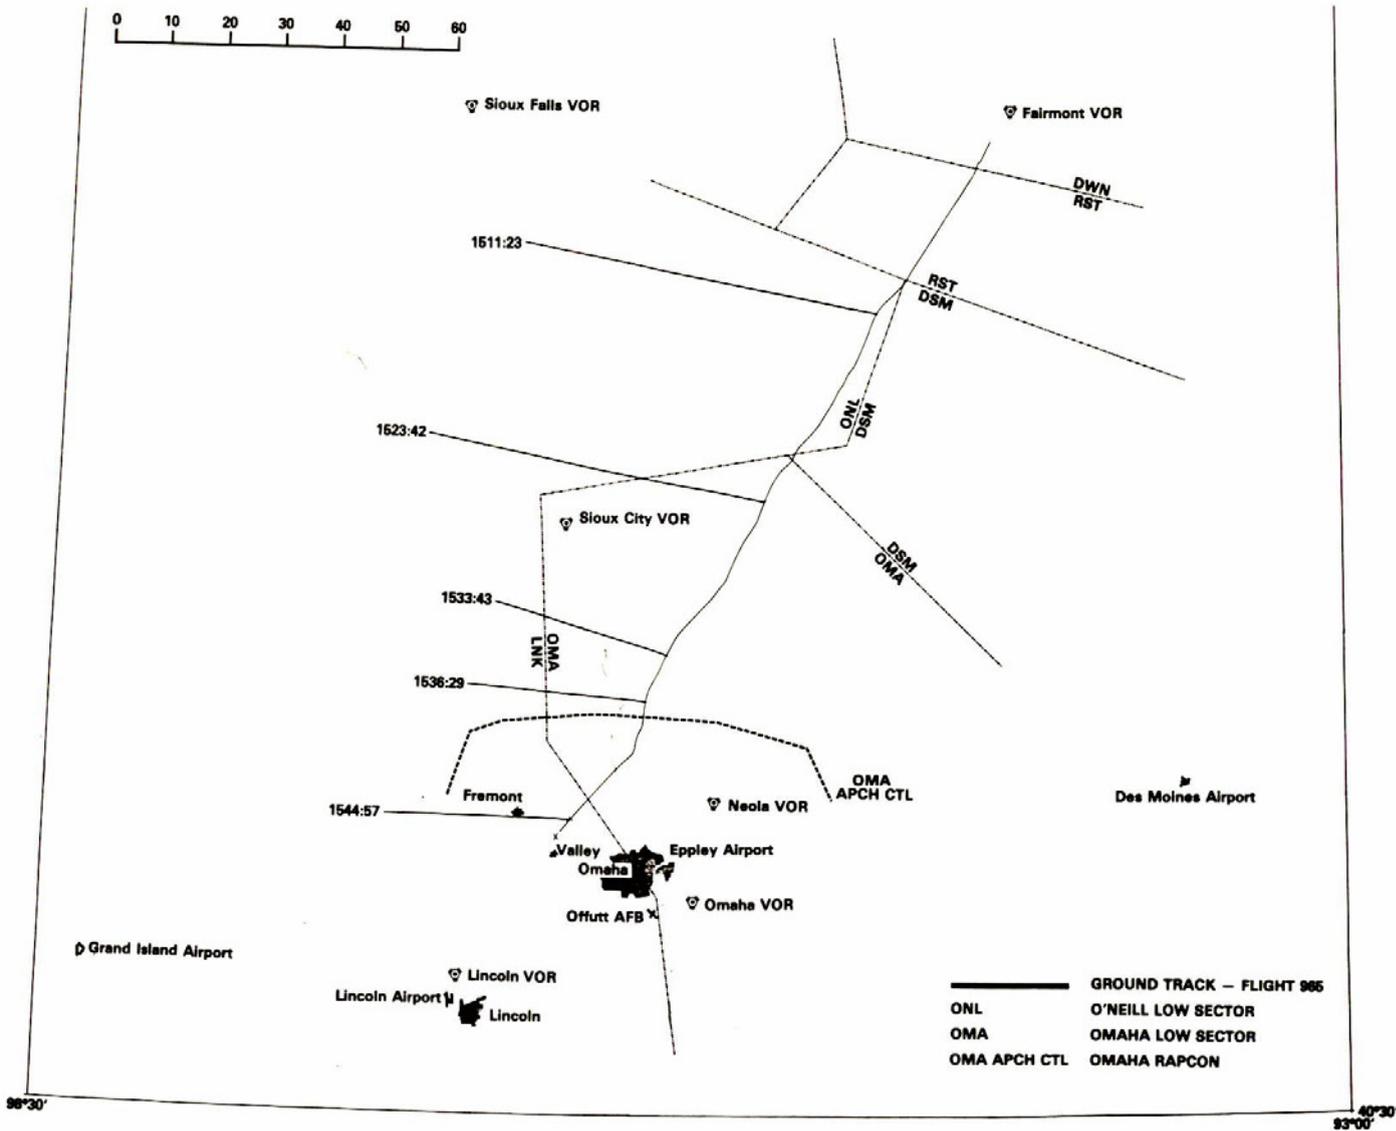
Figure 1.—Probable Ground Track

At 1511:23, the Minneapolis ARTCC O'Neill low controller said, "Wisconsin 965, there's a large area of weather twelve o'clock and about thirty five miles and extends from east of Neola up around Sioux City and down the west side to Fremont. Had one aircraft at flight level two zero zero went around the area. Another one at nine thousand inbound to Lincoln, found his way through it. Don't know how bad it is, anything else. He said he could pick his way through pretty good, though." (See figure 1.)

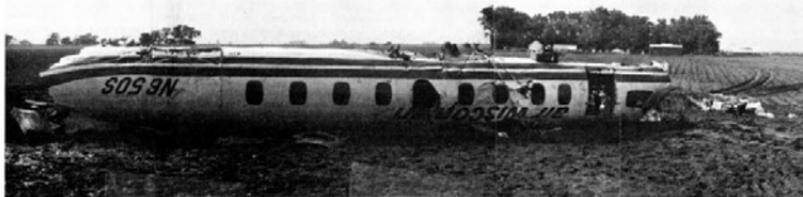
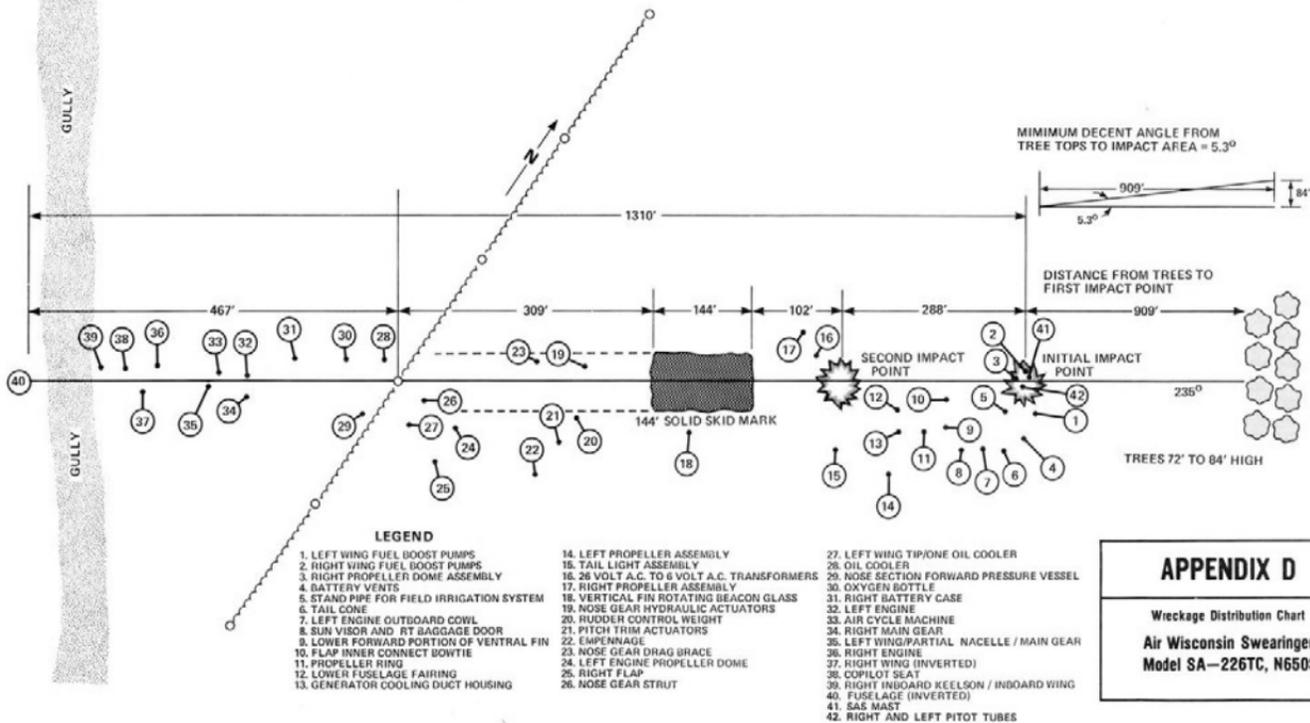
Wreckage Distribution Chart
Air Wisconsin Swearingen
Model SA-226TC, N650S

The empennage separated from the fuselage about 665 ft beyond the initial point of impact, and both engines and wings were found between 900 ft and 1,150 ft from the initial impact point. The propeller assemblies had separated from the powerplants, which had separated from the wings. (See appendix D.)
