Crash short of runway, Continental Airlines and Micronesia Inc., Boeing 727-22C, N18479, Yap Airport, Yap, Western Caroline Islands, November 21, 1980

AIRCRAFT ACCIDENT REPORT

**CONTINENTAL AIRLINES /
AIR MICRONESIA, INC.
BOEING 727-92C, N18479
YAP AIRPORT
YAP, WESTERN CAROLINE ISLANDS
NOVEMBER 21, 1980**

NTSB-AAR-81-7

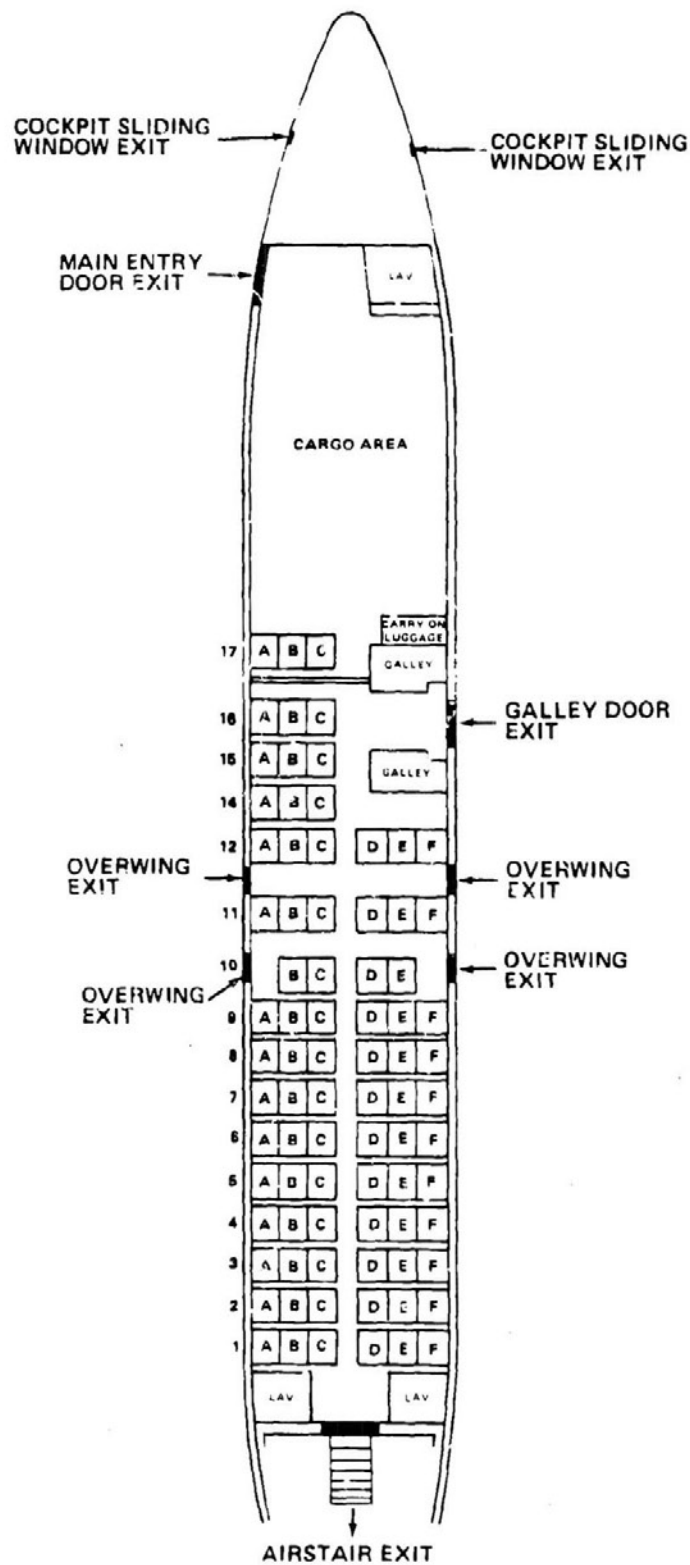
Figure 1.--Aircraft seating and exit locations.

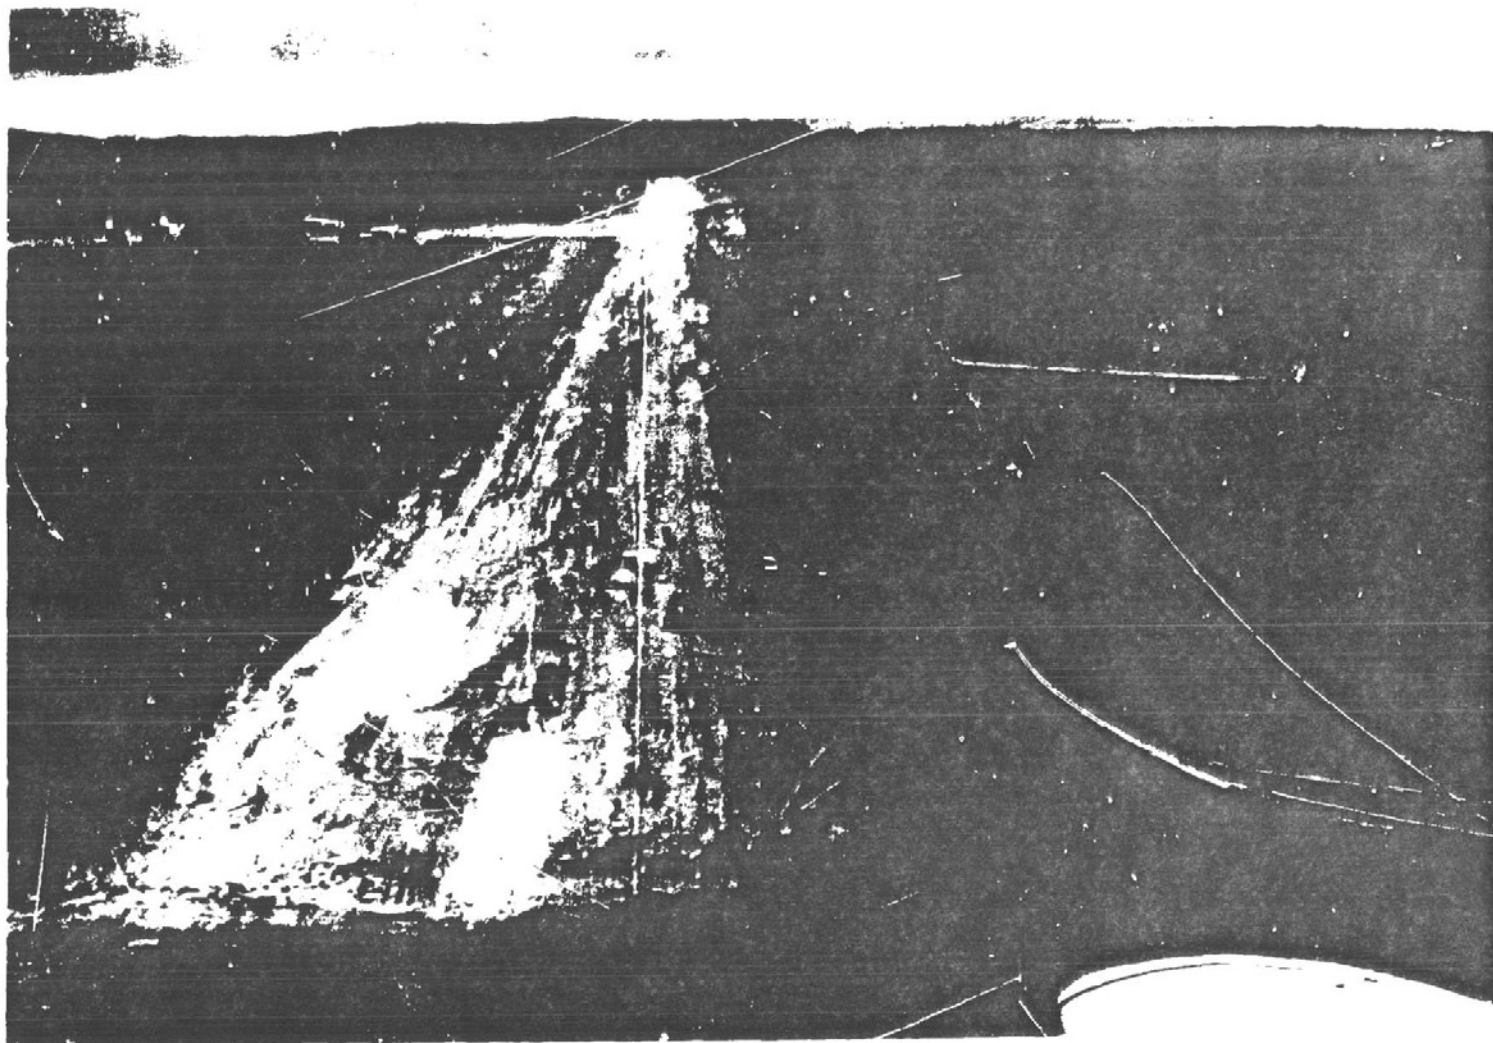
There is no VASI or other glidepath guidance information available for the runway. There are 1,000-foot distance markers along each side of the runway and 6-foot-high white bamboo A-frame touchdown zone markers on each side of the runway 1,000 feet from each end of the runway. There are no runway end identifier markers or stripes on the runway. (See figure 2.)

Figure 2.--Approach to runway 7 at Yap Airport seen from one-half mile from the runway threshold.

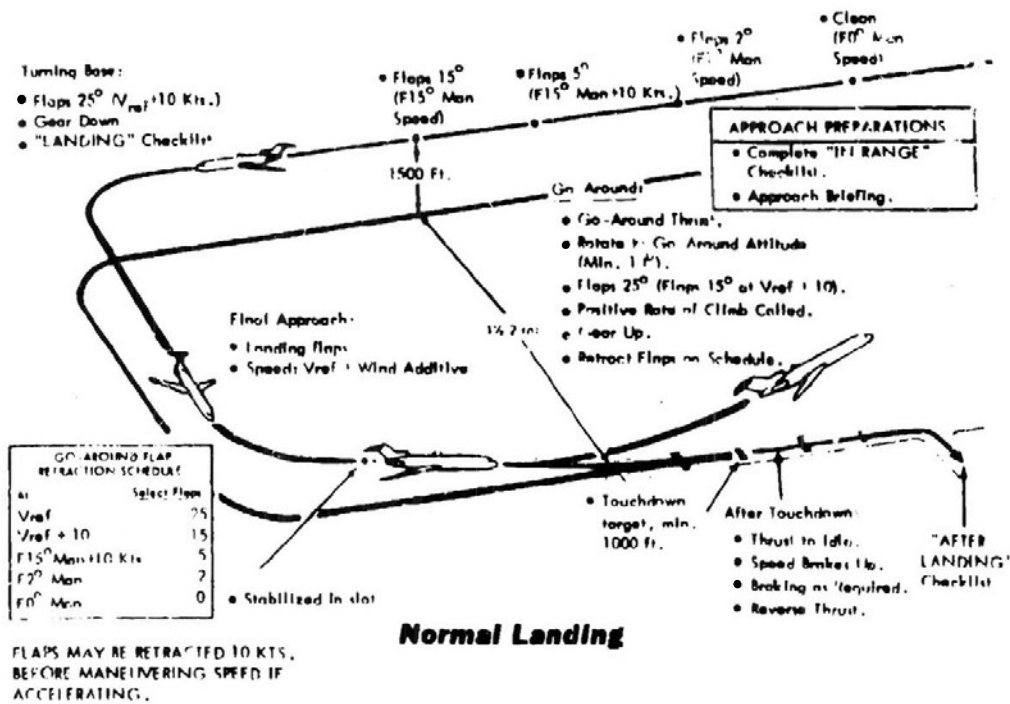
Figure 3.-- Depiction of normal landing from flight manual.

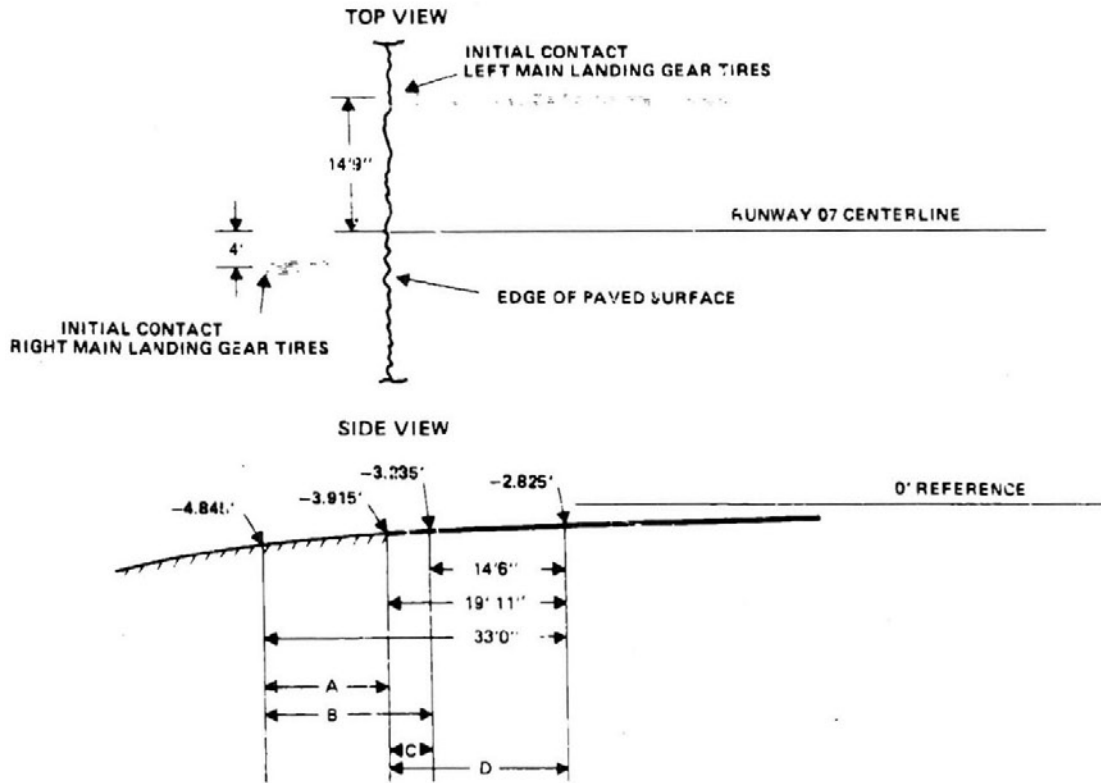
APPENDIX J **RUNWAY INFORMATION**

Yap Airport has one runway oriented 070°/250° magnetic. The runway is 4,820 feet long and about 100 feet wide. The runway base is composed of compacted coral with an asphalt-treated seal covering a width of about 75 feet. The seal coat had deteriorated in many places and there were rutted areas in the touchdown zone. The runway edges were not distinct because of grass which had grown through the surface along the edges. The approach end of runway 7 was not clearly defined, because the surface gradually sloped downward from the runway level. (See appendix D.)

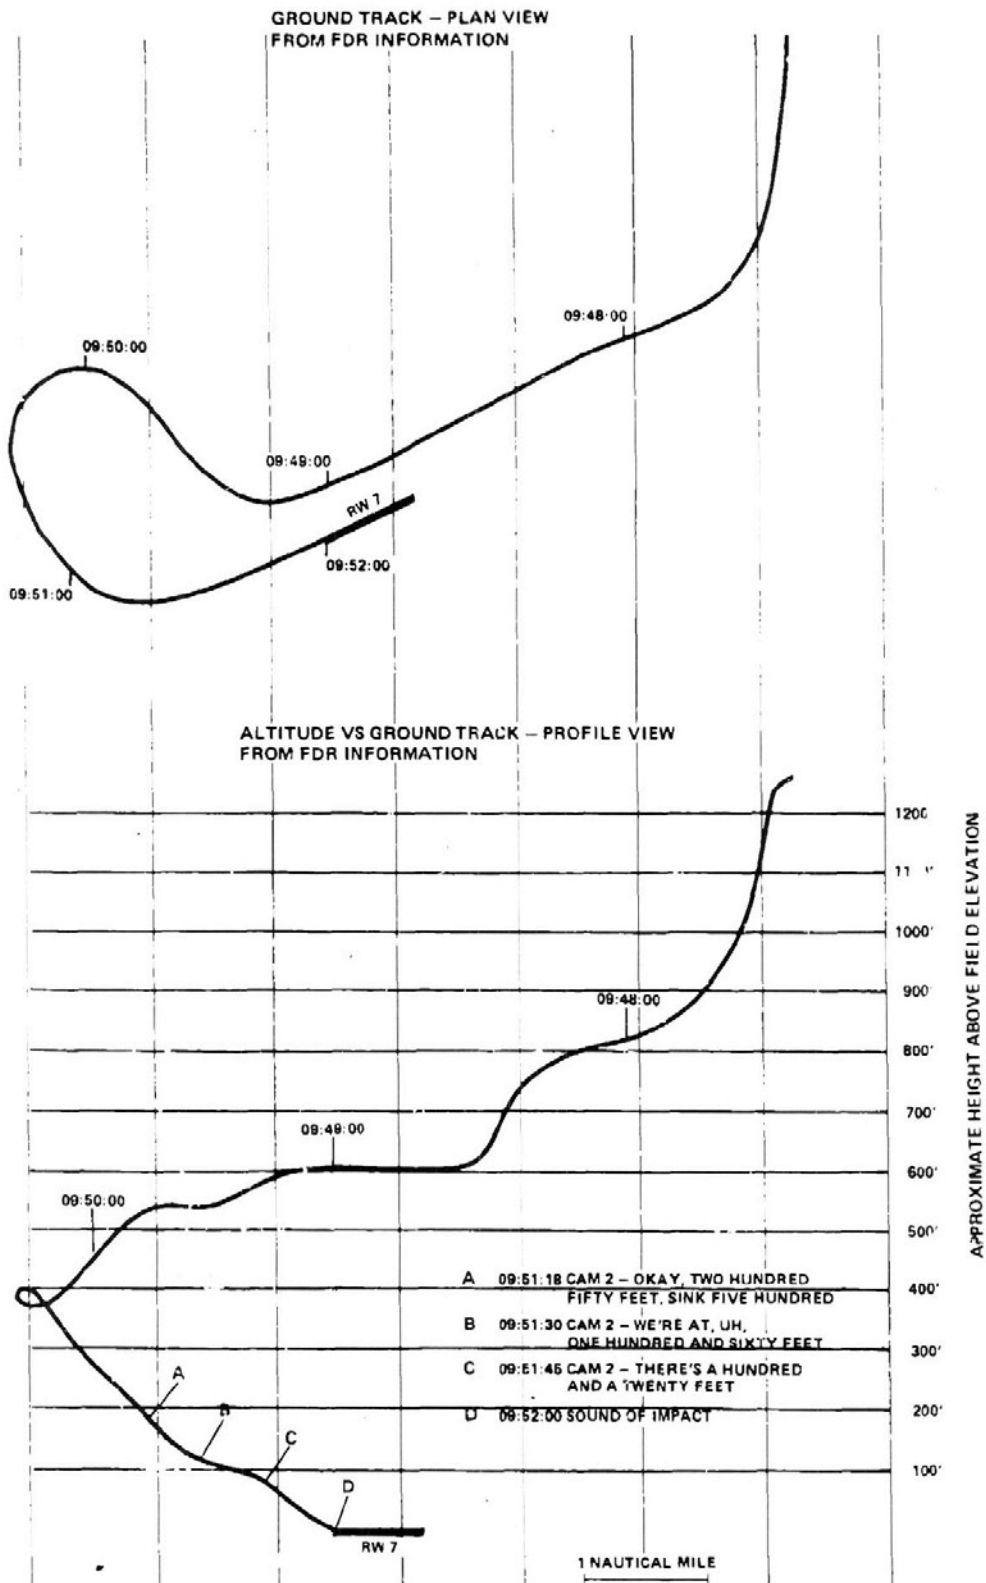
APPENDIX E **FLIGHT DATA RECORDER TRACES**

A Fairchild model 5424 flight data recorder (FDR), serial No. 6061, was installed in N18479. The recorder was recovered from the wreckage and sent to the Safety Board's laboratory in Washington, D.C., for examination. The recorder sustained no impact or fire damage. The metal foil recording medium was examined, and all traces were found to have recorded in a clear and active manner with no evidence of malfunction.
