Midair Collision of Aeronaves De Mexico, S.A., McDonnell Douglas DC-9-32, XA-JED, and Piper PA-28-181, N4891F, Cerritos, California, August 31, 1986

AIRCRAFT ACCIDENT REPORT

**COLLISION OF
AERONAVES DE MEXICO, S.A.
McDONNELL DOUGLAS DC-9-32, XA-JED
AND PIPER PA-28-181, N4891F
CERRITOS, CALIFORNIA
AUGUST 31, 1986**

NTSB/AAR-87/07

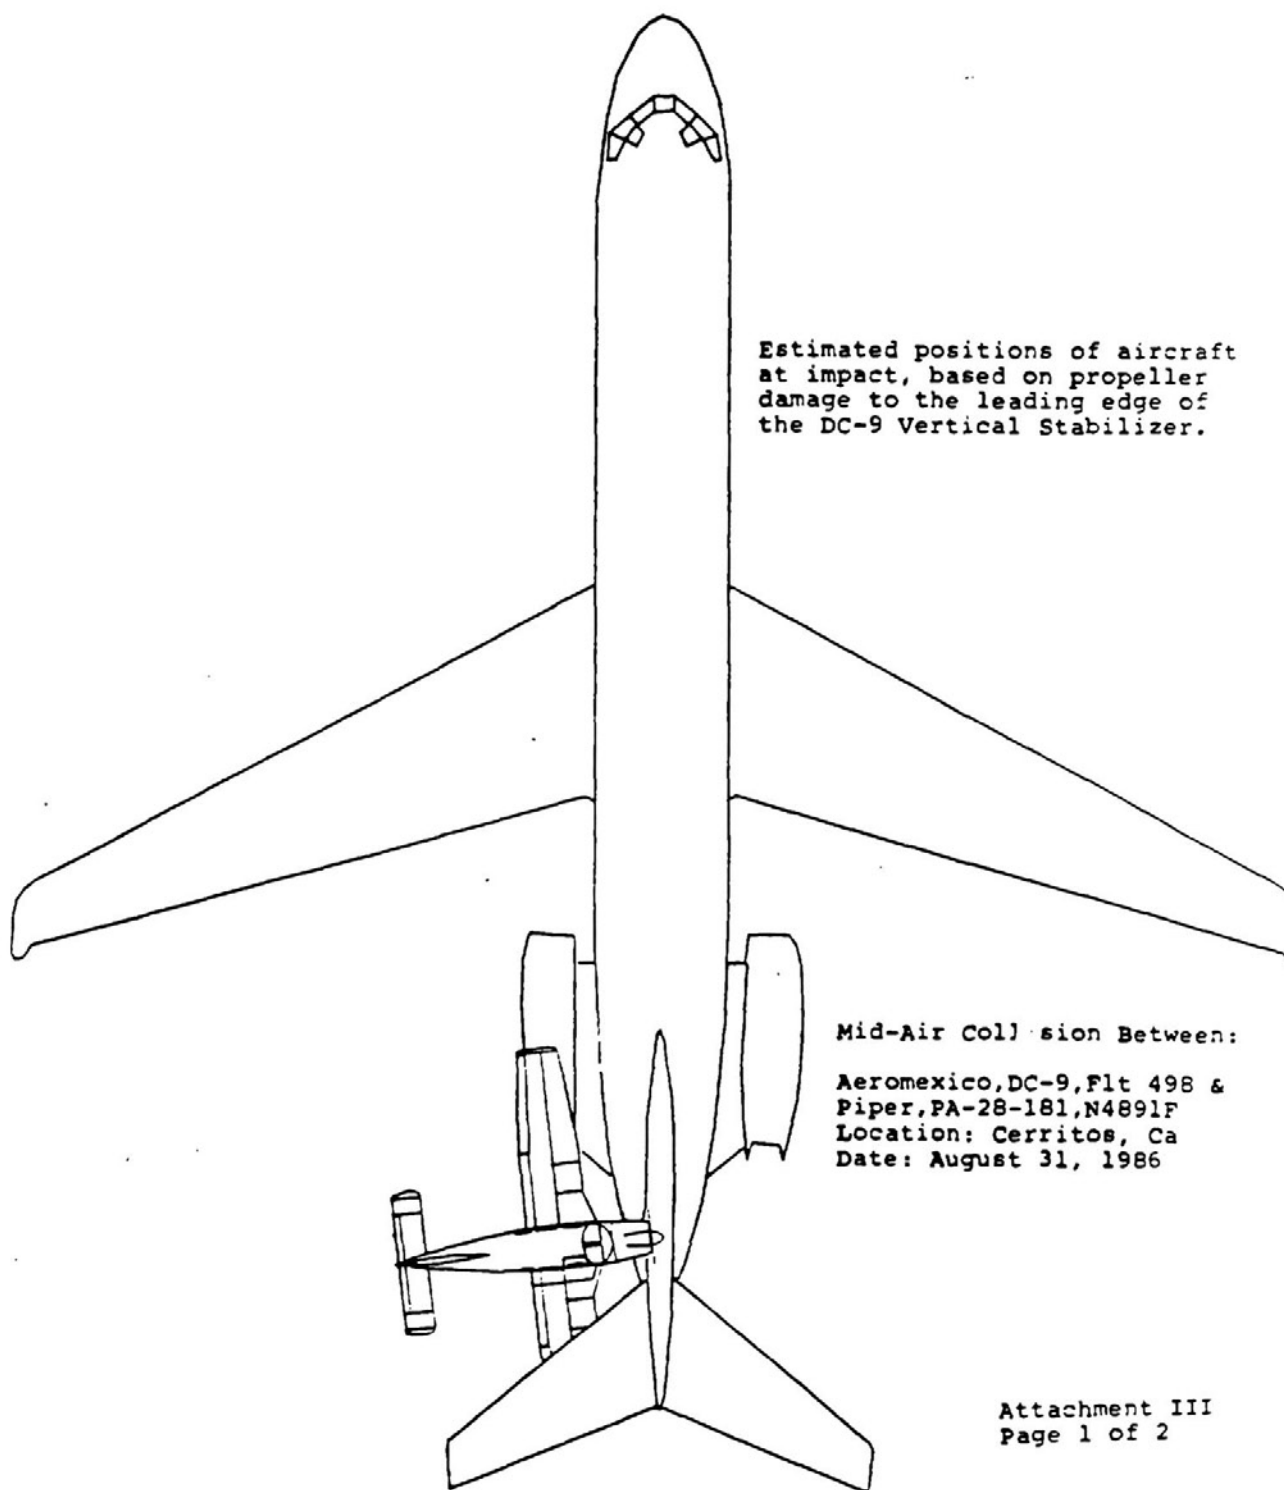
Figure 6.--Collision geometry as viewed from above the DC-9.

The damaged areas on the DC-9 vertical and horizontal stabilizers contained propeller slice marks, paint transfer marks from the nose wheel area and vertical stabilizer of the Piper, and embedded pieces from the cabin roof area of the Piper. The location and angles of these marks and damage on the DC-9, when matched to their respective locations on an intact Piper PA-28, showed that the front of the Piper had struck the left side of the DC-9 vertical stabilizer and that the impact angle was perpendicular to the longitudinal axis of each airplane. (See figure 6.) The impact angle was generally consistent with the flight tracks of the airplanes shown on the radar data plots.

The absence of any impact marks or damage on those portions of the DC-9 left wing and fuselage forward of the empennage that had not been consumed by fire and the damage to the DC-9 vertical and horizontal stabilizers, showed that the PA-28 airplane was about 8 to 10 feet above the top of the DC-9's fuselage and about 15 to 17 feet above its wings when the collision occurred. The damage also indicated that the longitudinal axis of the Piper was almost level at impact and that the initial impact was with the DC-9 vertical and horizontal stabilizers. The debris from the Piper cabin roof, embedded in the leading edge of the DC-9 horizontal stabilizer, and the fact that the roof of the Piper was sheared off at about the same height on both sides of its fuselage, confirmed the fact that the DC-9's horizontal stabilizer struck the top of the Piper's fuselage and that the Piper was in the almost wings-level attitude at impact. (See figure 7.)

Estimated positions of aircraft at impact, based on the propeller damage and scratch marks on the DC-9 Vertical and Horizontal Stabilizers.
