## Runway Departure Following Landing, American Airlines Flight 102, McDonnell Douglas Dc-10-30, N139AA, Dallas/Fort Worth International Airport, Texas, April 14, 1993

RUNWAY DEPARTURE FOLLOWING LANDING  
AMERICAN AIRLINES FLIGHT 102  
McDONNELL DOUGLAS DC-10-30, N139AA  
DALLAS/FORT WORTH INTERNATIONAL AIRPORT, TEXAS  
APRIL 14, 1993

**Abstract:** This report explains the runway departure of American Airlines flight 102, a DC-10-30, after landing at Dallas/Fort Worth International Airport, Texas, on April 14, 1993. The safety issues discussed in the report include weather conditions affecting the flight, flightcrew and air traffic control training and procedures, airplane emergency evacuation lighting, and runway maintenance. Recommendations concerning these issues were made to the Federal Aviation Administration, Dallas/Fort Worth International Airport, and American Airlines, Inc.

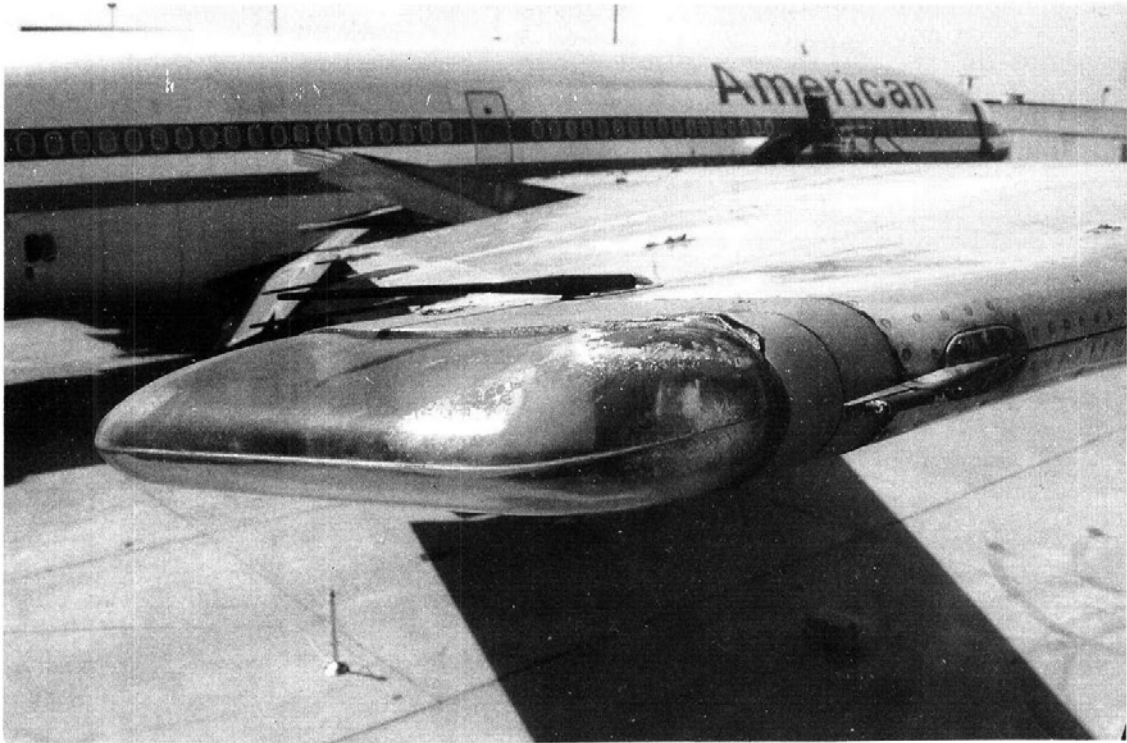
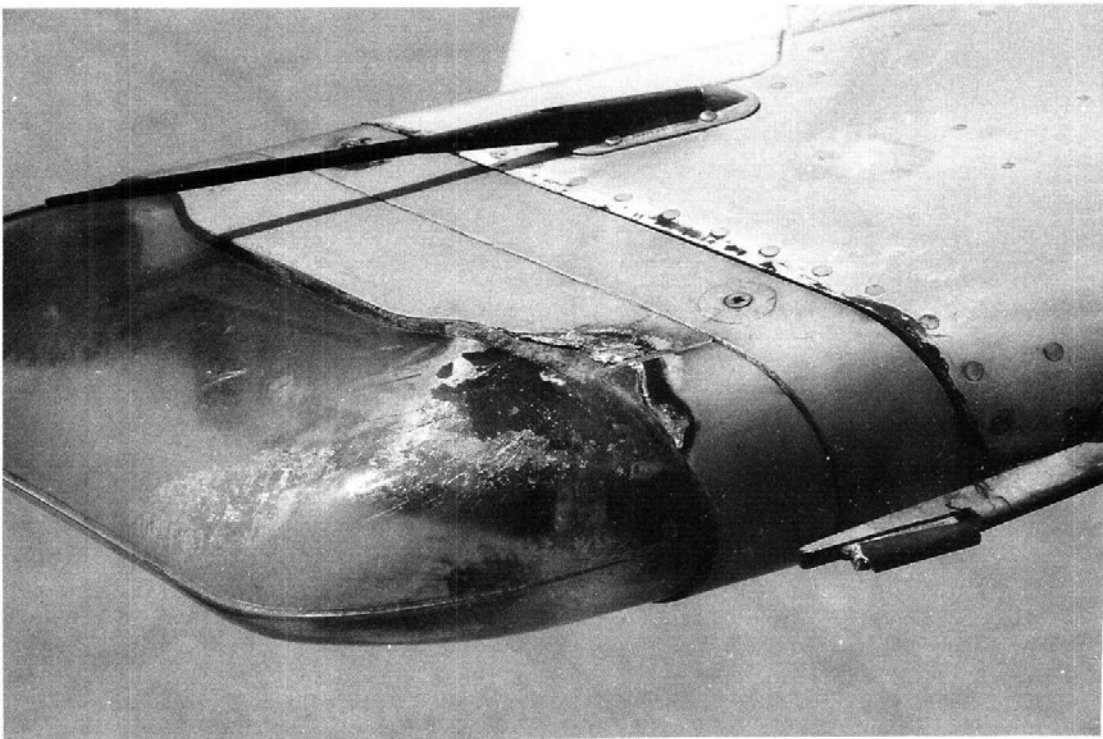
Around the Bridgeport VOR, at 0642:23, the flightcrew saw a brilliant flash of light and the cockpit area microphone picked up a rumble that sounded like thunder. This coincided with the report of a possible lightning strike observed by several passengers and flight attendants. The flight engineer found no system malfunctions and observed that the cockpit instrumentation appeared to be functioning properly. (See figure 1 photographs of lightning damage).

Figures 1a and 1b.--Lightning damage to right wing tip.

A lightning strike was reported to maintenance personnel by the crew of American Airlines Flight 73, on April 11, 1993. An inspection of the airplane, in accordance with maintenance manual procedures, found no damage from the lightning strike. There was, however, a lightning strike noted by the flightcrew, cabincrew, and passengers, occurring as the accident flight was inbound to DFW, about 17 minutes prior to landing. Examination, as part of the Safety Board's investigation following the accident, found evidence of a lightning strike at the top of the right wing tip.

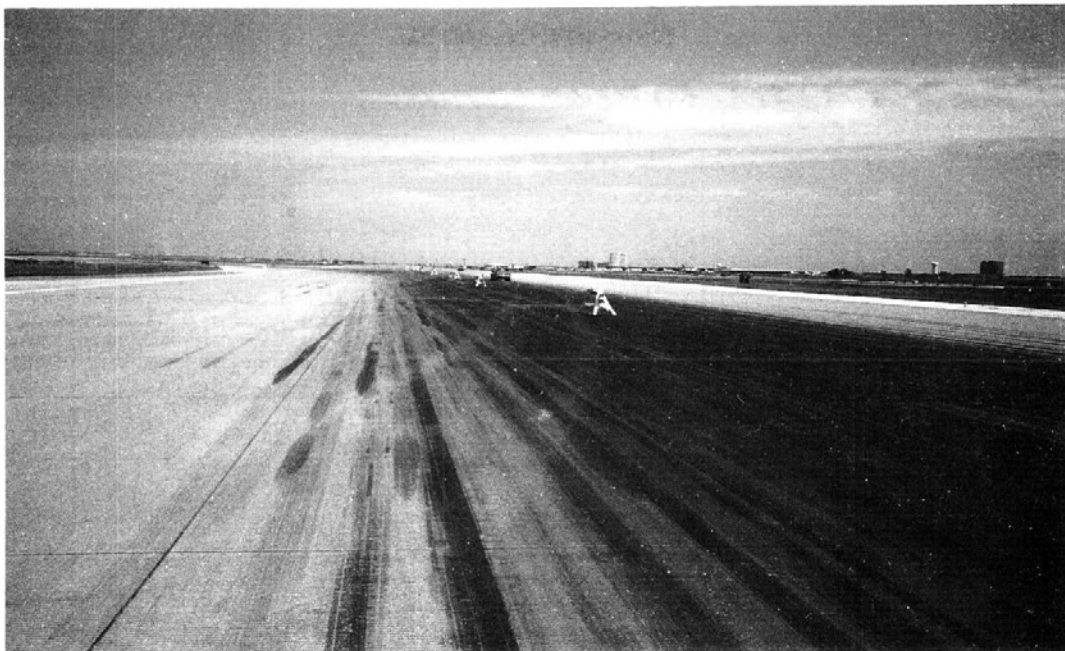
Figure 3a.--Tire marks on landing runway 17L (looking north).

Investigators examined the landing runway after the accident and found traces lighter than the surrounding runway surface, or white tire traces from the left, center, and right main landing gears, starting at 4,303 feet from the beginning of the runway, or with 7,085 feet remaining. The center gear tire marks were 4 feet to the right side of the runway centerline. There were no marks of any kind before this point on the runway that could be linked to the accident airplane.

The terms "erasure mark," or "white tire trace," pertain to the phenomenon whereby an airplane tire, subjected to braking and/or cornering on the wet surface, will scrub or erase contaminants from the runway surface resulting in a temporary white appearance of the surface in the tire track. There were a large number of these marks on runway 17L. White tire erasure marks (or traces) found on the surface of the runway were identified as the ground track of AAL102 by tracing the marks to the airplane and checking the spacing with the known dimensions of the DC-10's landing gear and tires. The distance between the white traces was consistent with the DC-10's landing gear measurements.

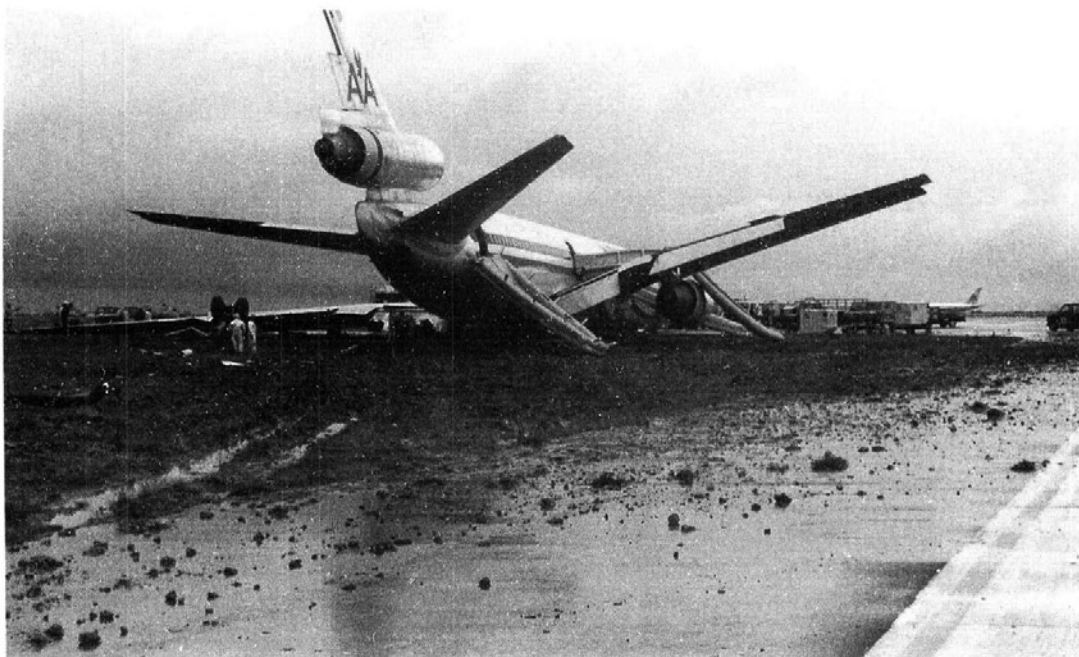
Investigators examined the landing runway after the accident and found three long sets of lightly shaded tire traces that paralleled the centerline but then angled to the right and departed the runway. The tracks from the right main landing gear continued as furrows in the soil.

Figure 3b.--Tire marks on high speed taxiway 3S, and trenches in the soil leading to the final resting position of the airplane.

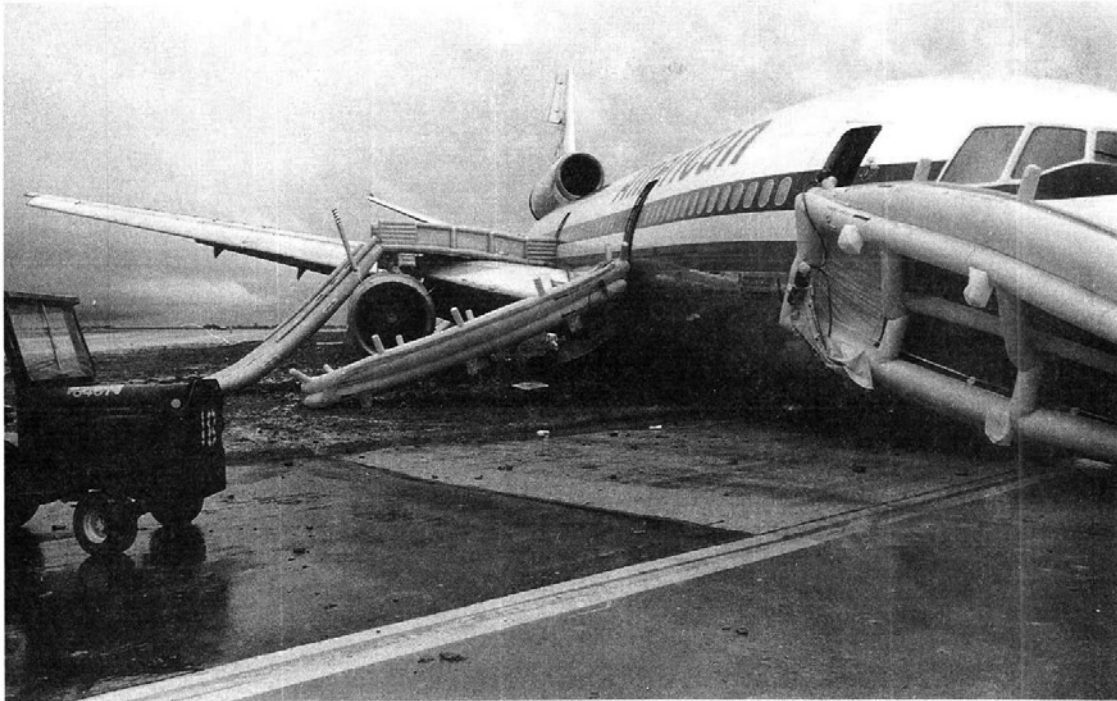
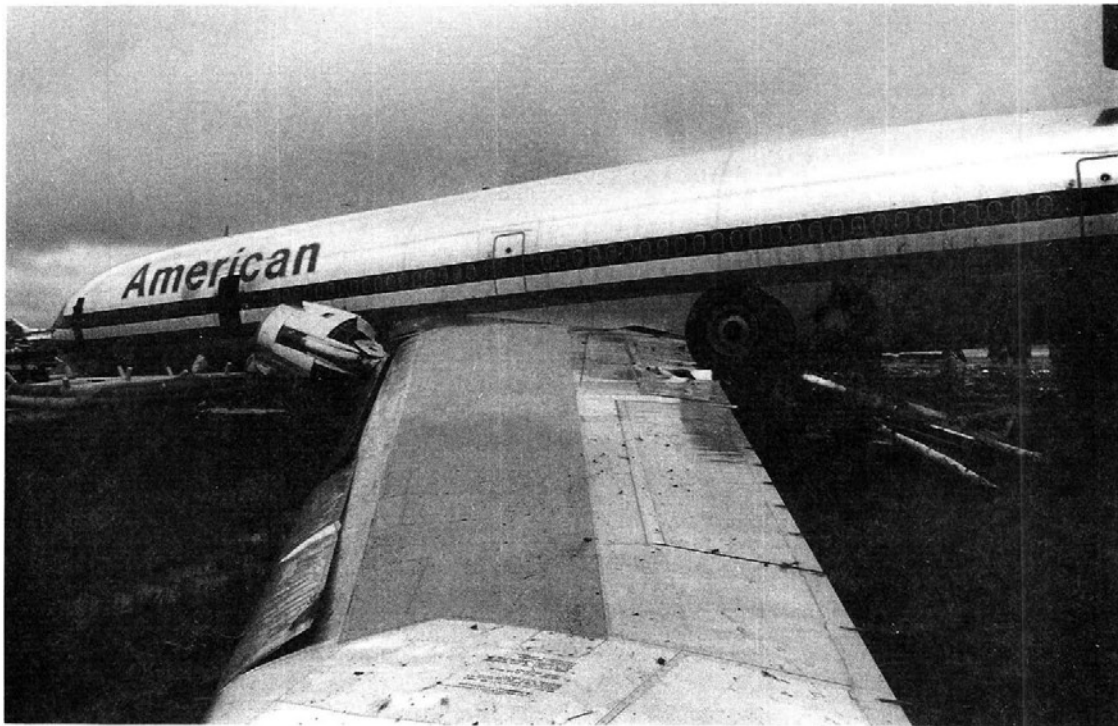
Figures 4a and 4b.--Airplane resting attitude and location.

The airplane came to rest supported by the forward fuselage, the center and right main landing gear, and the left wing and No. 1 engine. The left main gear strut was fractured and the nose gear strut was folded aft. The airplane came to rest slightly nose low and about 10 degrees left wing low. In its final resting position, the left wing and forward fuselage, as well as the right main and center gear, provided support and areas of ground contact.

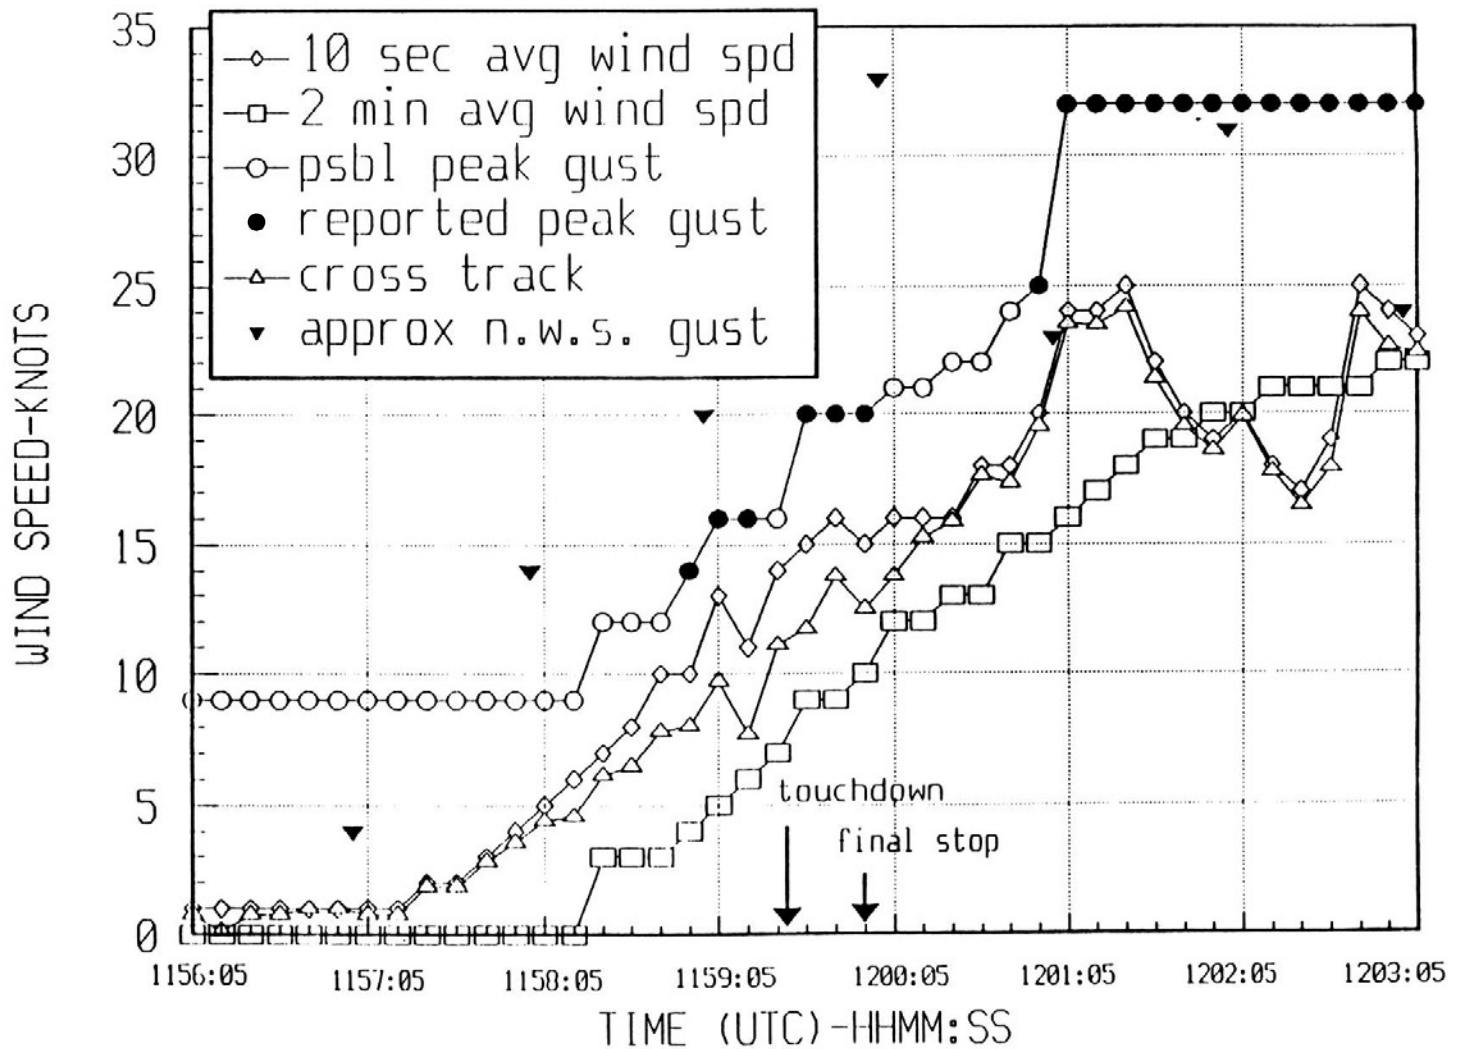
Figure 5.--LLWAS data.

all six sensors. The northwest, west, and center field sensors were found to be out of tolerance. The three anemometers were shipped to the manufacturer and under direction of the Safety Board's Investigation Weather Group Chairman, the "out of tolerance" anemometers were further evaluated. The sensor from the center field was found to be within manufacturer's tolerances. The generator output from the sensor from the northwest DFW field position was found stable, and tested root mean square errors were found only slightly out of tolerance. The sensor from the west field station at DFW failed potentiometer tests in nearly every direction, with high root mean square errors.

Belfort Instrument, the manufacturer of the sensors, concluded that the northwest and center field sensors were unlikely to have contributed to significant LLWAS errors. Considering the large magnitude of error in the west sensor's potentiometer, the manufacturer surmised that the potentiometer may have been damaged by an electrical transient.

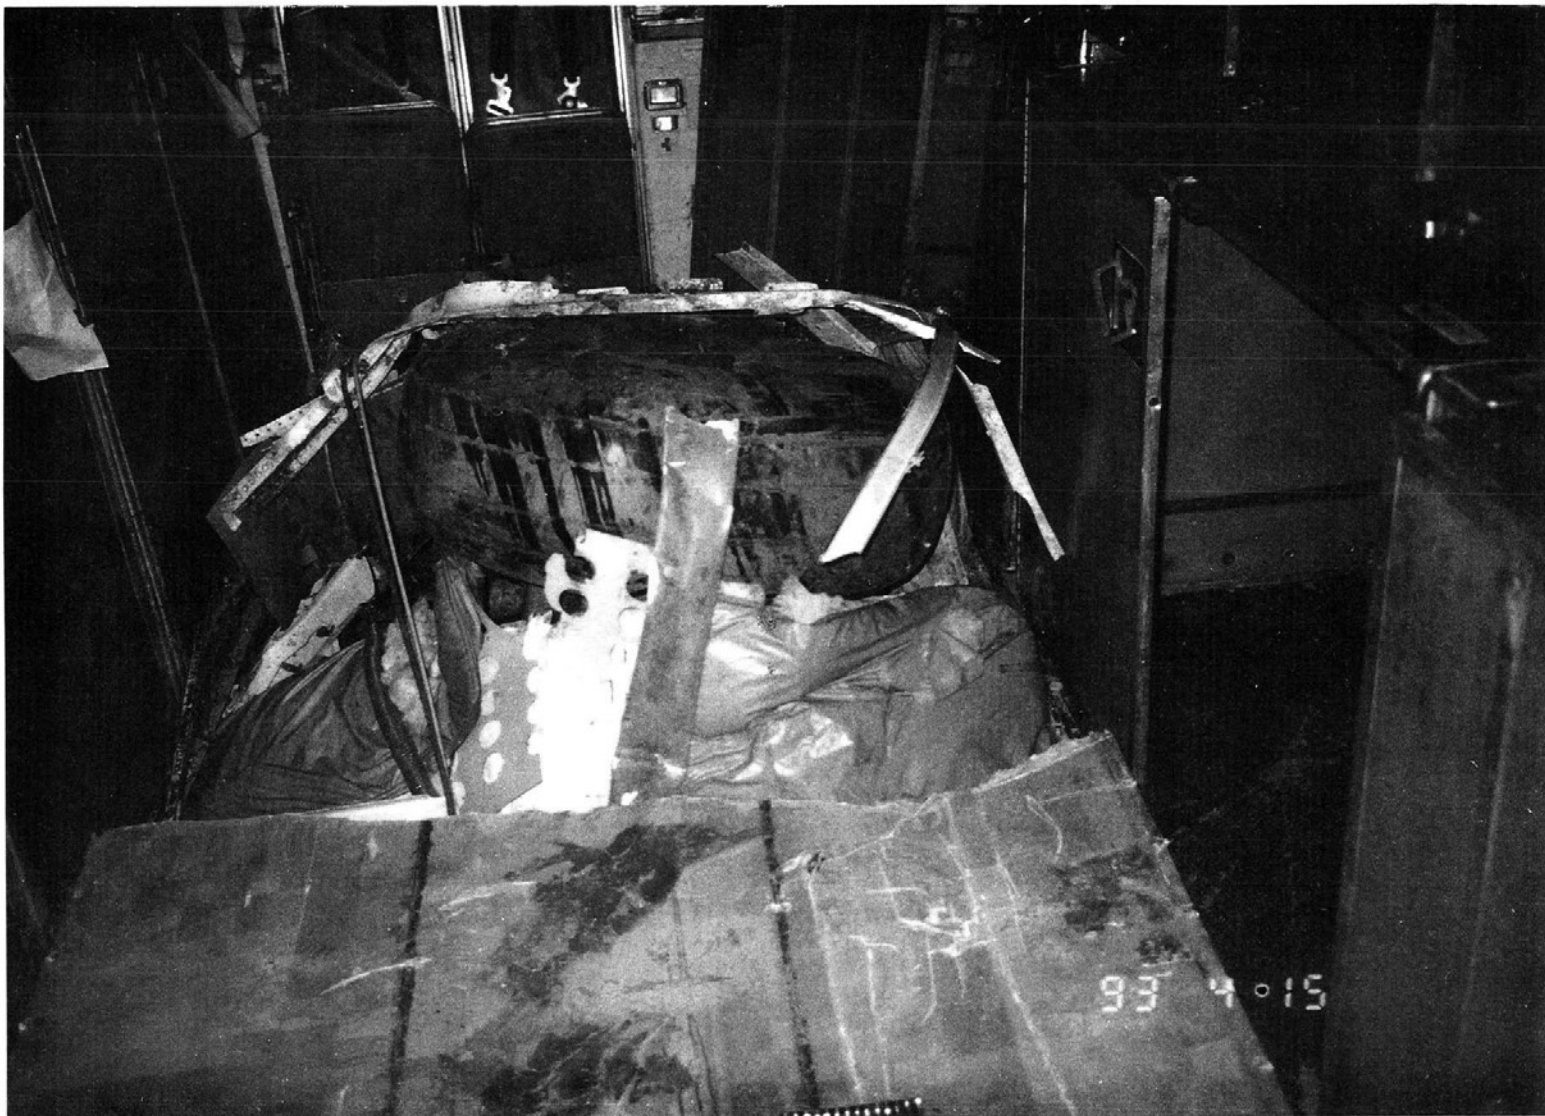
The nose gear was found folded aft. The wheel and tire assembly penetrated the floor of the lower lobe galley, and the wheels were turned about 90 degrees to the right. (See figure 7, which is a photograph of the lower lobe galley, showing the final position of the nose gear tires).

Figure 7.--Lower lobe galley.

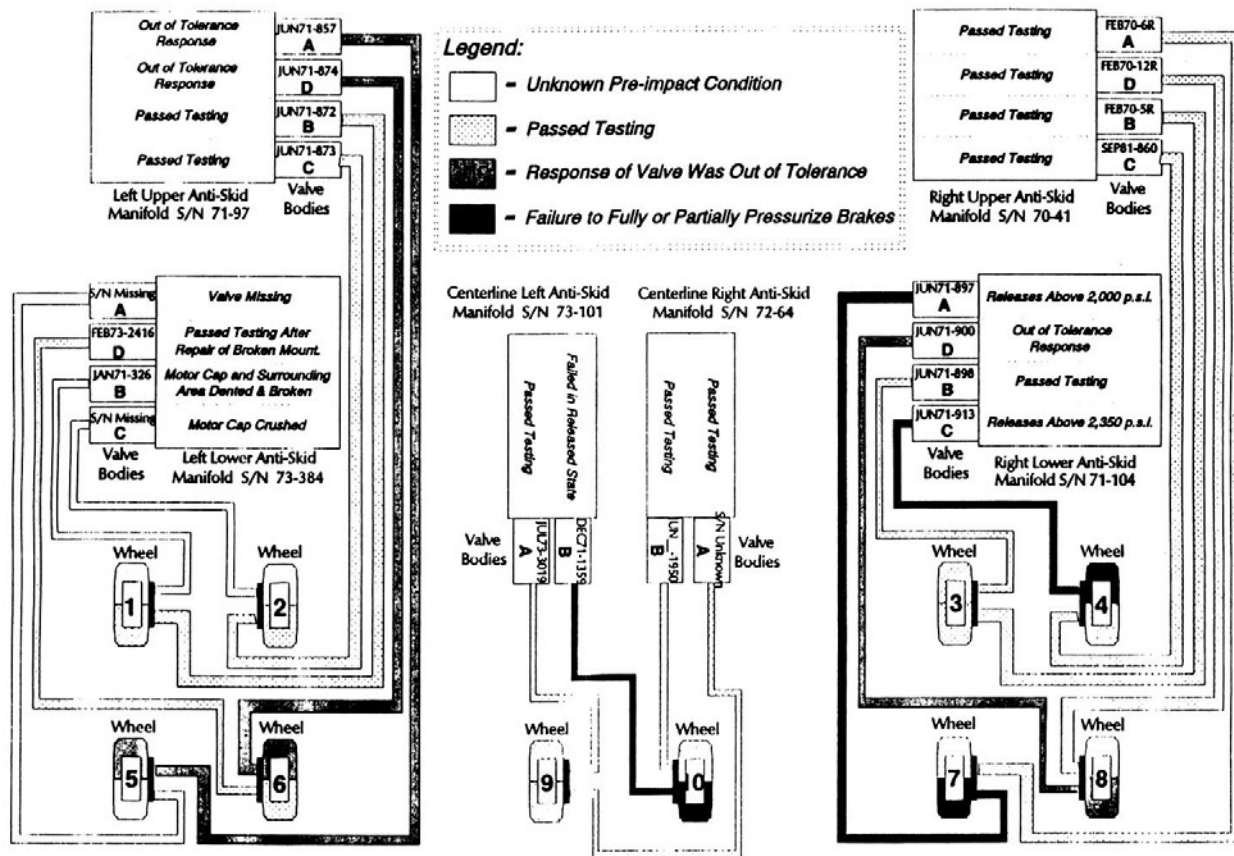
Figure 8.--Brake manifold system.

accident, and actuation of the mechanical portions of the system was confirmed. Electrical integrity was verified by a continuity check.
