## Uncontained Engine Failure, Delta Air Lines Flight 1288, McDonnell Douglas MD-88, N927DA, Pensacola, Florida, July 6, 1996

**Investigative Body:** National Transportation Safety Board (NTSB), USA

UNCONTAINED ENGINE FAILURE  
DELTA AIR LINES FLIGHT 1288  
MCDONNELL DOUGLAS MD-88, N927DA  
PENSACOLA, FLORIDA  
JULY 6, 1996

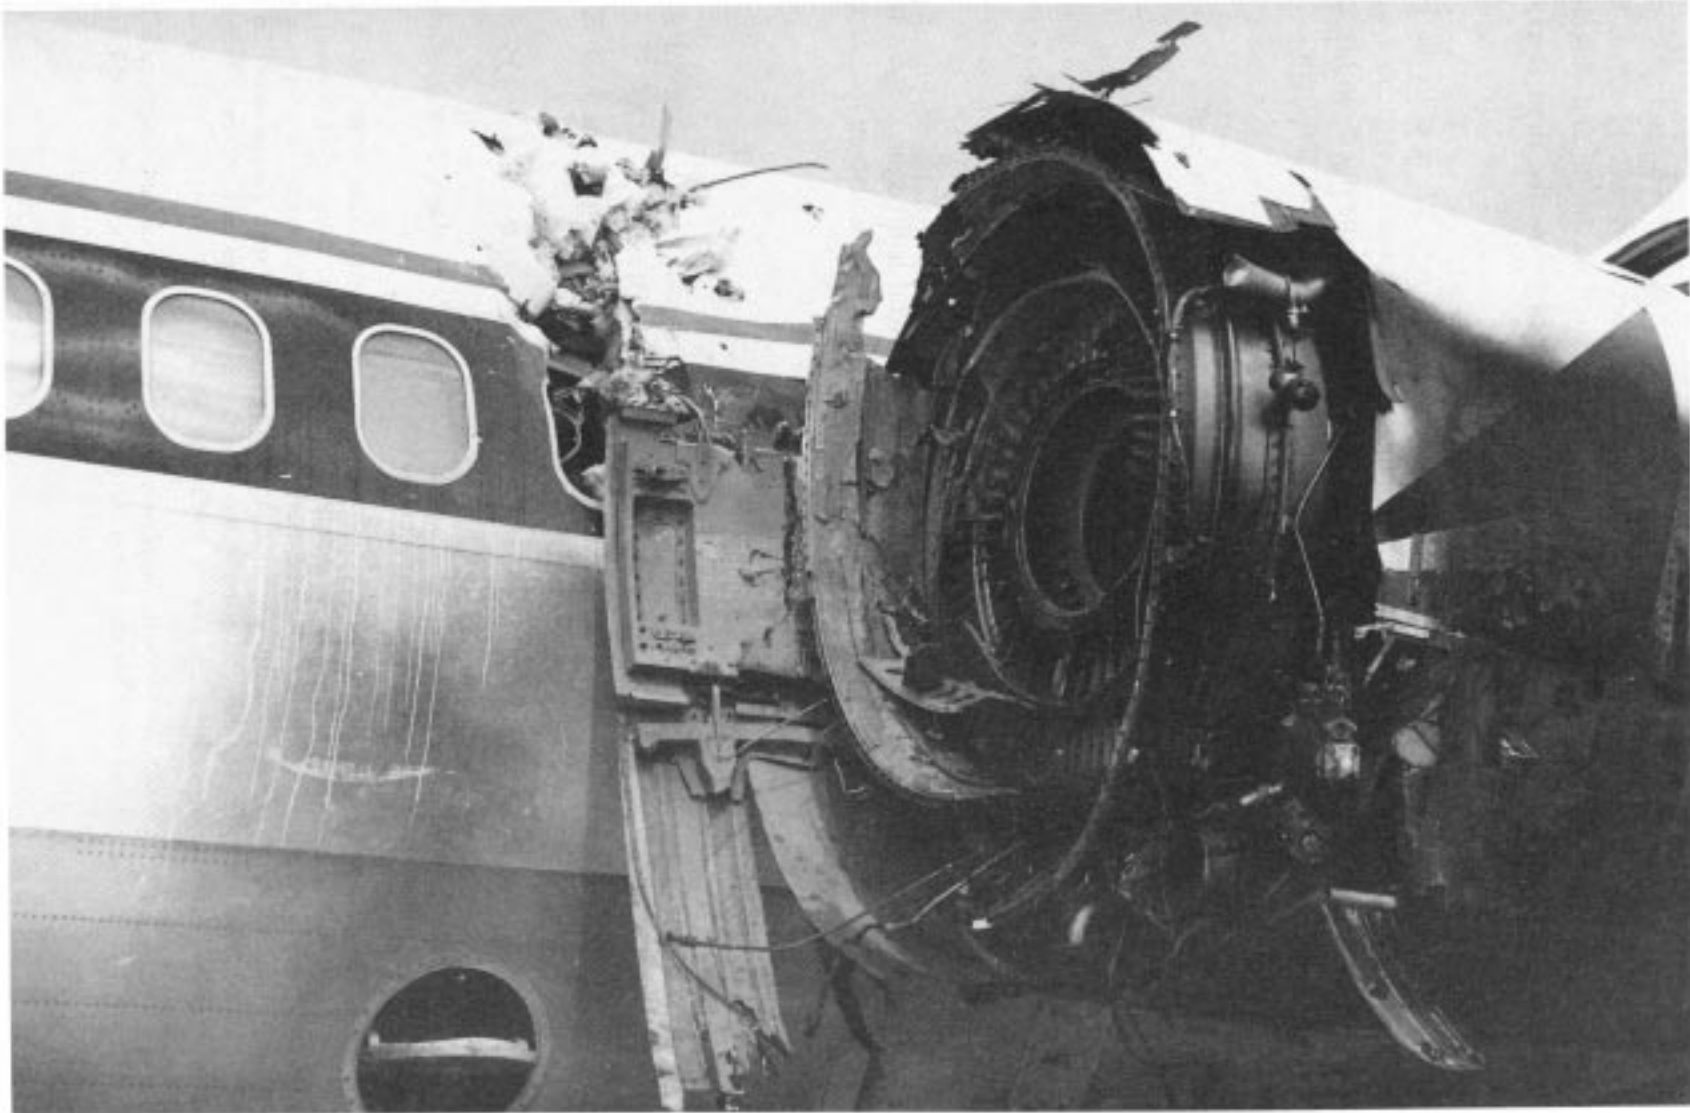
The aft left fuselage and interior of the airplane in the vicinity of the No. 1 engine were substantially damaged by debris from the engine (see figure 1). A total of 16 holes, punctures, or tears were documented on the left fuselage skin. Several large holes and tears were

Figure 1.—Damaged area of airplane near No. 1 engine.

The cabin interior was substantially damaged near seat row 37, next to the left engine. Debris from the left engine's fan hub and fan blades had penetrated the left cabin wall and overhead bin vertically from the lower left passenger window through the overhead bin and ceiling panel. Engine fan components had also pierced the side and ceiling of the right cabin wall.

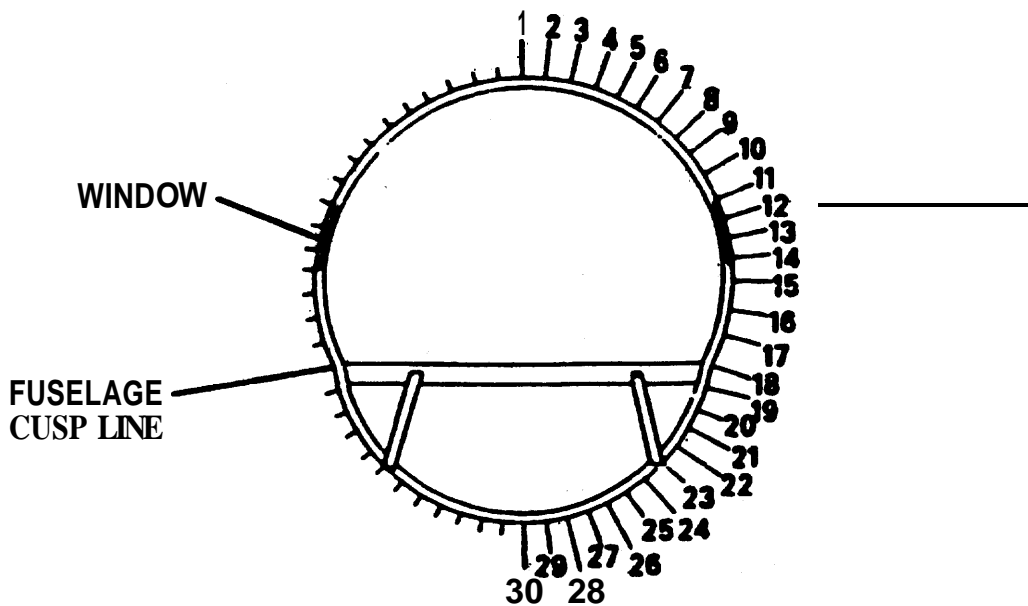
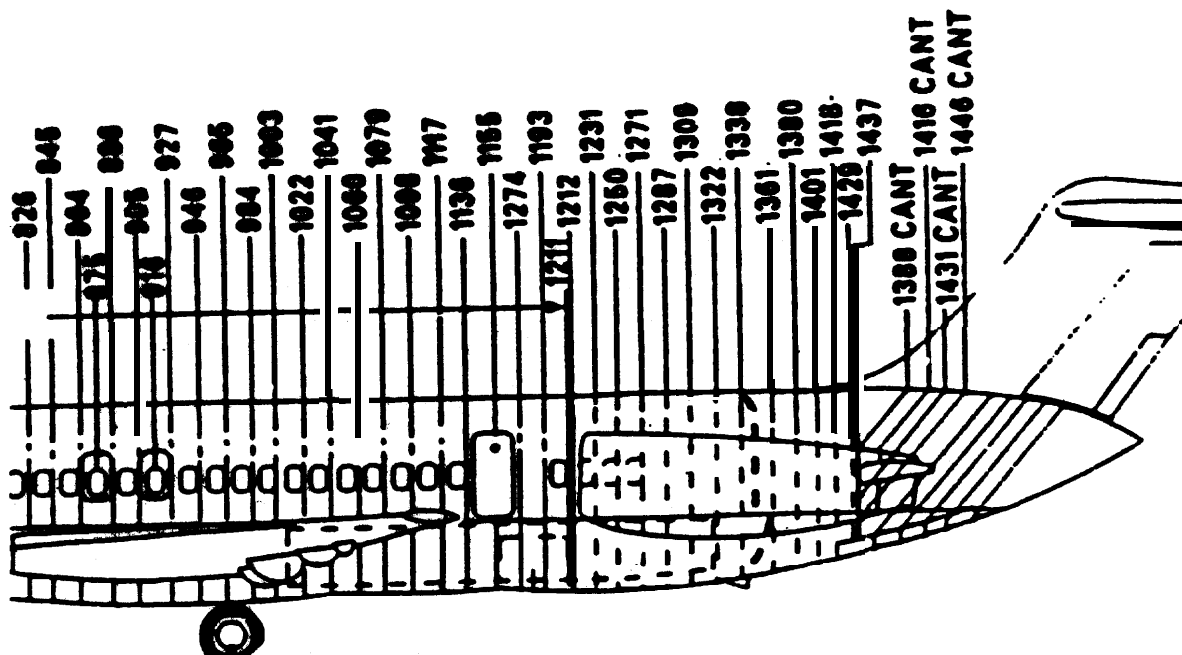
Figure 2.—Fuselage station and longeron identifications.

found between fuselage stations (FS) 1250 and FS 1282 (adjacent to row 37) and from the top of the window to longeron 2 (see figure 2).<sup>12</sup> Seven exit holes, punctures, and tears were documented on the right fuselage skin between FS 1228 and 1271 (just forward of row 37). Most of the wires in the wire bundle located along longeron 4 (on the right side of the fuselage) were severed near FS 1250. Of the 154 wires in the bundle, 146 had been severed. Four of the severed wires were channel differential protection wires that compared incoming and outgoing current for the right generator.<sup>13</sup> No evidence of penetrations existed below the floor level on either side of the fuselage.
