In-Flight Fire/Emergency Landing, Federal Express Flight 1406 Douglas DC-10-10, N68055, Newburgh, New York September 5, 1996

AIRCRAFT ACCIDENT REPORT

IN-FLIGHT FIRE/EMERGENCY LANDING
FEDERAL EXPRESS FLIGHT 1406
DOUGLAS DC-1 0-10, N68055
NEWBURGH, NEW YORK
SEPTEMBER 5, 1996

The National Transportation Safety Board determines that the probable cause of this accident was an in-flight cargo fire of undetermined origin.

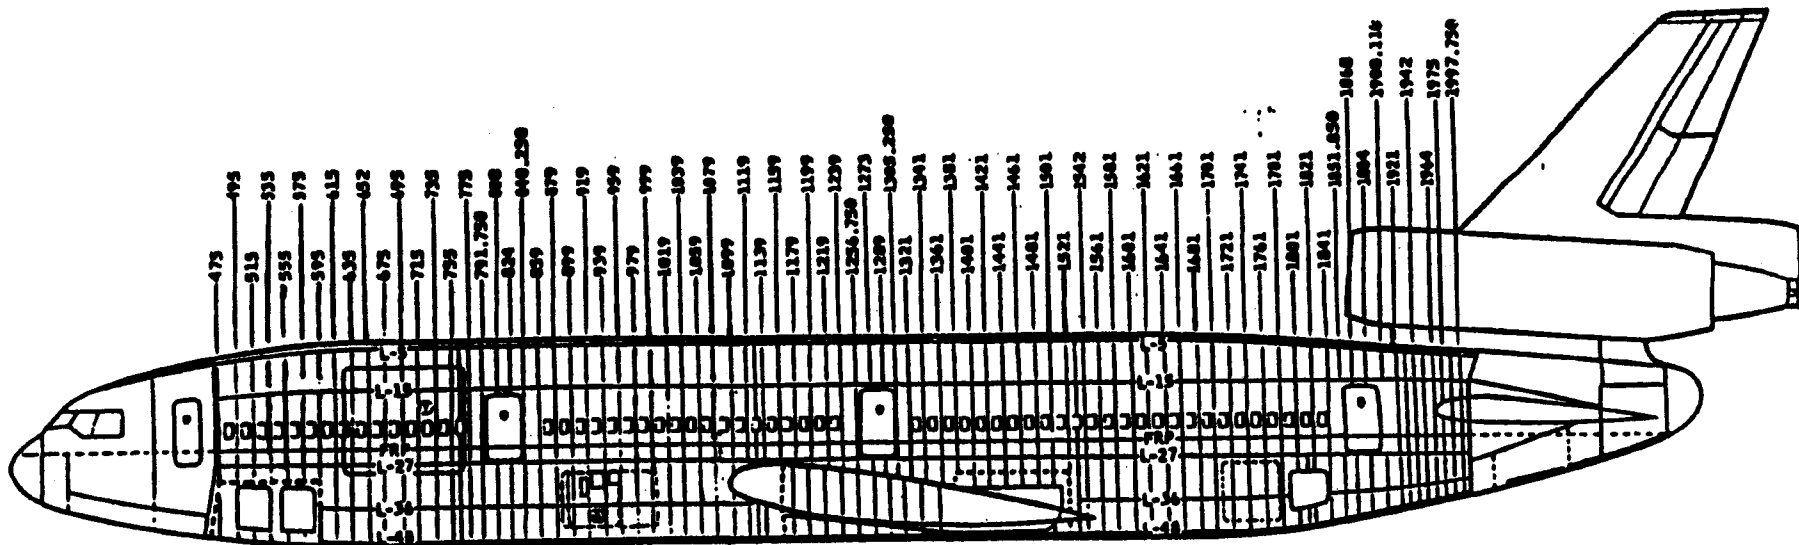
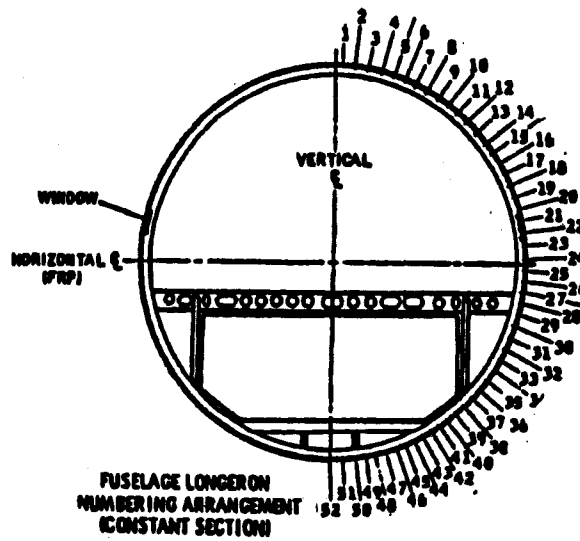
Figure 6.—DC-10-10, N68055, fuselage station and longeron number locations.

At the separated empennage section, the upper interior fuselage crown and the canted area of the aft pressure bulkhead were heavily sooted between longeron 15 left and longeron 23 right. Four of the upper fuselage ring frames were burned and melted between longeron 1 left and the upper canted bulkhead, parallel to longerons 18 left and right. The No. 2 engine bleed air duct was separated about 3 feet forward of the bulkhead. Electrical wires protruded about 20 feet from the aft pressure bulkhead and had cut and separated ends. The wire insulation remained intact on the wires that protruded from the left side of the aft pressure bulkhead, and the wire insulation was burned around the wires that protruded from the right side of the aft pressure bulkhead. No evidence of arcing of airplane wiring was seen. The lower section of the aft pressure bulkhead that was common to the lower cargo area was undamaged and had no soot or fire damage.

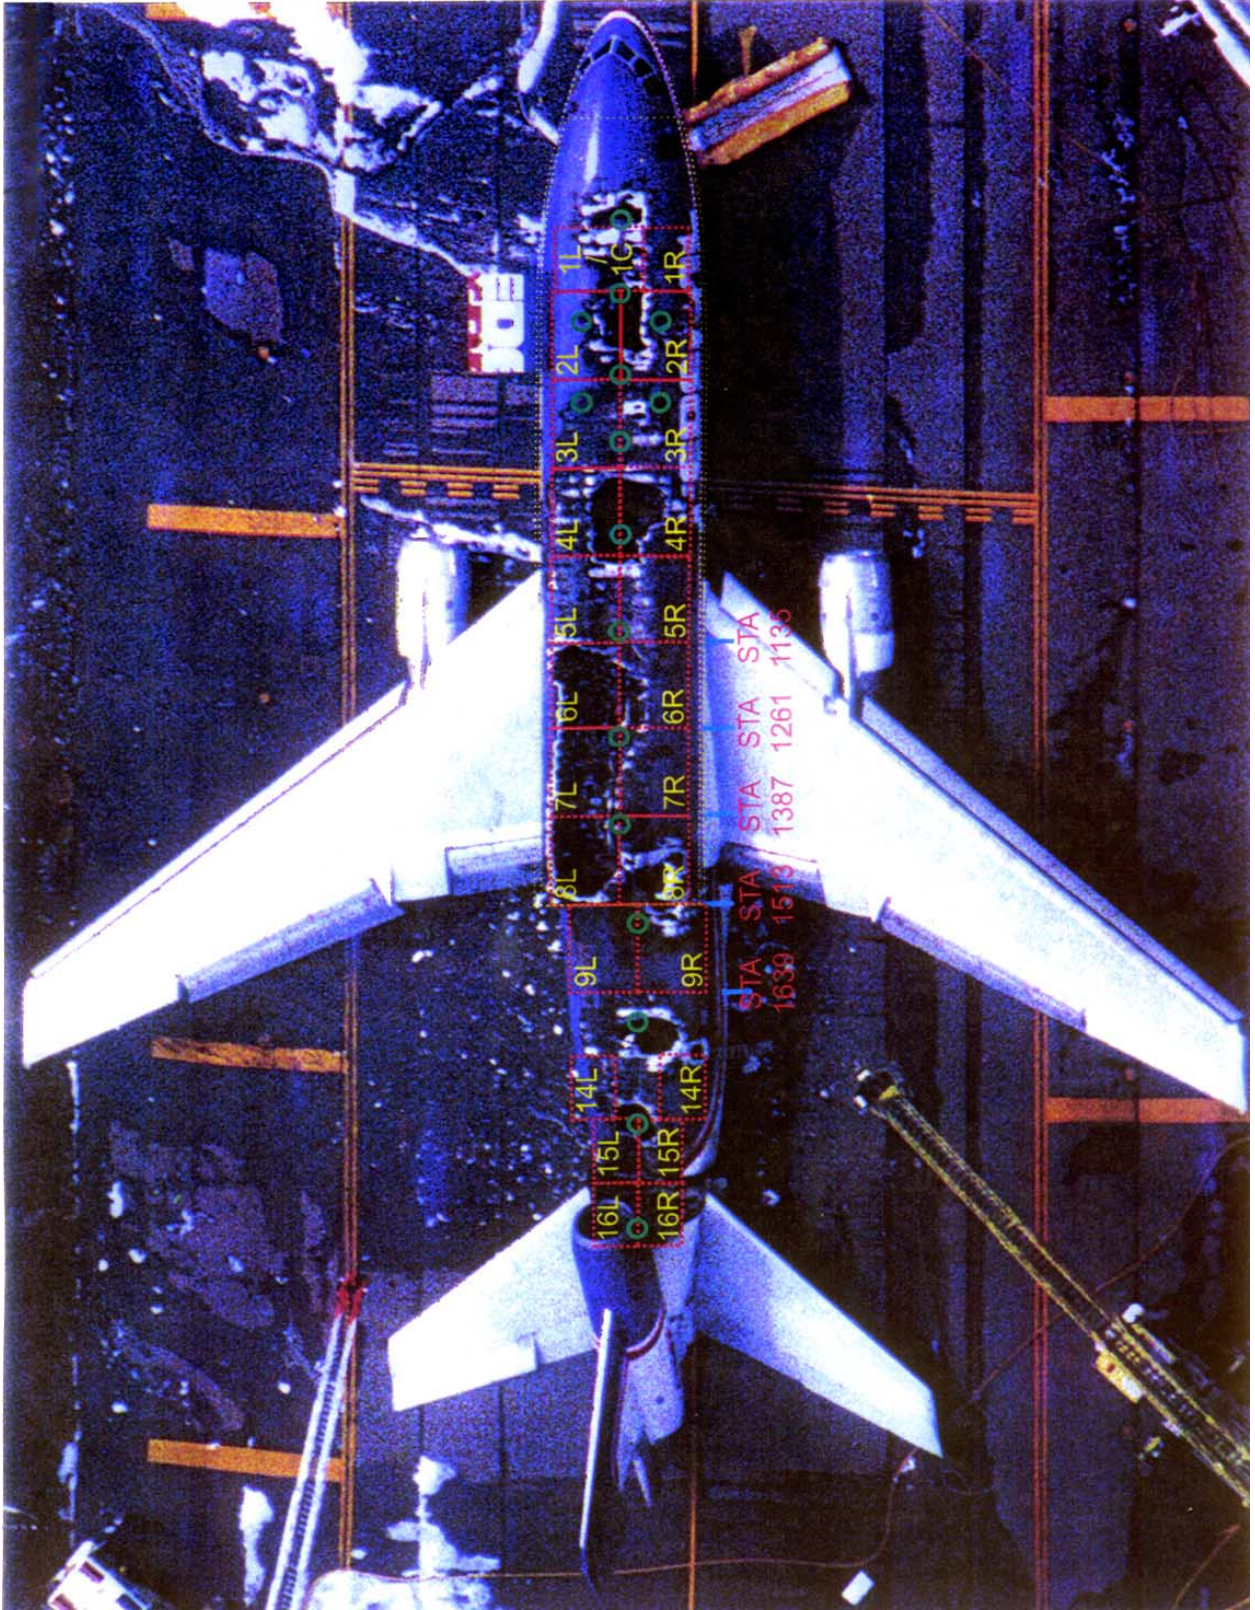
Figure 7.—DC-10-10, N68055, airplane with overlaid cargo container positions

The cabin sidewall panels were lightly sooted and remained attached to the left side of the fuselage between FS 450 and 840, above container position 3L. Burned and sooted upper sidewall panels hung down directly above the attached lower sidewall panels. The right side of the fuselage between FS 808 and FS 919, next to container position 3R, exhibited severe heat and fire damage, along with melted fuselage frame flanges. The airplane's exterior paint was scorched and bubbled on the left side, next to the first two windows between FS 859 and 899, near the aft of container row 3 and the front of container row 4.

The fuselage crown was consumed by the fire between FS 939 and FS 1039, from approximately the middle of container row 4 to the middle of container row 5. The frame flanges on either side of this consumed area of the fuselage crown were burned and melted. The left side of the fuselage crown was also consumed by fire between FS 1179 and FS 1531, an area corresponding to approximately the middle of cargo container 6L to the middle of cargo container 9L.
