Crash into terrain, Eurocopter AS350-B2, N169PA, Meadview, Arizona, August 10, 2001

Aircraft Accident Brief

Accident Number: LAX01MA272
Aircraft and Registration: Eurocopter AS350-B2, N169PA
Location: Meadview, Arizona
Date: August 10, 2001
Adopted On: June 3, 2004

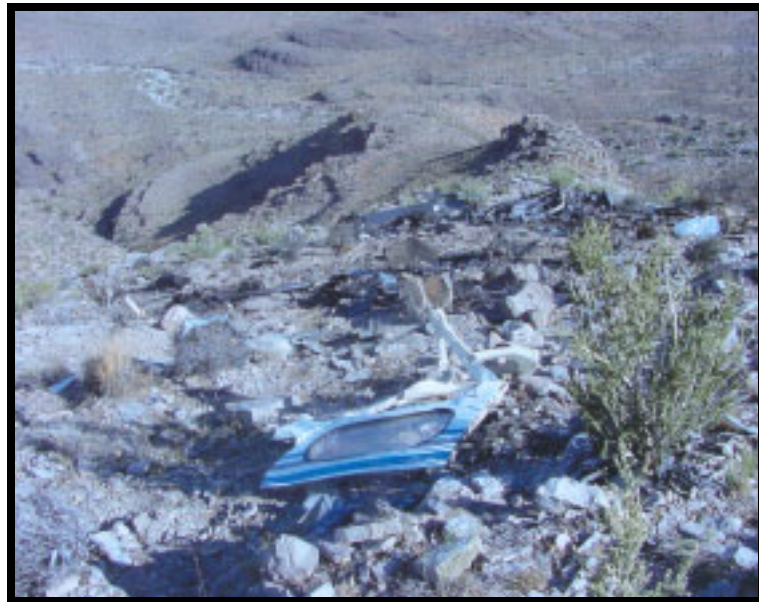
The left front door was found up slope from the IPI. (See figure 5.) It had separated from the fuselage with a portion of the forward fuselage doorpost attached to the upper and lower hinges. The doorpost section was torn from the fuselage structure. The lower hinge was bent and distorted, whereas the upper hinge was intact and undamaged. The hinge pins were fully seated in their corresponding gudgeons and also remained attached to the door jettison arm and rod mechanism, with the internal cockpit-side jettison handle in a near normal position. The door-operating handle was found in the closed and latched position.

Figure 5. View of crash site showing left door (in foreground) found upslope from IPI.
