## Loss of Pitch Control During Takeoff, Air Midwest Flight 5481, Raytheon (Beechcraft) 1900D, N233YV, Charlotte, North Carolina, January 8, 2003

**Micro-summary:** This Beechcraft) 1900D experienced a loss of pitch control on takeoff, resulting in a crash and destruction of the airplane.

**Aircraft Accident Report**  
**NTSB/AAR-04/01**

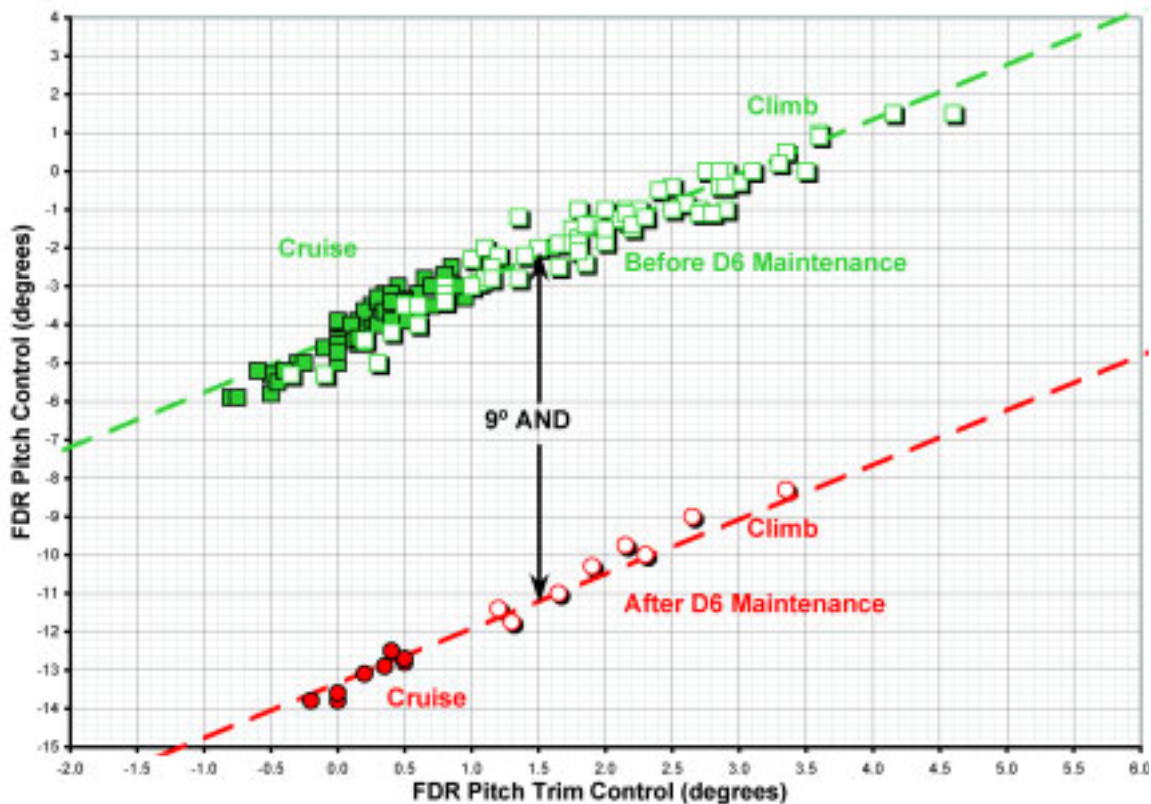
The position of the trim tab is the predominant predictor of elevator position during climb and cruise flight. Figure 8 shows that a strong correlation exists between elevator (FDR pitch control position) and trim tab (FDR pitch trim control) data. The figure shows two distinct data groups: the larger group represents flights before the D6 maintenance check, and the smaller group represents flights after the D6 maintenance check.

**Figure 8.** Flight data recorder pitch control and pitch trim control positions.

The larger group of data shown in figure 8 (that is, the flights before D6 maintenance) compared well with the Beech 1900D flight test certification data, indicating that the pre-maintenance FDR pitch control position data represented the actual elevator position to within about 1°. However, the smaller group of data (that is, the flights

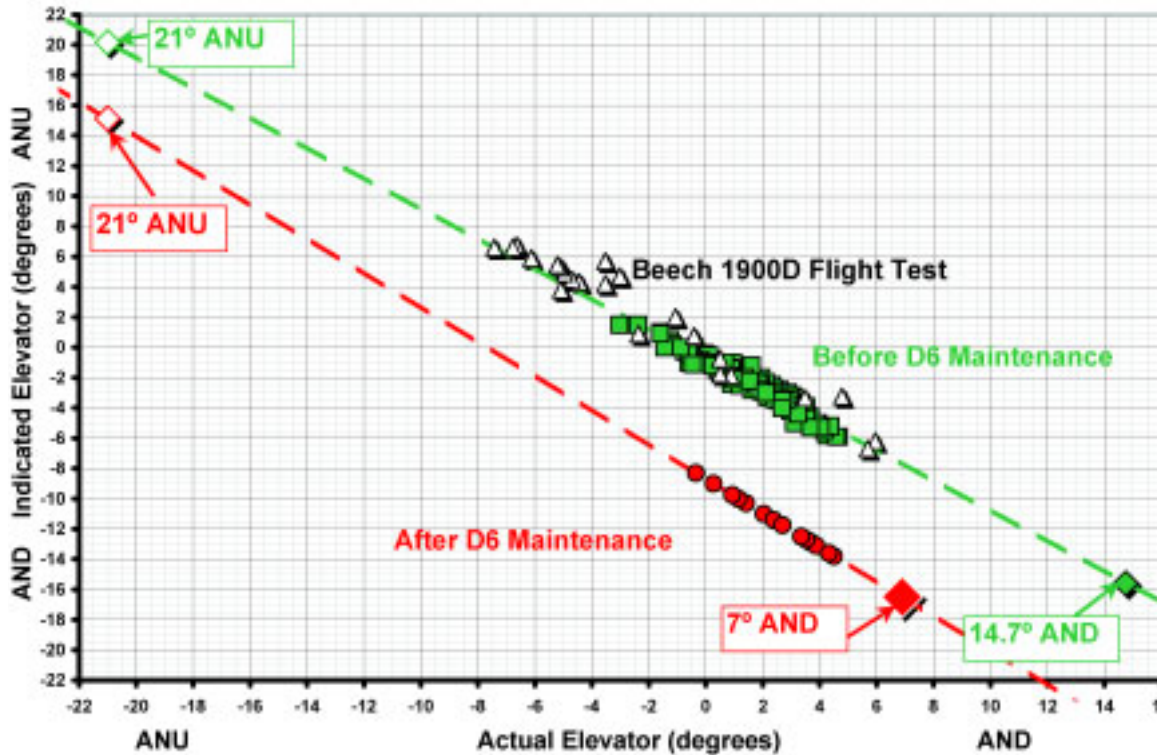
**Figure 9.** Elevator travel available before and after the detail six maintenance check.
