**In-Flight Engine Failure and Subsequent Ditching, Air Sunshine, Inc.,
Flight 527, Cessna 402C, N314AB, About 7.35 Nautical Miles West-
Northwest of Treasure Cay Airport, Great Abaco Island, Bahamas, July 13,
2003**

NTSB/AAR-04/03

**In-Flight Engine Failure and Subsequent
Ditching**

Cessna 402C, N314AB

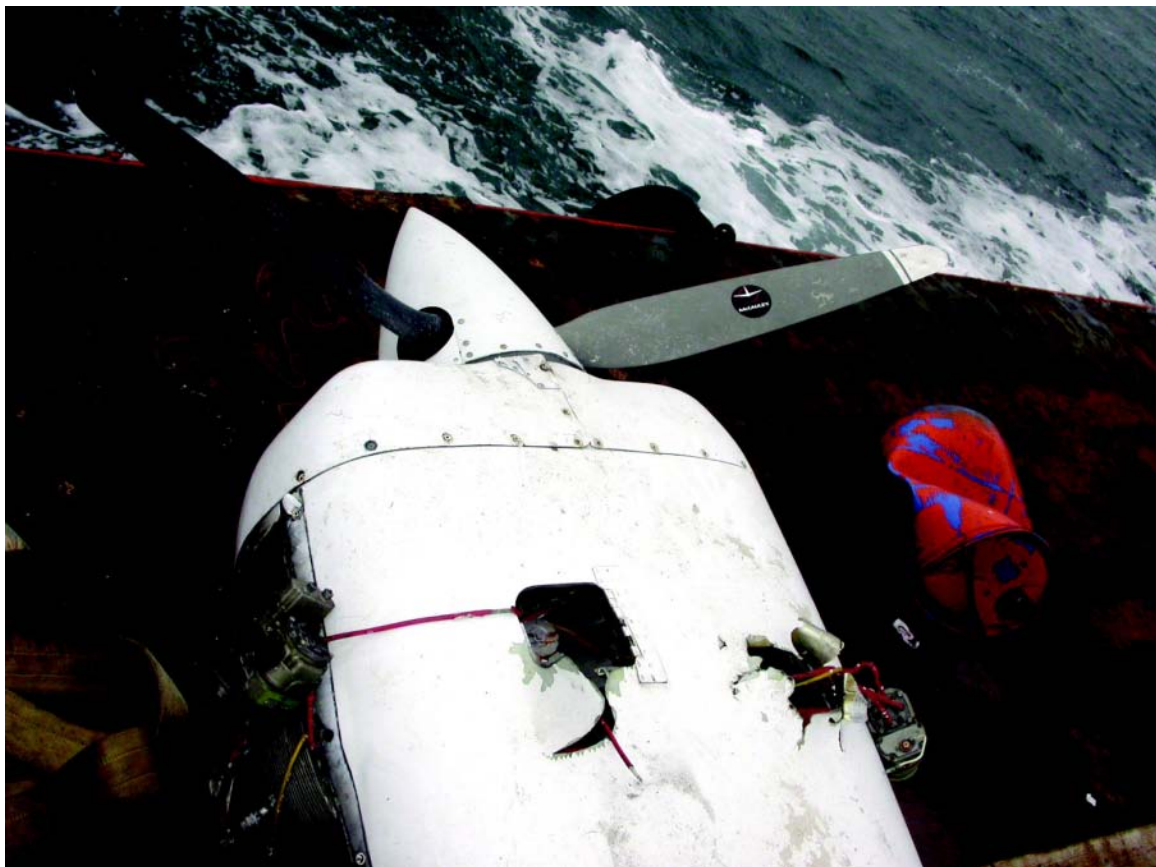
The right engine was attached to the airframe in its normal position, and the propeller was attached to the engine. Damage was noted on the leading edge skin from the engine outboard to the wing tip; the leading edge skin from the engine nacelle inboard of the wing root was crushed up and aft. The lower inboard engine cowling was separated and was not recovered; the lower outboard engine cowling was in place.

The right engine No. 2 (inboard aft) cylinder was found separated from the engine crankcase, exposing a portion of the crankshaft, and held onto the engine by the exhaust pipe tubing and by an electrical cable that was secured to the cylinder assembly by an adel clamp. The two magnetos were found protruding through the upper outboard engine cowling but remained attached to the engine by ignition leads. (See figure 3.) Two 6-point flanged nuts, one 12-point flanged nut with a fractured threaded piece, and a nonfractured connecting rod were recovered from the engine compartment area. Piston ring pieces were found in the partially separated No. 2 cylinder assembly.

Figure 3. Exterior of the upper outboard engine cowling.

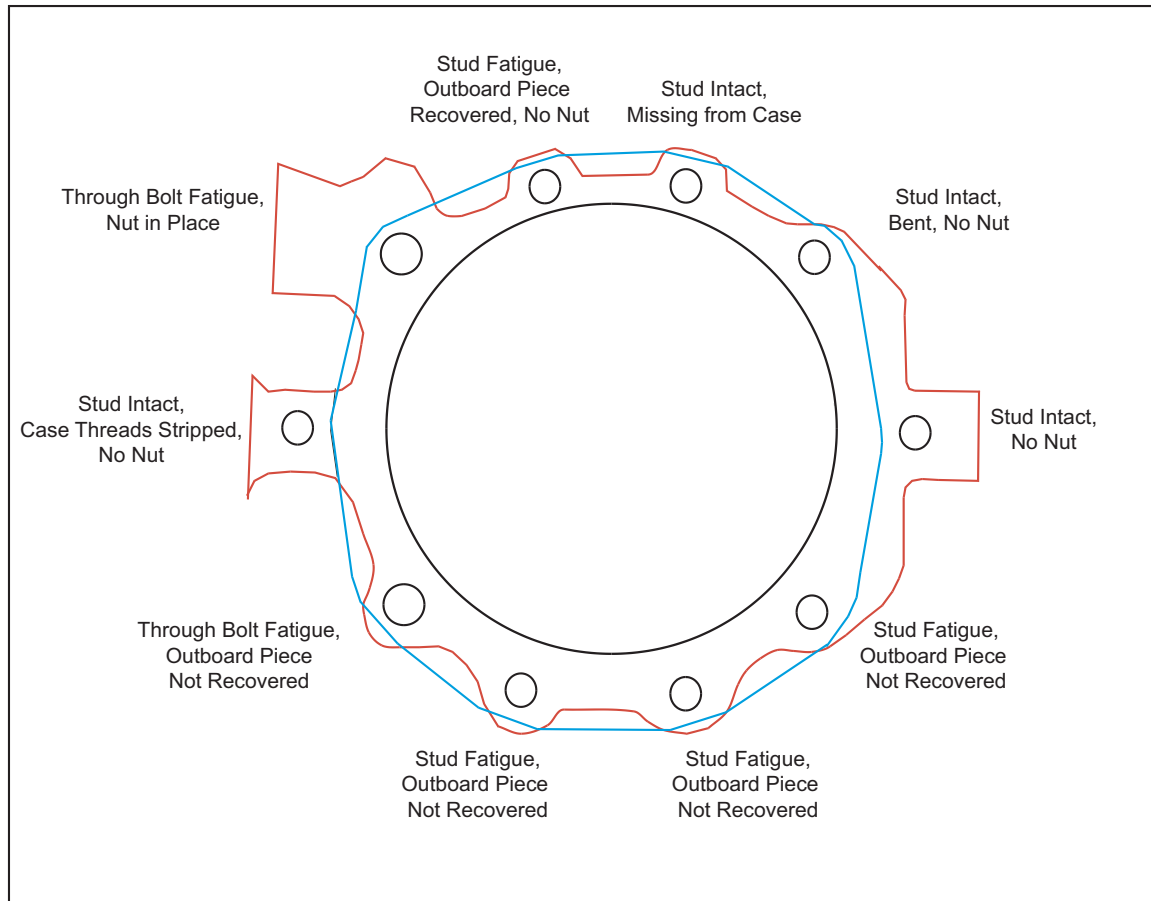
The outboard portions of one of the fractured hold-down studs and one of the fractured through bolts were recovered. The stud piece was found without a nut attached,

and the through bolt piece was found with a nut attached. The outboard portions of the other three fractured studs were not recovered. The other fractured through bolt, which is where the nut would normally be, was not recovered. Figure 4 shows the condition in which the right engine No. 2 cylinder retention system components were found.

Figure 4. The condition in which the right engine No. 2 cylinder retention system components were found.

Note: The cylinder base flange is outlined in blue, and the mounting surface is outlined in red.
