## Hard Landing, Gear Collapse, Federal Express Flight 647, Boeing MD-10-10F, N364FE, Memphis, Tennessee, December 18, 2003

**NTSB/AAR-05/01**

**National  
Transportation  
Safety Board**

**NTSB/AAR-05/01  
PB2005-910401  
Notation 7632A  
Adopted May 17, 2005**

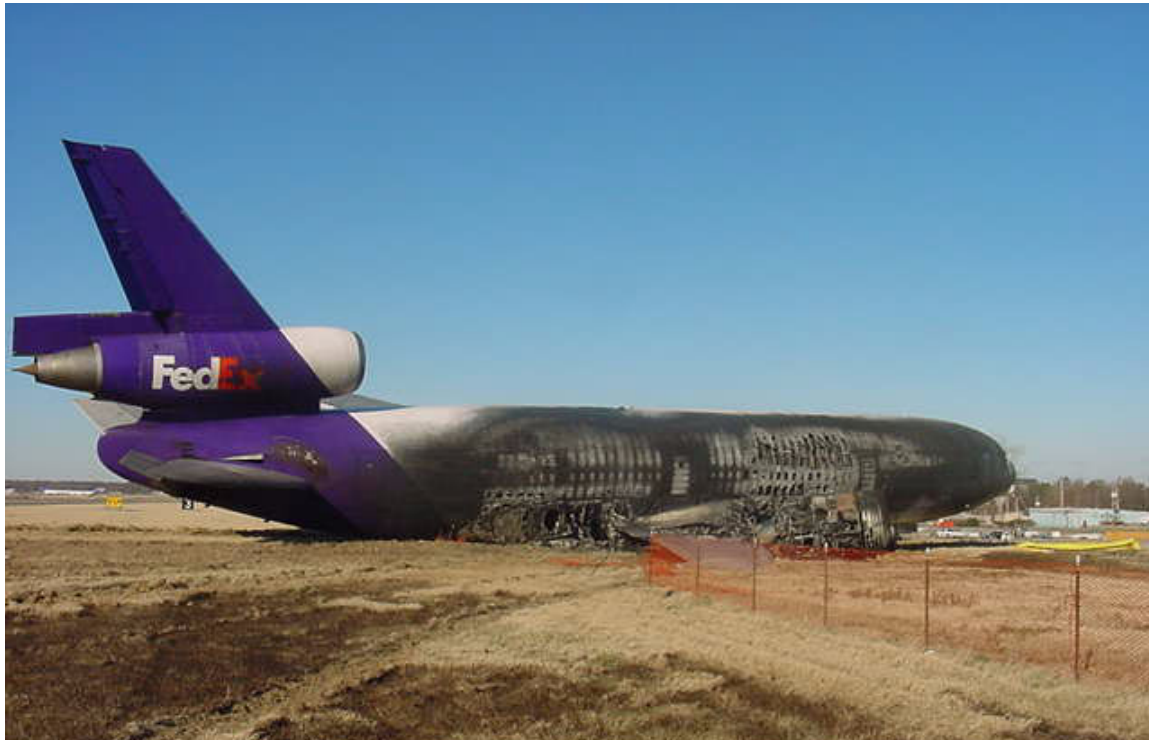
**Figure 2.** Photograph of the damage to the right side of the airplane.

The airplane came to rest in the grass about 155 feet right of the runway 36R centerline and 5,979 feet from the approach end of the runway. The airplane was aligned on a magnetic heading of about 070° and in a slight (about 20°) right-wing-down attitude. The right main landing gear assembly collapsed, and the airplane was supported by its nose landing gear, left main landing gear, and the lower surface of the right wing. The fuselage remained largely intact, but the right wing and the fuselage immediately adjacent to it exhibited substantial impact and fire damage. The right side of the fuselage also exhibited impact damage (including punctures and metal buckling) and extensive fire and heat damage (including paint blistering and some areas of burn-through). The right wing, slats, flaps, and ailerons showed evidence of substantial impact, fire and heat damage, and the right engine was separated from the wing at its wing-to-pylon attachments. Soot deposits were observed on portions of the lower fuselage and most of the right side of the fuselage. (Figure 2 is a photograph of the damage to the right side of the airplane.) The left

side of the fuselage, left wing, and the nose and tail sections exhibited minimal impact or fire damage.

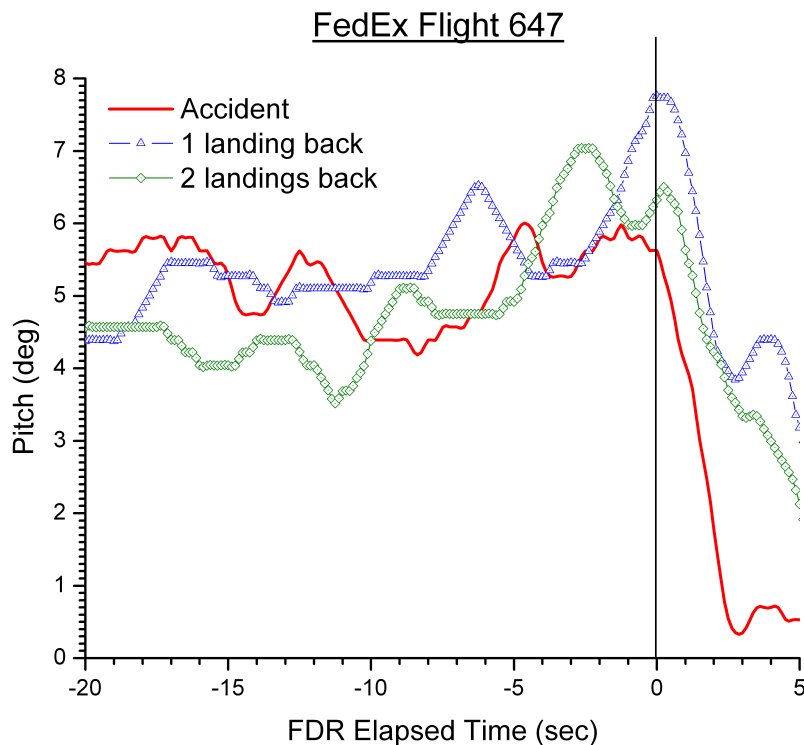
**Figure 6.** Pitch attitudes recorded by the FDR during the accident landing and two previous landings. The vertical black line (FDR elapsed time 0 seconds) represents the airplane's touchdown.

The Safety Board's study of the FDR pitch data showed no evidence of an increase in the airplane's pitch attitude (flare) before touchdown. By contrast, during the two previous landings recorded by the FDR, the airplane's pitch increased during the seconds before touchdown, reaching nose-up pitch attitudes of more than  $7^\circ$ . Figure 6 shows the pitch attitudes recorded by the FDR during the accident landing and two previous landings.

Although the FDR pitch data showed no evidence of a flare before the airplane touched down, the FDR elevator position data showed that the elevator moved from about  $2.75^{\circ}$  to  $12.75^{\circ}$  airplane nose up almost immediately after the left main landing gear touched down, just as the right main landing gear touched down. The study also revealed that the airplane's longitudinal axis was not aligned with its direction of flight or the runway when it touched down. Rather, the nose of the airplane was aligned on a heading of about  $352.6^{\circ}$ , about  $5.4^{\circ}$  left of the runway's magnetic heading of  $358^{\circ}$  and about  $6.5^{\circ}$  left of the airplane's ground track of about  $359.1^{\circ}$ . This information is consistent with the physical evidence noted in section 1.12.2.
