**Runway overrun, Executive Airlines (doing business as American Eagle)  
Flight 5401, Avions de Transport Regional 72-212, N438AT, San Juan,  
Puerto Rico, May 9, 2004**

**Crash During Landing  
Executive Airlines (doing business as  
American Eagle) Flight 5401  
Avions de Transport Regional 72-212, N438AT  
San Juan, Puerto Rico  
May 9, 2004**

**NTSB/AAR-05/02**

**Abstract:** This report explains the accident involving Executive Airlines (doing business as American Eagle) flight 5401, an Avions de Transport Regional 72-212, which skipped once, bounced hard twice, and then crashed at Luis Muñoz Marin International Airport, San Juan, Puerto Rico. Safety issues discussed in this report focus on flight crew performance, the lack of company bounced landing recovery guidance and training, and malfunctioning flight data recorder potentiometer sensors. Safety recommendations concerning these issues are addressed to the Federal Aviation Administration.

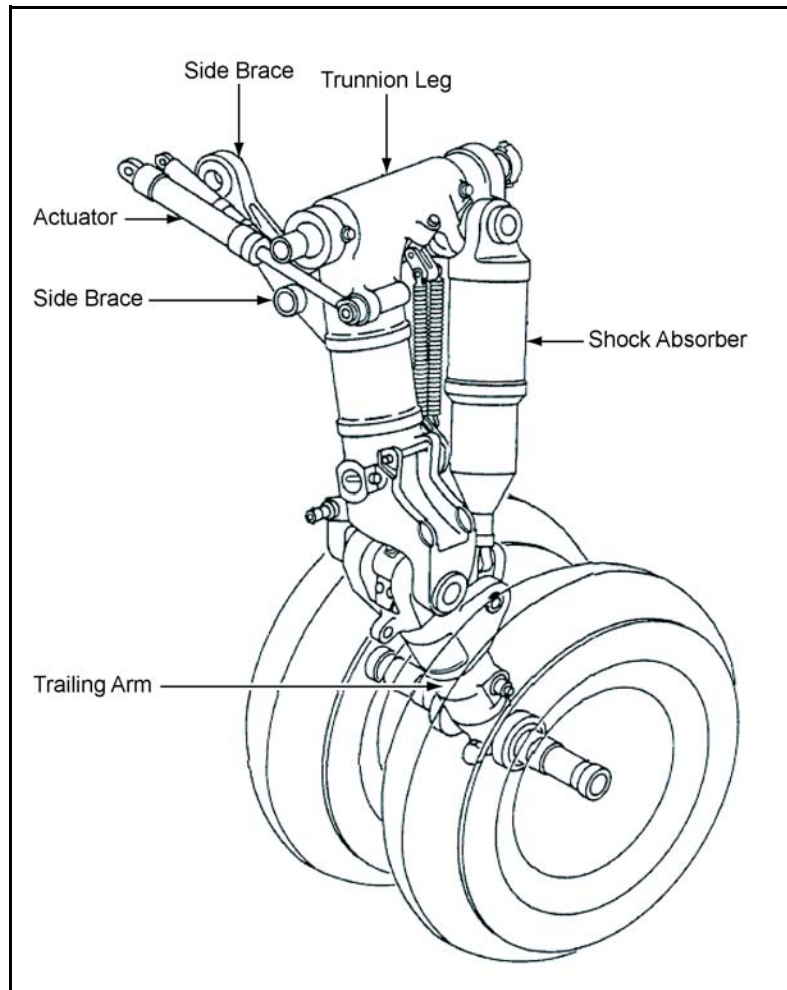
**Figure 2.** Main landing gear assembly.

The left MLG was fractured circumferentially at its vertical trunnion leg just below the actuator attach point. The upper portion of the vertical trunnion leg, which remained attached to the horizontal trunnion leg, was 4 inches long. The horizontal trunnion leg remained attached to the fuselage by the trunnion attach points, and no evidence of any damage to these components was found. The lower portion of the vertical trunnion leg, which remained attached to the wheel assembly, was 24 inches long.

Sections of the vertical trunnion that contained the fractures were removed from the airplane and sent to the Safety Board's Materials Laboratory for further examination. The examination revealed that the fracture surfaces were consistent with overstress separation. No evidence of fatigue was found.

The upper portion of the left MLG side brace remained attached to the fuselage, and the lower portion had separated from the fractured vertical trunnion leg and showed no evidence of scraping or scoring. The secondary side brace remained attached to the left MLG and exhibited minimal damage. The left MLG shock absorber was found separated from the MLG assembly. The shock absorber was found along the wreckage path in the fully compressed condition, and no shock absorber fluid was present. The shock absorber base was fractured about 5 inches from the bottom. The upper portion of the shock absorber was intact.

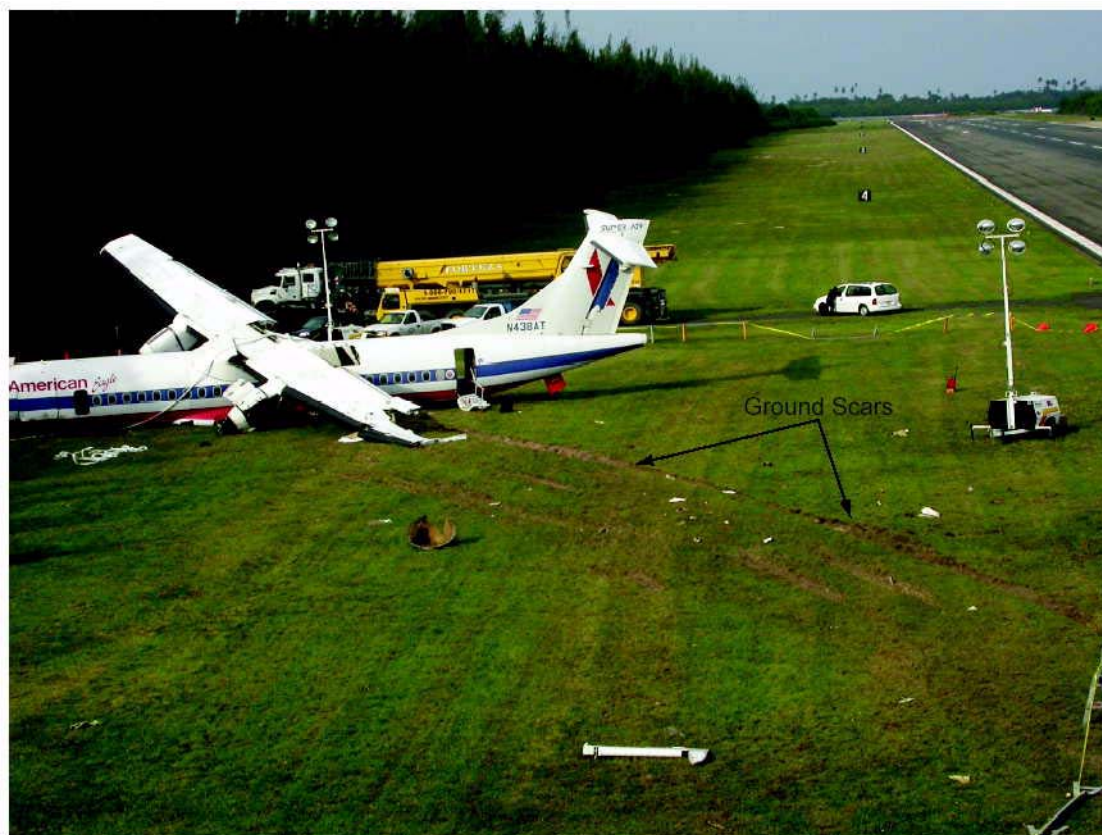
**Figure 3.** Ground scrape marks and the main wreckage.

The first evidence of ground impact (from the airplane's third touchdown) was located on runway 8 about 44 feet left of the runway centerline and about 3,361 feet beyond the runway threshold. Various ground impact, gouge, scrape, and tire marks were found near the first ground impact mark. These marks were on a magnetic heading of about 075° and were consistent with the landing gear tires on the accident airplane. The tire marks extended about 40 feet from the first ground impact area in the direction of the main wreckage. No other tire marks that were consistent with the tires on the accident airplane were found beyond the first impact area. An oily spray pattern extended outward to the left of the gouge marks. The oily substance was consistent with the fluid contained in the MLG shock absorbers. Most of the pieces found at the first ground impact area were small sections of the NLG, including the NLG door, pieces of the left MLG, and the fuselage belly fairing.

Evidence of another ground impact (from the airplane's fourth touchdown) was found on the grassy area about 145 feet left of the runway 8 centerline and 4,053 feet beyond the runway threshold (about 692 feet from the initial ground impact area). This evidence included left wing tip scrape marks, left engine propeller strike marks, and a fuselage belly impact impression, which were all on a magnetic heading of about 070°. The marks on the grassy area continued from the second ground impact area to the main wreckage location. Sections of the outboard left wing and the left propeller blades were also found in this area.

The main wreckage was located about 217 feet left of the runway 8 centerline and about 4,317 beyond the runway threshold. The main wreckage consisted of most of the airplane structure, except for the lower section of the left MLG tire assembly, which was found about 302 feet left of the runway 8 centerline and 3,944 feet beyond the runway threshold (about 373 feet from the main wreckage). Figure 3 shows ground scrape marks and the main wreckage.

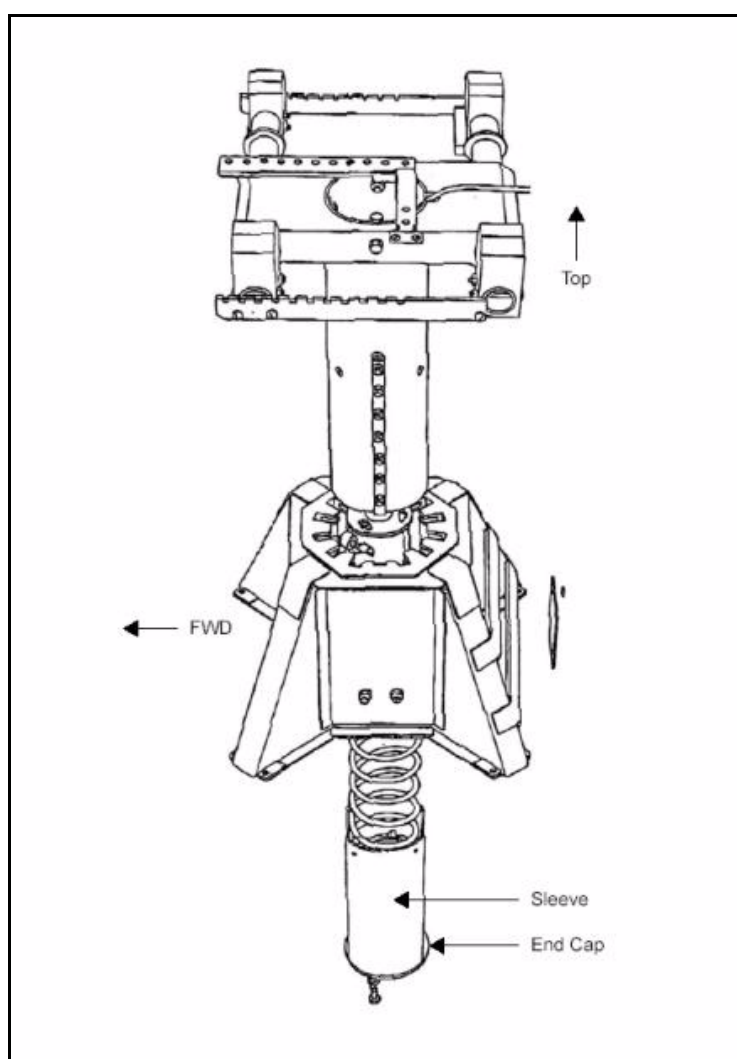
**Figure 5.** Schematic of the cockpit seat assembly.

Visual examinations of the captain seat revealed that the weld that attached the end cap to the sleeve was fractured at both welded joints, releasing the end cap from the sleeve. Visual examinations of the fractured welded joints revealed the presence of dark, oxidized, preexisting regions that were consistent with weld discontinuities at the inner diameter side of both joints. On the forward sidewall fracture, intermittent weld discontinuities extended along most of the 4.2-inch circumferential length of the joint to a depth of about 0.03 to 0.06 inch.<sup>39</sup> On the aft sidewall fracture, the weld discontinuity was continuous and extended along the entire circumferential length of the joint to a depth of about 0.03 to 0.06 inch.

A Safety Board materials engineer estimated that the weld discontinuities extended through about 25 percent of the cross-sectional area on the forward side and about 40 percent of the cross-sectional area on the aft side. The discontinuities contained repeating columnar patterns with curved features at an angle to the surface, which was consistent with a lack of fusion that resulted from molten regions not bonding during the welding process. High-magnification optical and scanning electron microscope examinations of the aft sidewall fracture showed the presence of small fatigue cracks that had propagated from the weld discontinuity region toward the outer diameter, which slightly increased the total penetration of the preexisting defect region.

Visual examinations of the intact welded joints on the first officer seat revealed that gaps existed between the mating surfaces of both welded joints, which was consistent with incomplete weld penetration. The forward sidewall region had about a 2.9-inch-long gap (the total joint length was 4.2 inches). The aft sidewall region had two slightly overlapping gaps that extended about 3 inches. A section of the forward sidewall welded joint was excised and fractured open, revealing that the gaps at the inner diameter of the welded joint had features similar to the preexisting weld discontinuity (lack of fusion) regions on the inner diameter of the welded joints on the captain seat. The maximum penetration of the weld discontinuity was about 0.045 inch in the section that was fractured open for examination.
