Cockpit fire—precautionary landing, Air France Boeing 777-228ER, F-GSPZ, Churchill, Manitoba 290 nm NE, 17 October 2002

AVIATION INVESTIGATION REPORT

A02C0227

COCKPIT FIRE – PRECAUTIONARY LANDING

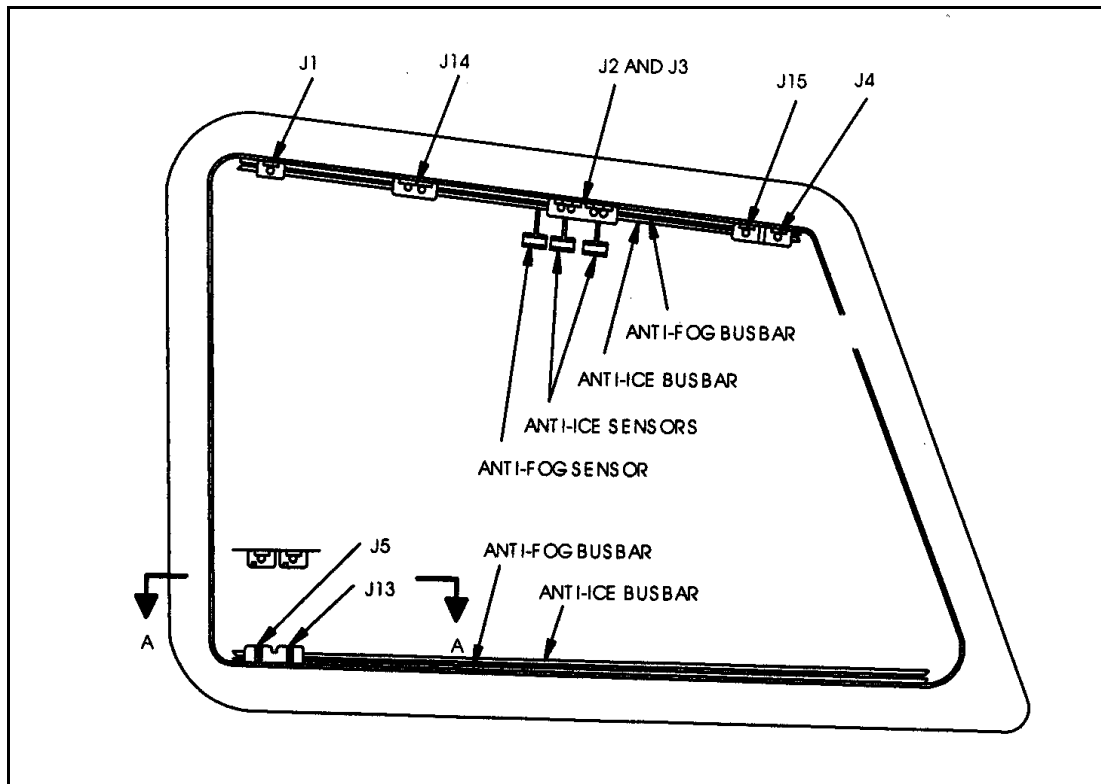
Left Forward Flight Compartment Window

Windshield Location	Terminal Number	Terminal Type	Terminal Torque		
			Target	Actual	Difference
Left Fwd	J1	Power	25–30 in/lbs	See Note 1	
	J4	Power	25–30 in/lbs	8 in/lbs	-68%
	J5	Power	25–30 in/lbs	Burnt See Note 2	
	J13	Power	25–30 in/lbs	Burnt See Note 2	
	J15	Power	25–30 in/lbs	12 in/lbs	-52%
Left Fwd	J2 A	Sensor	12–15 in/lbs	15 in/lbs	Good
	J2 B	Sensor	12–15 in/lbs	12 in/lbs	Good
	J3 A	Sensor	12–15 in/lbs	10 in/lbs	-17%
	J3 B	Sensor	12–15 in/lbs	15 in/lbs	Good
	J14 C	Sensor	12–15 in/lbs	See Note 3	
	J14 D	Sensor	12–15 in/lbs	5–10 in/lbs	-17 to -58%
Right Fwd	J1	Power	25–30 in/lbs	Loose	-100%
	J4	Power	25–30 in/lbs	Loose	-100%
	J5	Power	25–30 in/lbs	8 in/lbs	-68%
	J13	Power	25–30 in/lbs	8 in/lbs	-68%
	J15	Power	25–30 in/lbs	5 in/lbs	-80%
Right Fwd	J2 A	Sensor	12–15 in/lbs	8 in/lbs	-33%
	J2 B	Sensor	12–15 in/lbs	5 in/lbs	-58%
	J3 A	Sensor	12–15 in/lbs	15 in/lbs	Good
	J3 B	Sensor	12–15 in/lbs	10 in/lbs	-17%

Note 2: In order not to disturb the terminal prior to laboratory examination, the terminal torque was not checked, but determined to be at least finger tight. During the laboratory examination, the breaking torque was measured at less than 5 in/lbs.

J1, J4, J1, J13, J15: Power Terminals
