AVIATION INVESTIGATION REPORT

A04W0032

LANDING BESIDE THE RUNWAY

BOEING 737-210C C-GNWN

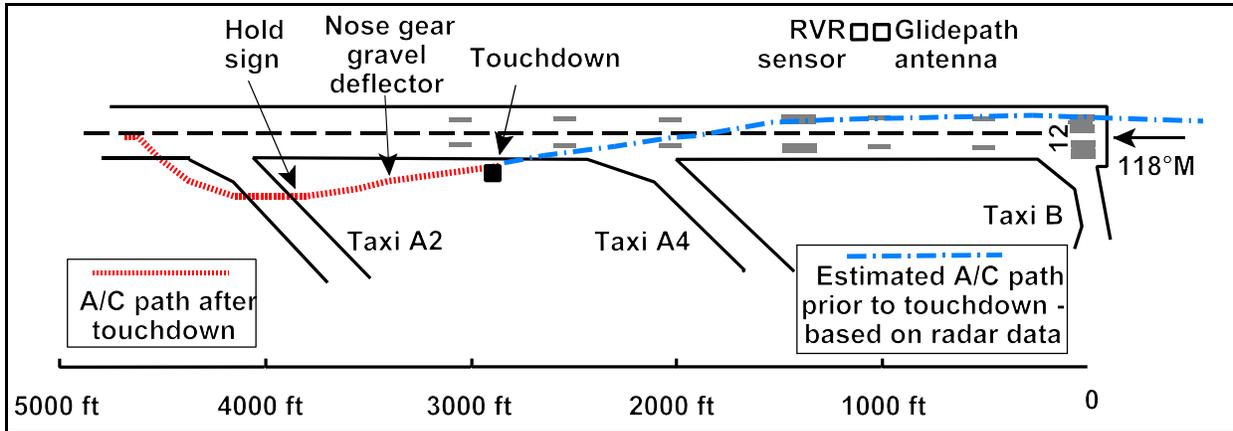
At touchdown the aircraft's heading was 117° M. The right main landing gear touched down first, approximately 8 feet off the left edge of the runway and 2700 feet from the threshold. The initial track of the main gear through the snow was approximately 109° M. Reverse thrust and a large input of right rudder were applied shortly after touchdown. The marks left by the aircraft through the snow were consistent with the aircraft sliding sideways, up to 23° nose-right of the aircraft's track. These corrective actions by the flight crew resulted in the aircraft regaining the runway after travelling 1600 feet beside it and crossing Taxiway A2. The aircraft was brought to a stop on the runway centreline, 4550 feet from the threshold (see Figure 1). At the time of touchdown, the RVR was 1200 for Runway 12 and 800 for Runway 30.

Figure 1. Overhead view of Runway 12 at CYEG
