In-flight electrical smoke, Final Report of the Aircraft Accident Investigation Bureau concerning the incident to the airplane Mc Donald Douglas MD 83, OH- LPH, Finnair on 15 April 2000 at Zurich Airport

Final Report of the Aircraft Accident Investigation Bureau

to the airplane Mc Donald Douglas MD 83, OH- LPH, Finnair
on 15 april 2000
at Zurich Airport

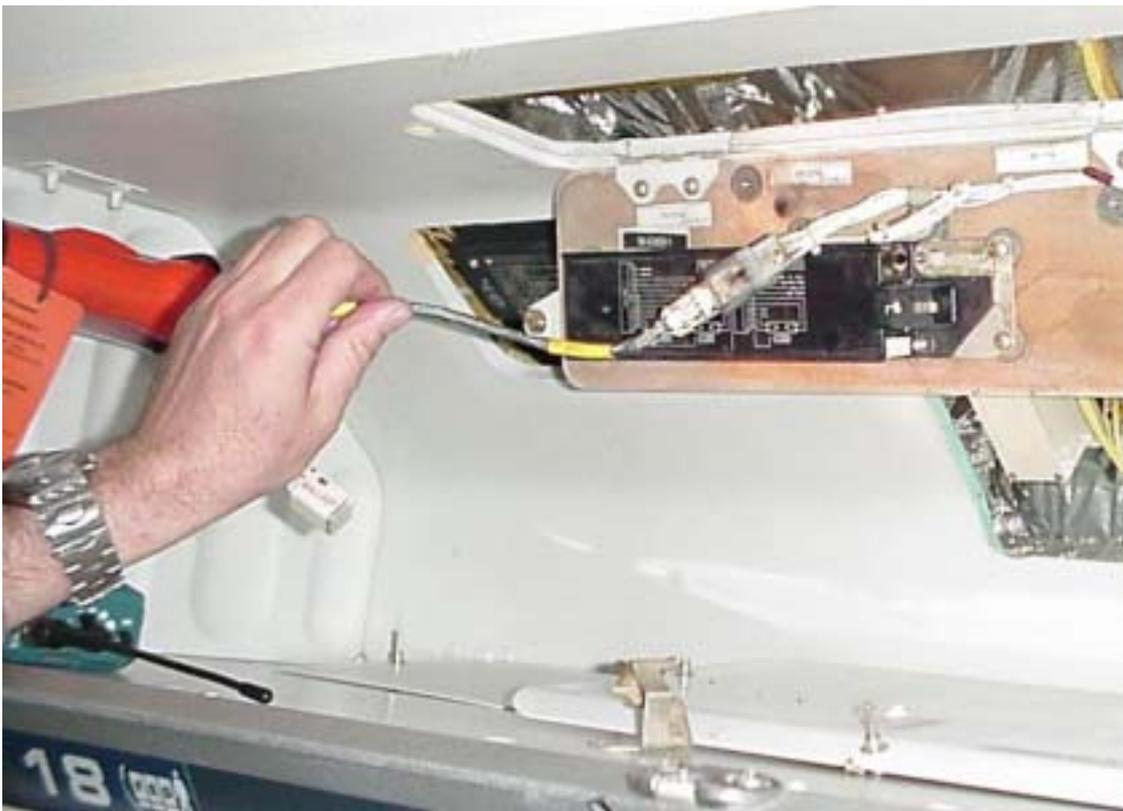
Fig. 1

- After opening of the ceiling panel above hat rack row 18 RH, the access door to the sidewall light ballast was opened. The connector on the a/c side wiring was found burned. (Fig. 1)

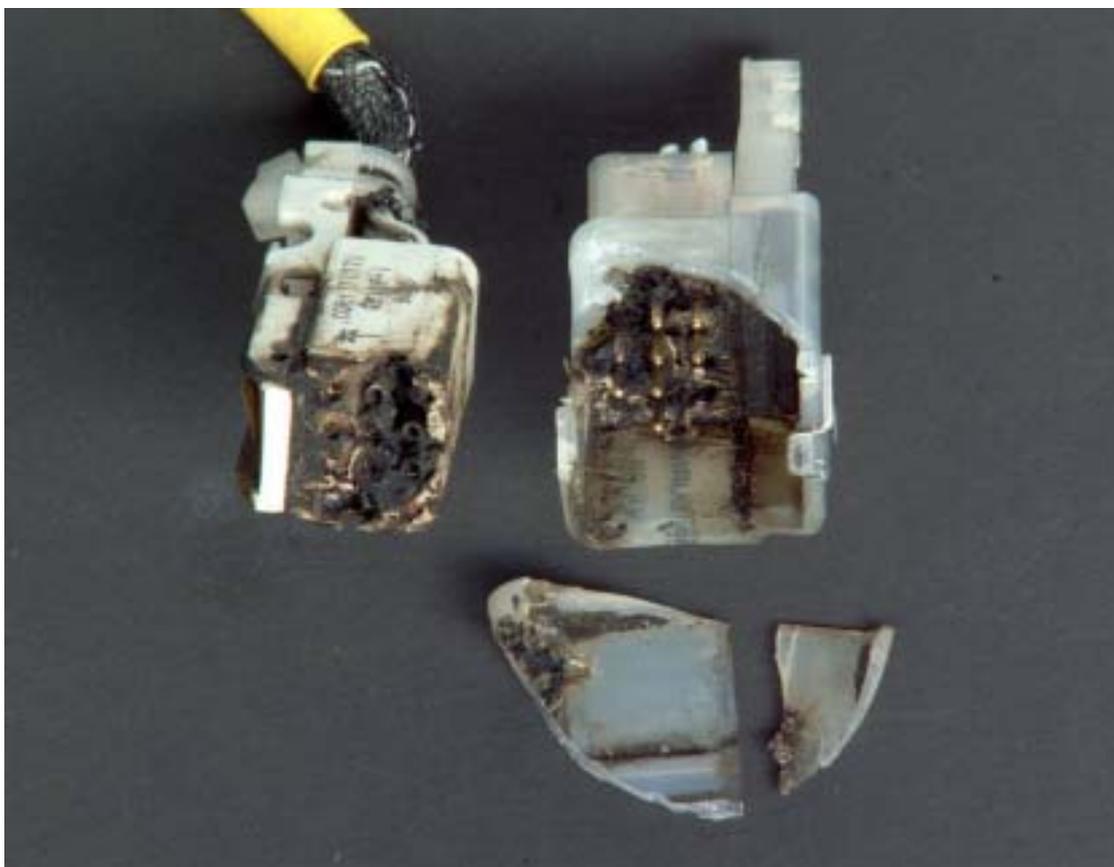
Fig. 2

- The connector was removed for investigation.
- The external housing of the female and male part of the connector did not show signs of external heat damage. (Fig. 2)

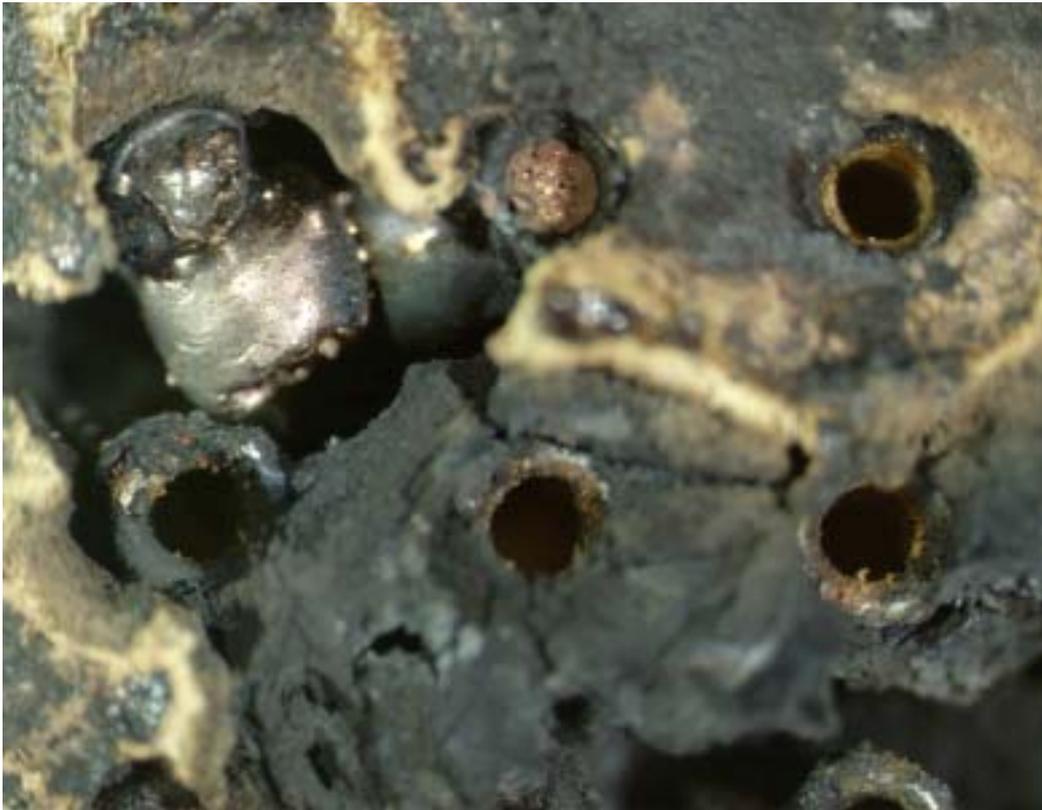
Fig. 3

- The connection between wire and contact did not show thermal damage and had a firm seat.
- In the socket part of the connector, at contact "A", there was a melted pearl of metal. (Fig. 3)

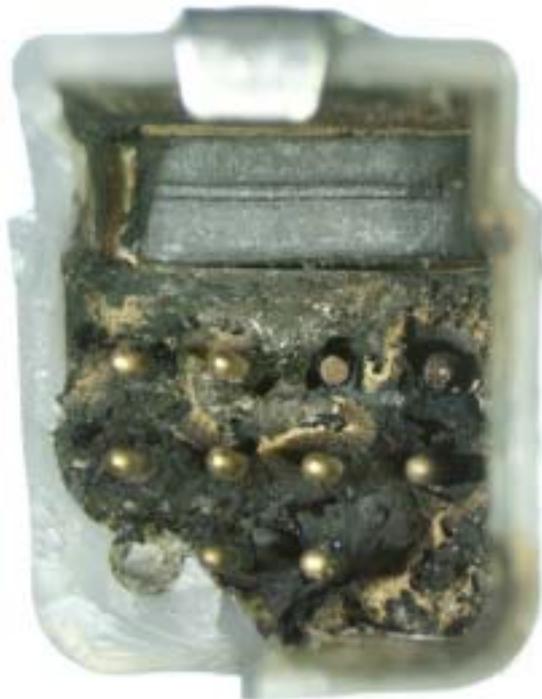
Fig. 4

- Otherwise in the pin part of the connector, the forward part of pin "A" is missing.
- The copper of the remaining pin "A" shows a strong blistering, which indicated high temperatures normally obtained through an electric arc. (Fig. 4)

Due to the found increase in temperature that was produced at pin "A" and was of such a nature, that an increase in resistance is suspected as a cause and not the presence of humidity in the connector.

This increase in resistance can result from a mechanically damaged pin or a malformed pin with a shaving. In this case, the current which has to pass will heat up the reduced remaining section and in case of AC- current may produce an arc. This arc will melt the copper as found in the burned connector.

The incident was caused by an increased electrical resistance on a contact of the connector between the a/c wiring and the special interconnect cable (P/N C773-10-450) to the ballast.
