In-flight Smoke, Final Report No. 1844 by the Aircraft Accident Investigation Bureau concerning the serious incident to the aircraft Embraer EMB-145LU, HB-JAH operating under flight number CRX 3439 on 28 November 2001 during approach to Zurich Airport

Final Report No. 1844 by the Aircraft Accident Investigation Bureau

concerning the serious incident
to the aircraft Embraer EMB-145LU, HB-JAH
operating under flight number CRX 3439
on 28 November 2001
during approach to Zurich Airport

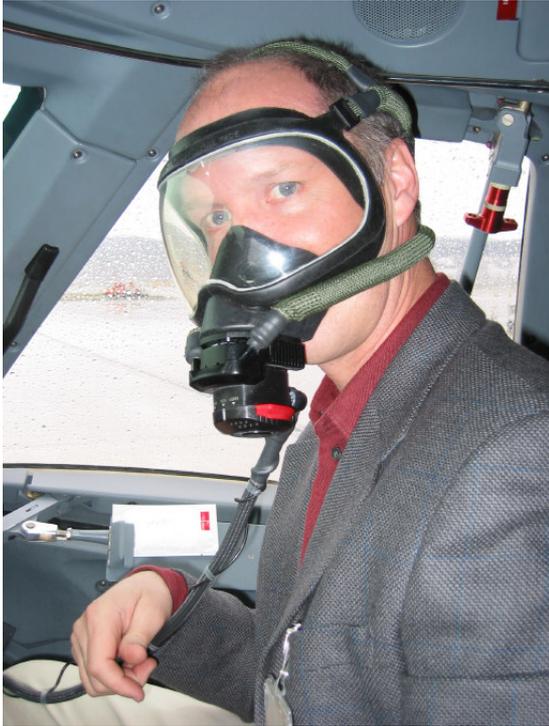
Picture 1

The aircraft HB-JAH was equipped with quick donning full face masks (picture 1), manufactured by B/E Aerospace. A push-button activated inflatable harness system allows a quick donning of those masks. They were stored in separate stowage compartments called "stowage box" located left of the pilot seat and right of the copilot seat (picture 2). Those stowage boxes have been layed out for oxygen masks without a full face part while in this aircraft full face masks were installed. The space in the stowage box to stow the full face mask, was very tight. To allow an easy pull out of the masks out of the stowage boxes and to avoid scratches on the full face mask screen the manufacturer installed a cloth bag, called "liner", in the stowage boxes.

Full face mask

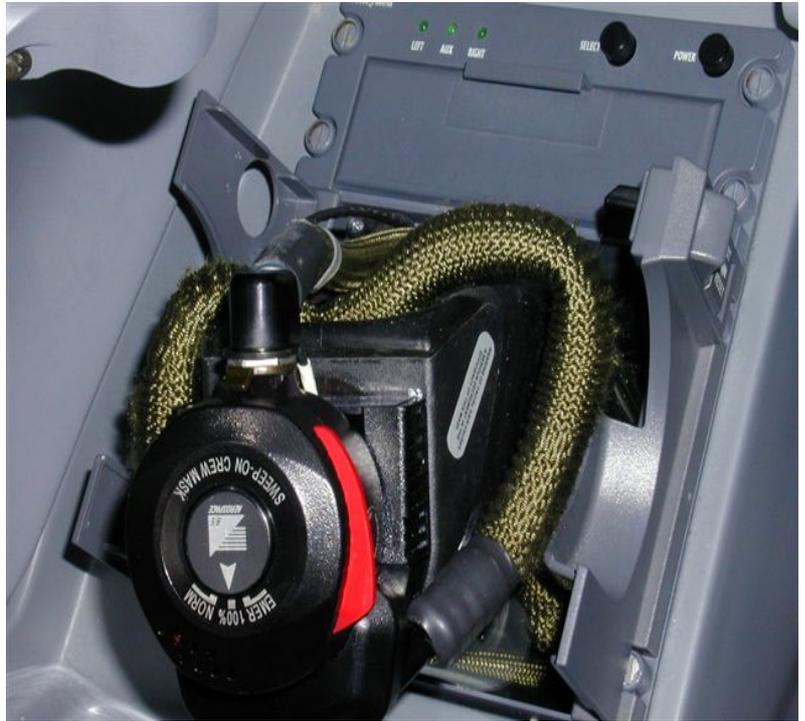
Picture 2

The copilot reported problems pulling his oxygen mask out of the stowage box. During the investigation it was found that there was no liner installed because there have been some cases in which the mask and the liner got caught up.

For flights above FL250 quick donning masks are required. According to certification requirements they have to be donned within 5 seconds. Practical tests with other crews and other aircraft out of the operators EMB 145 fleet showed that as a rule the masks were not donned within the required 5 seconds due to problems to get the masks out of the stowage box.

Oxygen mask, halfway pulled out of the "stowage box"

Ten (10) months before this serious incident the manufacturer of the masks informed the operators in a "service information letter" about the mentioned problems and proposed a modification. This modification included a new liner, which is attached to the bottom of the stowage box and which is supposed to remain in the stowage box when the mask is pulled out. This modification has not been performed on Crossair's airplanes. Later on, partly as a consequence of this serious incident, the modification has been performed on all of Crossair's Embraer 145.

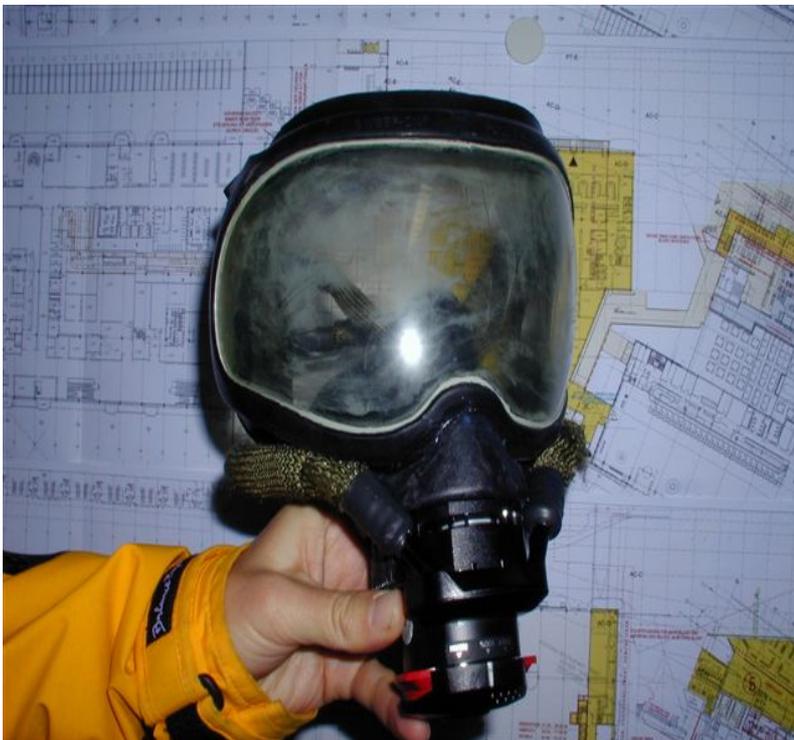
Picture 3

Wearing the oxygen mask with its restricted transparency, the copilot assumed that the development of smoke had increased. The screen of his mask was on the inside and the outside covered with a layer. During a spot check on some aircraft of the EMB-145 fleet the investigators found four (4) other masks with considerable soiled screens.

About three months after this serious incident, the manufacturer of the masks informed all operators having installed this type of mask about the origin and the process to remove this layer. This layer developed some time after the production of the masks due to a material like wax, used in the production process and not properly removed afterwards.

The heavily contaminated screen of the copilot's full face mask gave him the impression of an increased smoke development. Therefore the assessment of the situation made by the two pilots was quite different. The additional communication problems inside the cockpit as well as with air traffic control hampered the crew coordination in a way that it practically broke down, at least during certain phases of the approach.

Copilot's heavily contaminated full face mask screen

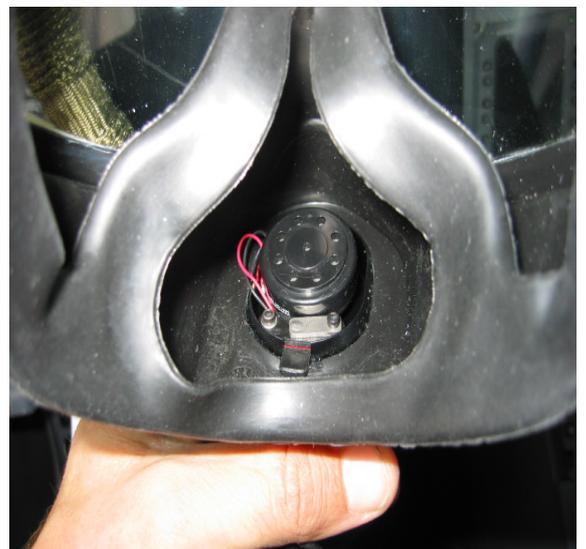
Picture 4

After having put on the masks, the pilots have been confronted with communication problems which hampered the communication and teamwork in the cockpit considerably. The communication problems were caused by an intermittent failure of the mask microphones mute switch.

The microphones built into the masks were from the manufacturer "Telex". About the function principle of those masks: during inhaling oxygen flows into the mask, in which the microphone is installed (picture 4). In order not to send the loud noise of the expanding oxygen into the intercom system, those microphones have an electromechanical function (called reed-switch), which should switch the microphone off during the breath in. Due to a malfunction this reed-switch function was unreliable, from time to time the microphone remained off despite the pilot was not inhaling. As a result the intermitting function of the microphones hampered the communication between the pilots considerably.

Built in mask microphone

According to a service letter of the microphone manufacturer, the so called reed-switch, which interrupts the microphone circuit during inhaling, can be overridden. In the mean time this measure has been completed on the whole EMB-145 fleet.
