Ground collision, Final Report by the Aircraft Accident Investigation Bureau on the collision on the ground between Crossair AG AVRO RJ100, HB-IYX and TAM, Brazilian Airlines Airbus A330-200, PT-MVB on 27 December 2001, 19:39 UTC Zurich Airport

**Final Report
by the Aircraft Accident
Investigation Bureau**

Crossair AG AVRO RJ100, HB-IYX

TAM, Brazilian Airlines Airbus A330-200, PT-MVB

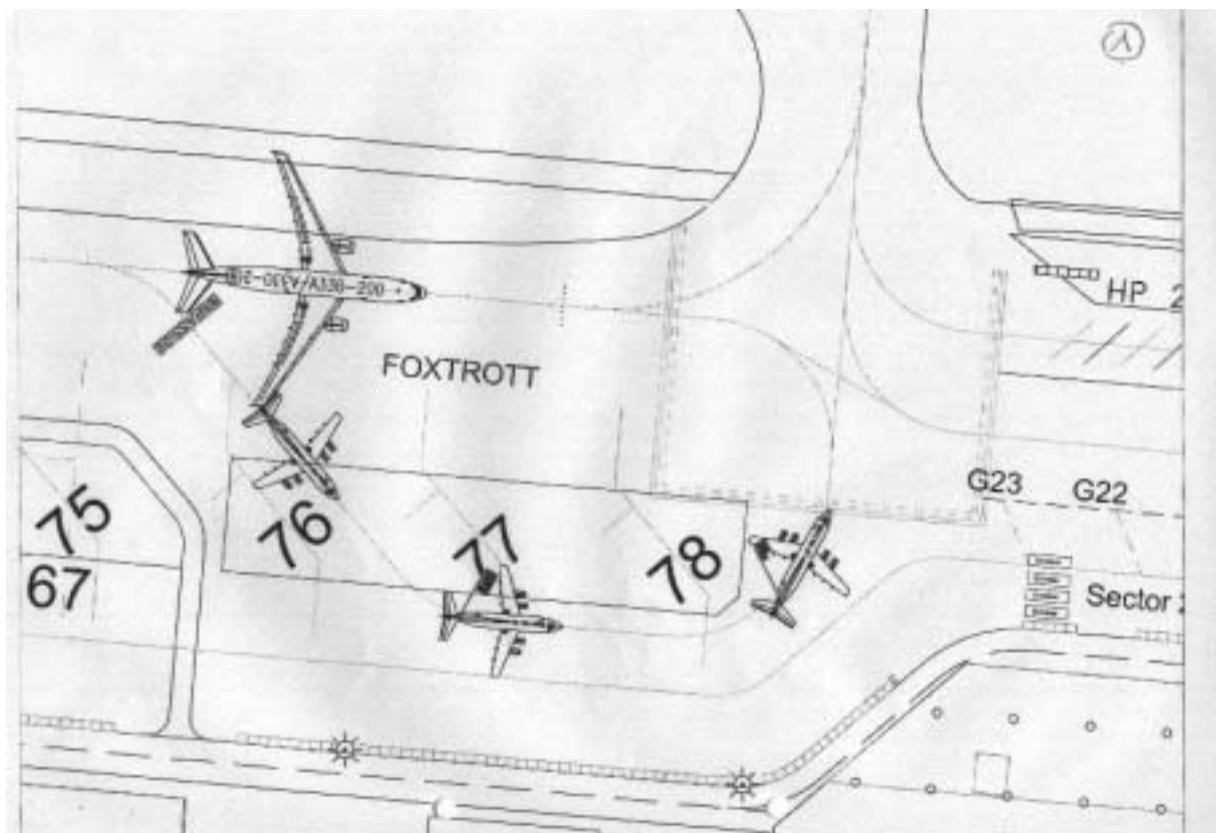
Appendix 1

The collision occurred because the crew of the taxiing TAM8071 did not realise that CRX874 was stationary on the right of their taxiway and had not yet taxied completely into the standby for de-icing position and that the space available was not sufficient for an aircraft of the size of an A330-200 to pass.

Sketch simulation collision A330-200 vs AVRO RJ100
