Final Report No. 1874 by the Aircraft Accident Investigation Bureau

of the aircraft Beech Super King Air 300LW, D-ICBC

on 14 February 2002

on the Piz Sarsura (20 km NE of Samedan aerodrome),
Zernez municipality

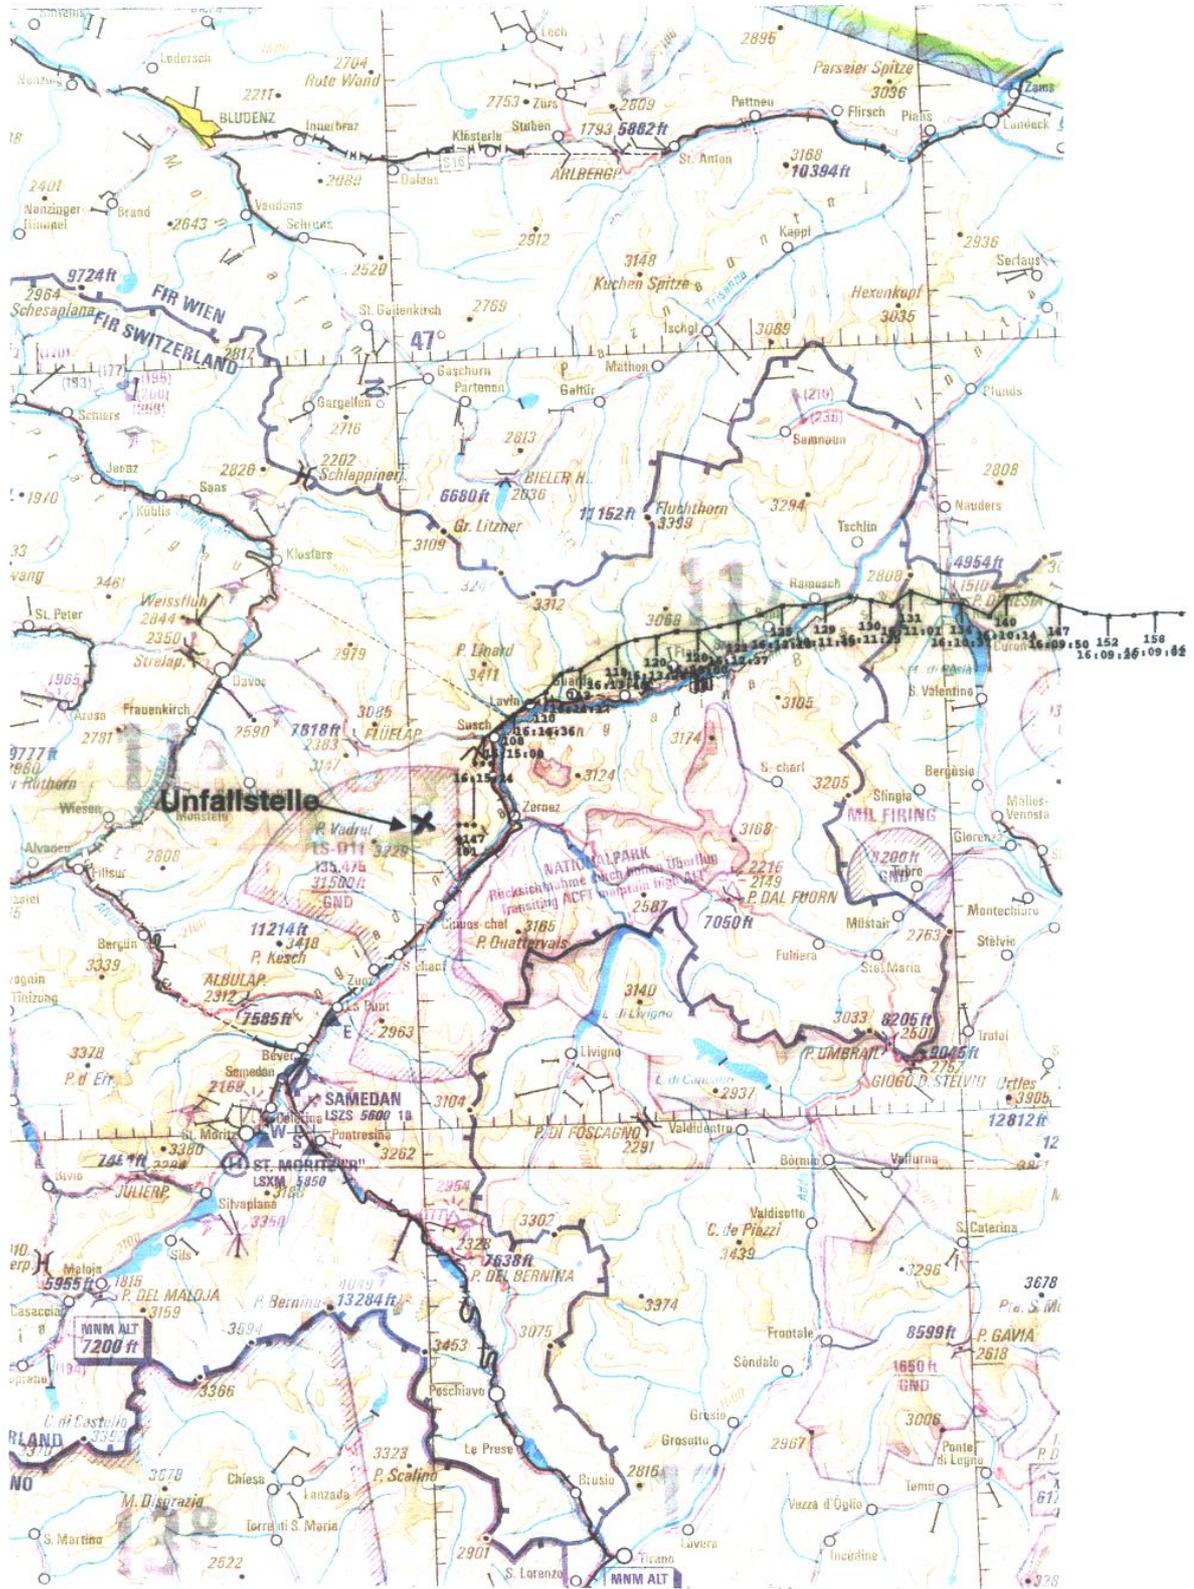
Ausschnitt ICAO Karte der Schweiz 1: 500 000

In the cockpit of the aircraft, no documentation was found as it would be required for approaches under visual flight rules, such as, for example, the ICAO chart of Switzerland and the corresponding visual approach charts for Samedan. Only the vicinity chart from the route manual used by the crew was found. Moreover, the site of the accident is located outside the mapped section of this chart (see Annex 3).

The visual flight documentation contains much information which facilitates or enables the crew to assess the geographical and topographical conditions. If they had used the ICAO chart, among other things, the crew would have been able to realise that they had already descended below the maximum elevation figure for the entire area over which they were flying. Moreover, from the ICAO chart it would have been possible to realise that the runway direction did not correspond to the orientation of the valley and that there was terrain at an elevation of over 3000 m/M on the extended centreline of the runway being approached (see Annexes 1 and 2).

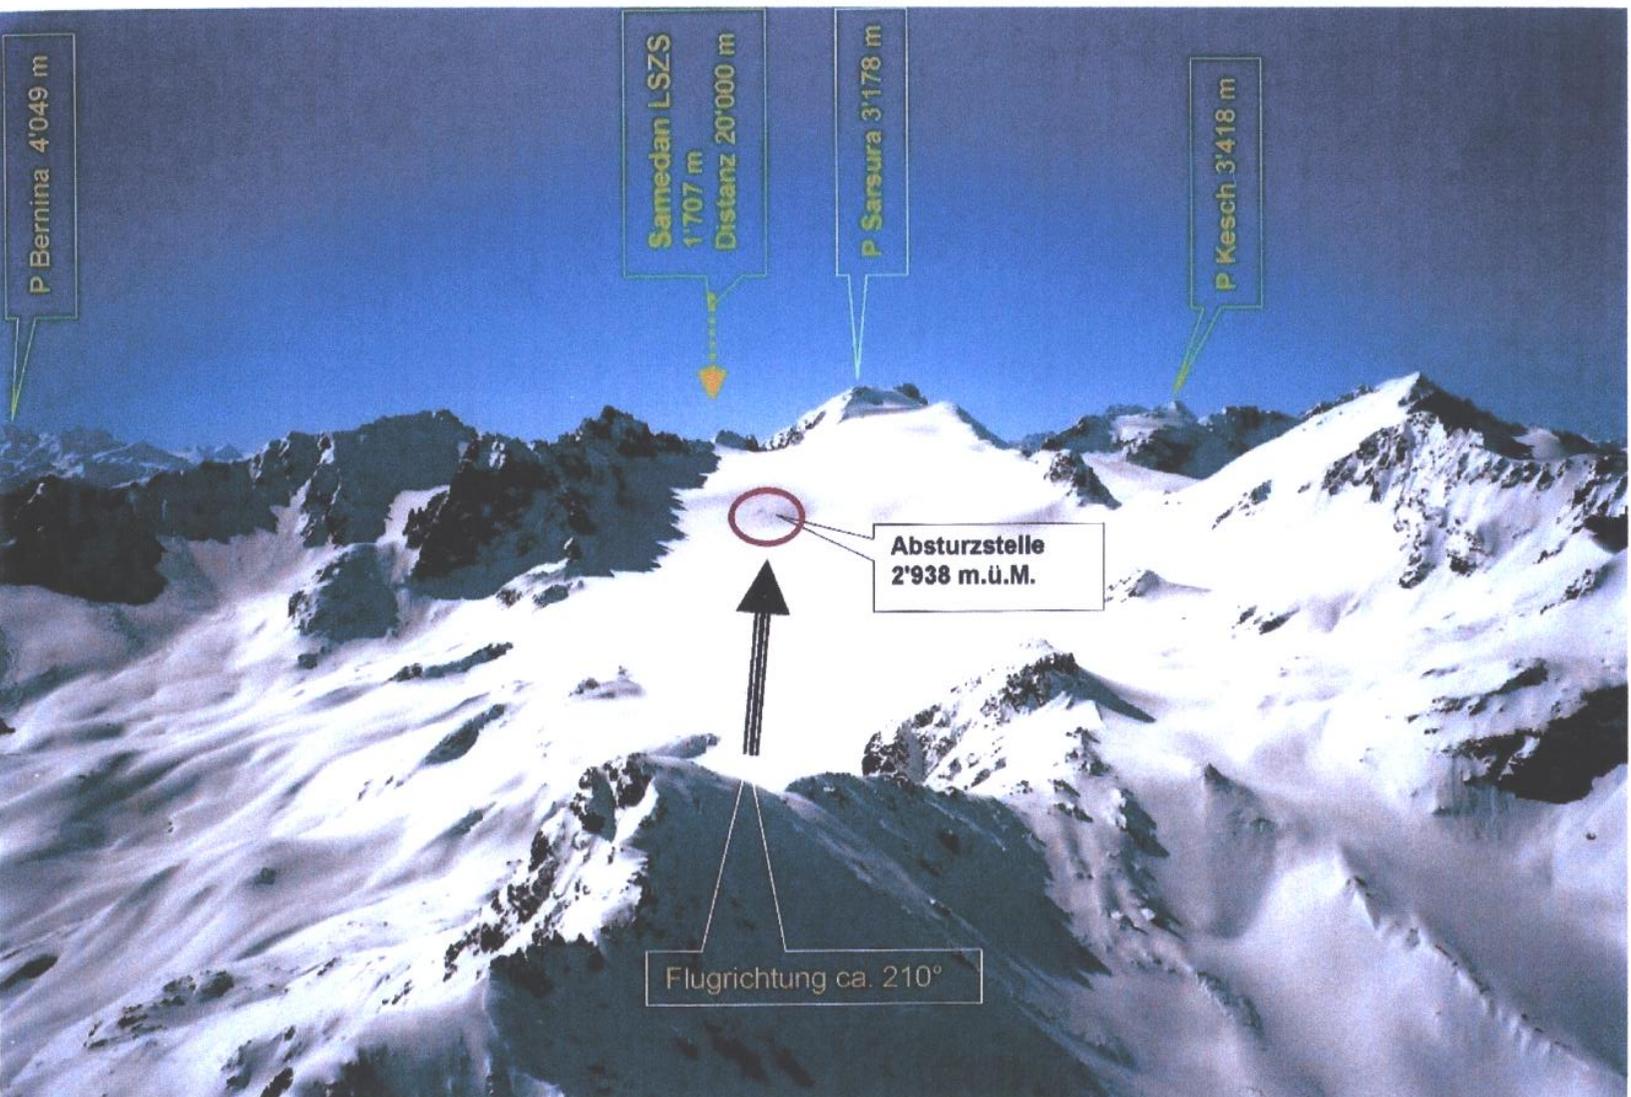
Ansicht Unfallstelle

Thereby the aircraft collided with the elevated terrain of the Sarsura glacier at an elevation of 9640 ft AMSL. Both pilots were fatally injured. The aircraft was destroyed.

A little later, the aircraft collided with the elevated terrain of the Sarsura glacier at an elevation of 9640 ft AMSL. Both pilots were killed immediately. The aircraft was destroyed.

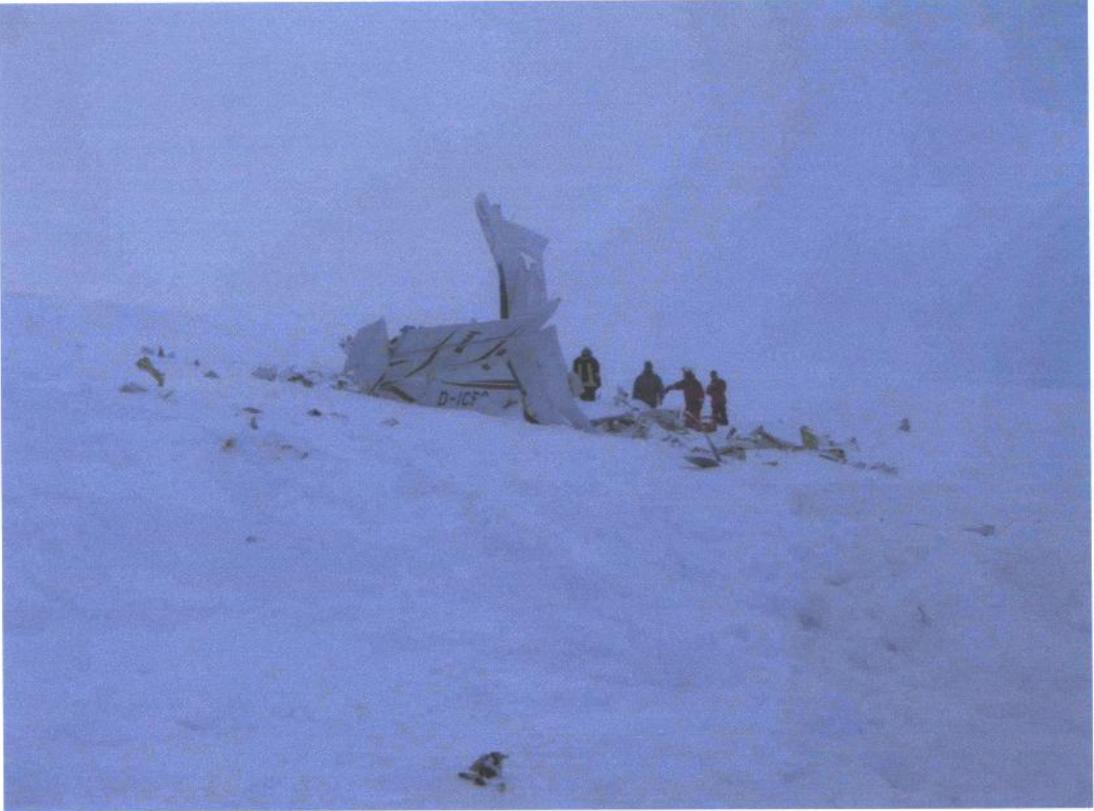
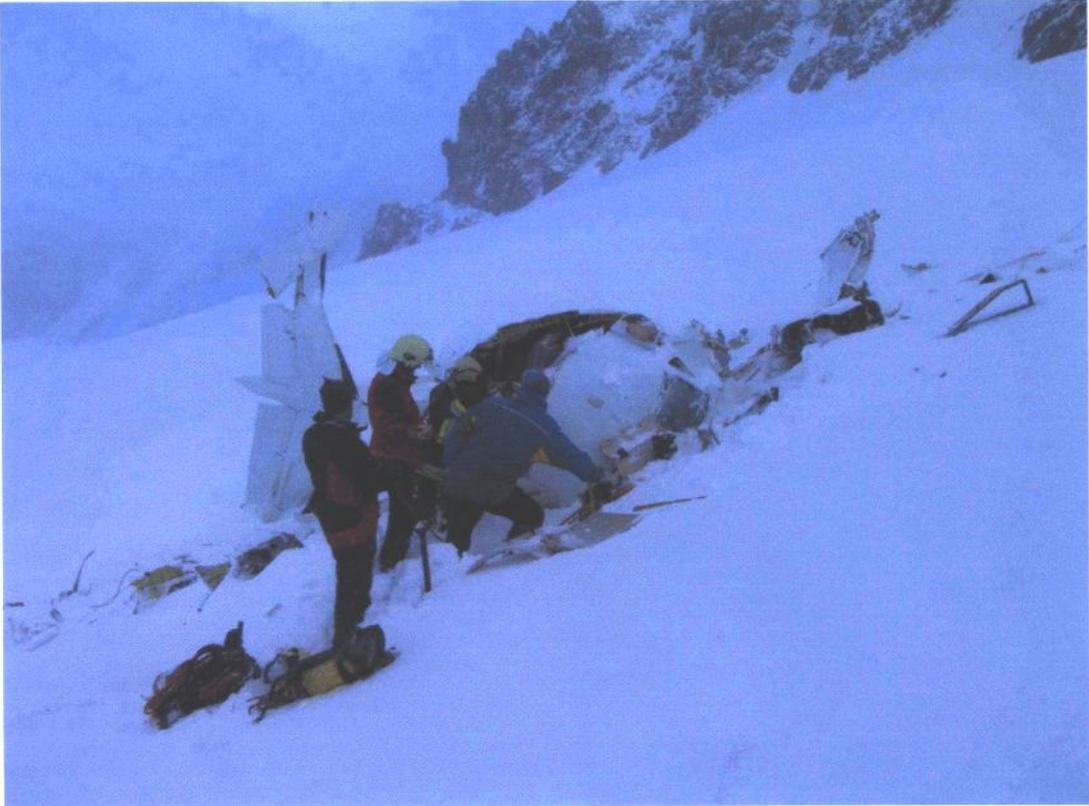
Ansicht Wrack

The left elevator was broken in the middle and the elevator position and trim were neutral.

The rudder was deflected 15° to the right and the trim tab was at 4° to the left. The rudder control and rudder exhibited slight to moderate damage.

The cockpit area was badly damaged and the nosecone was shattered.

The top of the fuselage was practically intact over the front section and damaged by the elevator assembly over the rear section.

The front section of the underside of the fuselage was badly damaged as far back as to the wings. Behind the trailing edge of the wings, the fuselage was virtually undamaged.

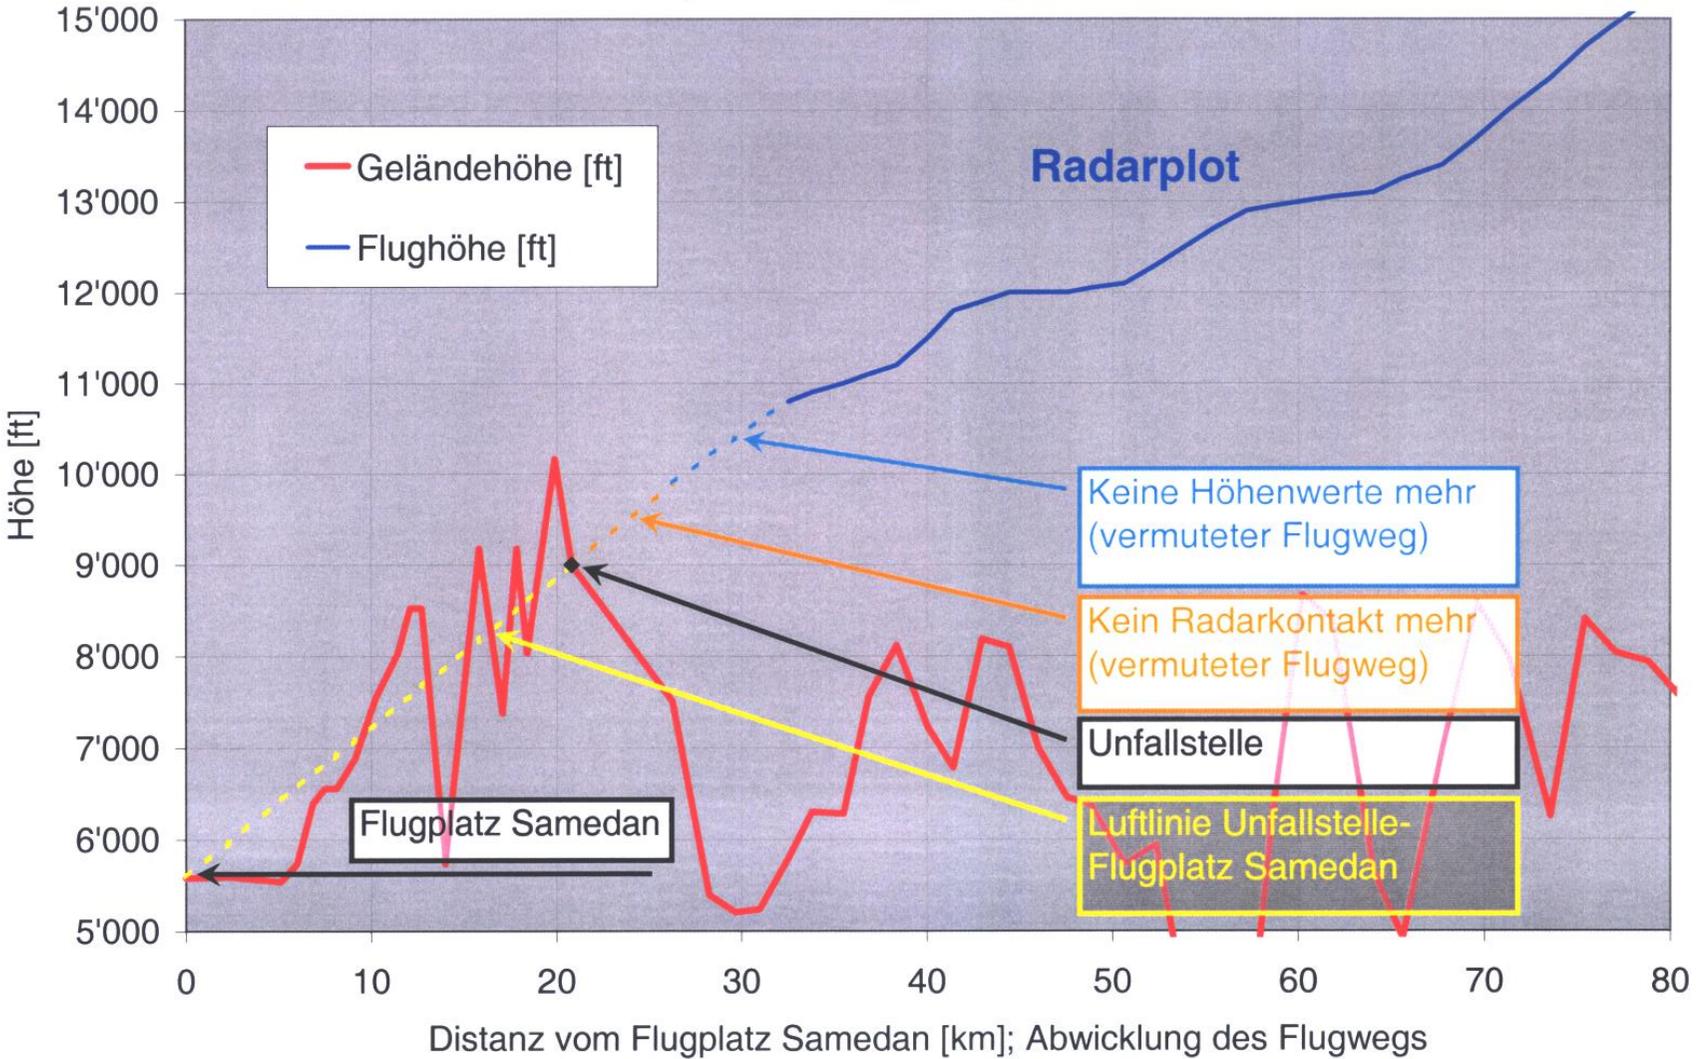
Höhenprofil Flugweg D-ICBC

After leaving flight level 170, the aircraft turned slightly to the right onto a course of approximately 265° and maintained its continuous descent. At 16:11:25 UTC, the aircraft passed flight level 130 and began to turn slowly to the left. This turn brought the aircraft precisely onto the extended centre line of runway 21 in Samedan. The aircraft was last captured by the radar at 16:15:24. The last flight level indicated on the secondary radar was FL 101.

The accident is caused by the fact that the crew on its approach according to visual flight rules to Samedan aerodrome, under critical weather conditions and applying inappropriate flying tactics lost the situational awareness and thereby the aircraft D-ICBC collided with the terrain.
