**Wing contact with ground during go-around, Final Report by the Aircraft Accident Investigation Bureau concerning the serious incident to the DC-9-83 aircraft, HB-INV, operated by Helvetic Airways under flight number OAW 8100 on 21 October 2004 in Pristina**

# Final Report by the Aircraft Accident Investigation Bureau

to the DC-9-83 aircraft, HB-INV,  
operated by Helvetic Airways under flight number OAW 8100  
on 21 October 2004  
in Pristina (Kosovo, Serbia-Montenegro)

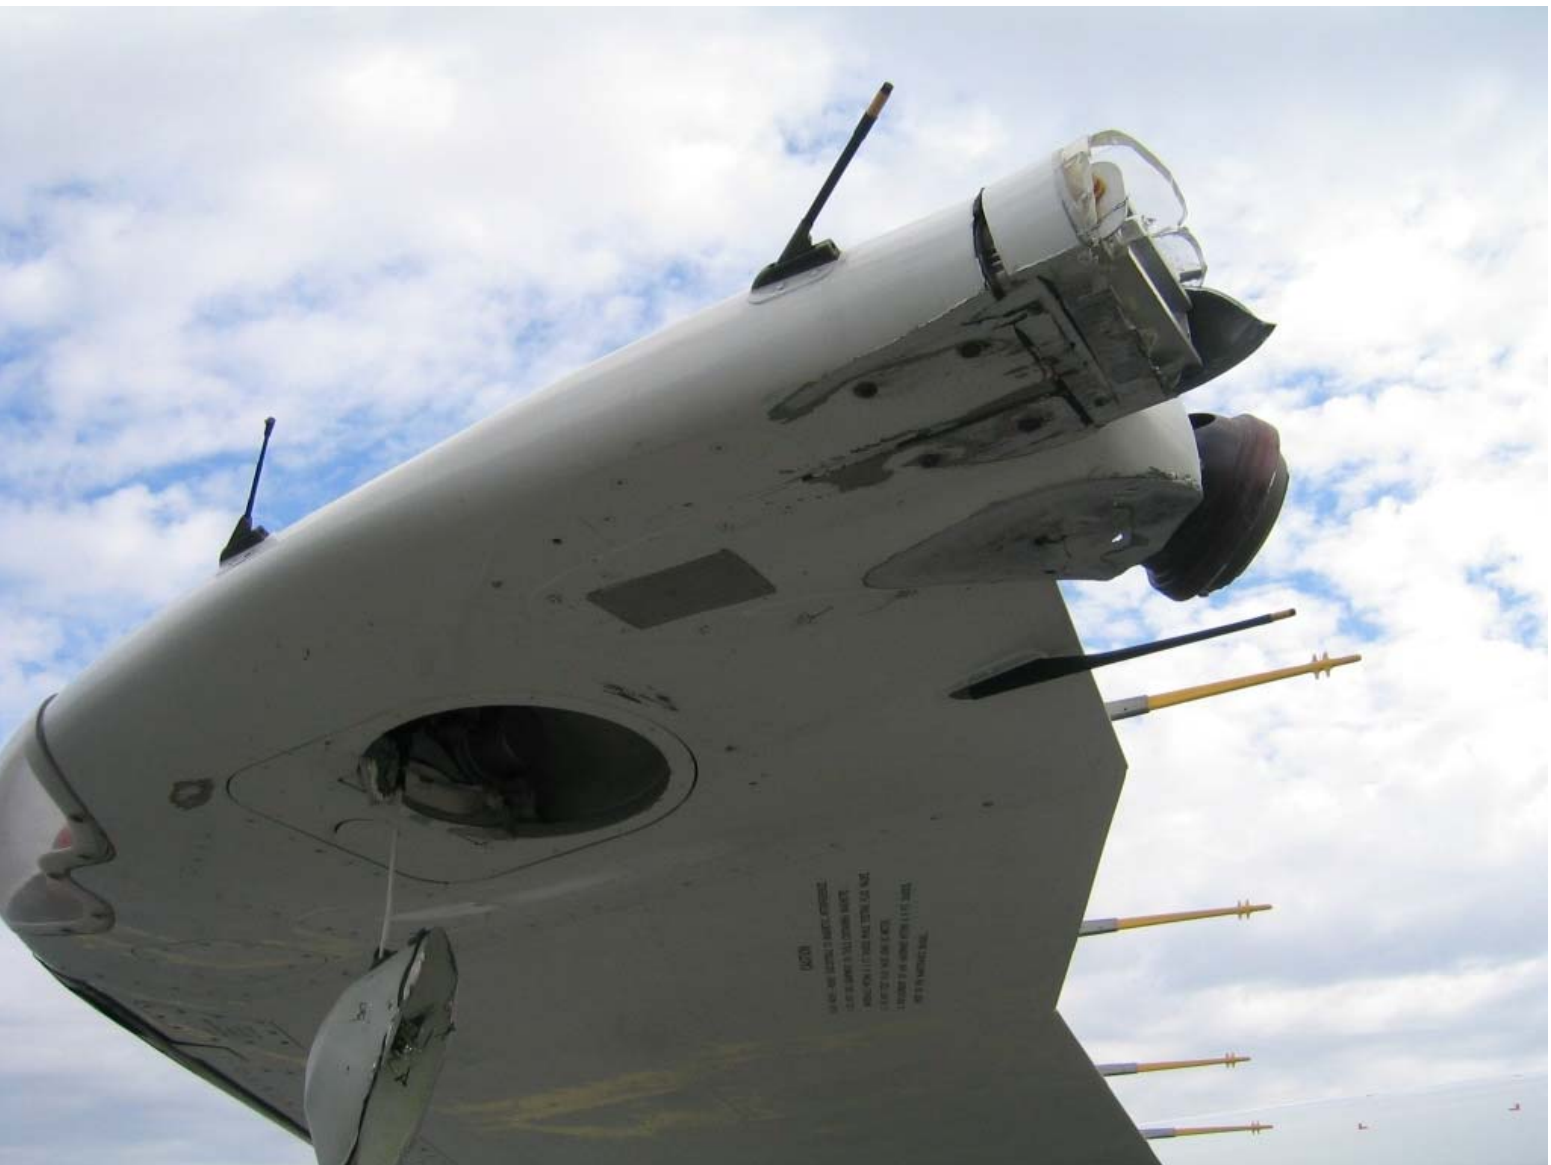
5.1 Damage to the left wing

The extended landing light was torn off and was left hanging from the electrical cables. The left wing strobe light and logo light were damaged.

- The damaged outboard slat #5 was replaced.
- In the area of outboard slat #5, a visual check of the structure, the electrical wiring, the slat tracks, the slat bearings and the anti-ice system was carried out.
- At the wingtip, a small puncture was sealed using high speed tape.
- The logo light, the strobe light and the landing light were repaired or replaced.

After the ferry flight to Zurich, the wingtip was repaired definitively in accordance with the SRM (structural repair manual).
