Landed short, Serious incident occurring January 20th, 1999 at Frankfurt/Main to a Boeing B747-400

EX002-0/99
September 1999

Translation of the German Investigation Report.

Classification:	Serious Incident
Date of event:	20 th January, 1999
Location:	Airport Frankfurt/Main
Aircraft:	Civil Jet Aircraft
Manufacturer / Type:	Boeing B747-400
Injuries to persons:	none
Damage to aircraft:	severe
Third party damage:	Airport Equipment

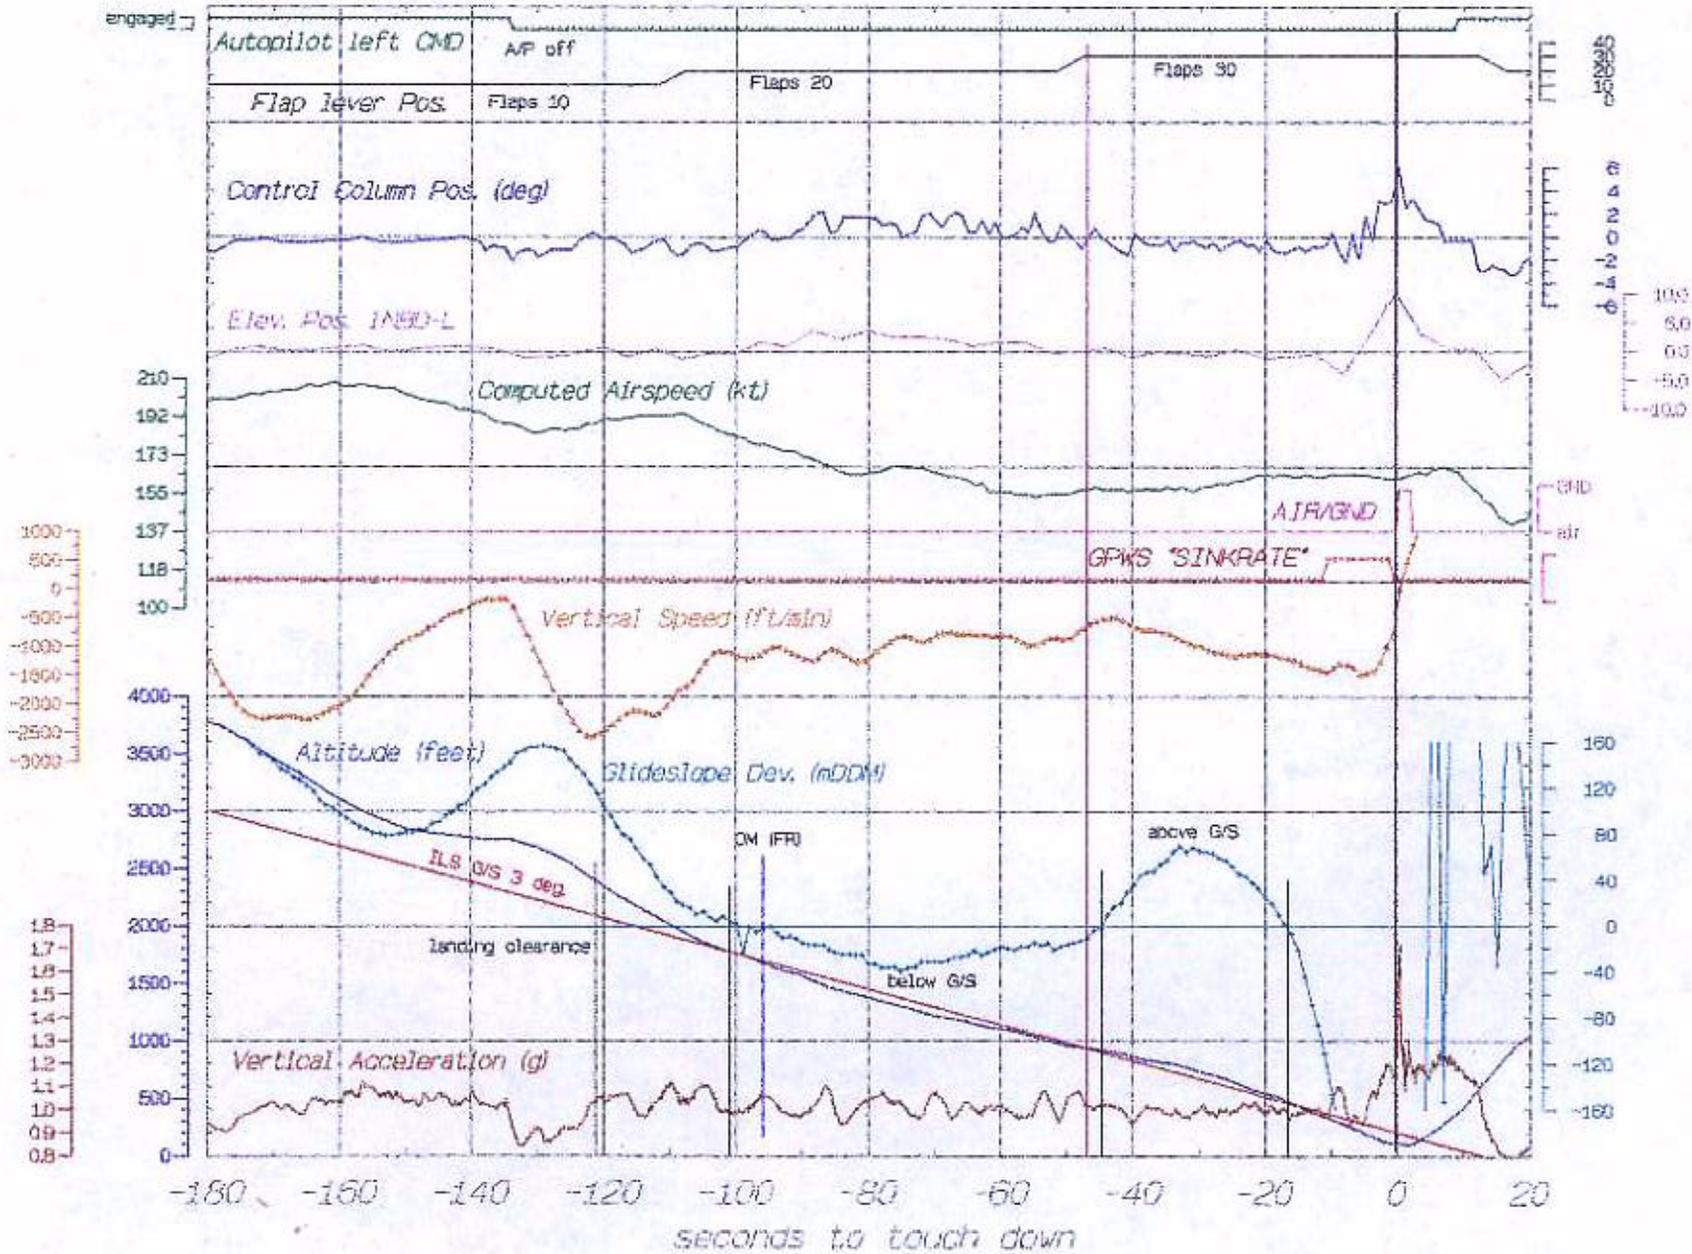
VT-EVA Enclosure 1

Evaluation of Flight Data Recorder (DFDR)

Time(sec)	Sequence
-183	Descent up to 4 000 ft /QNH with FLCH-mode, Flap setting 10°, IAS =210 kt
-154	Descent up to 3 000 ft/QNH with V/S-mode, with 2 200 ft/min, IAS = 190 kt
-135	ALT Capture / ALT HOLD, A/P off
-123	manual flight with a sinkrate up to 2 500 ft/min, Flight Director (FD) still in ALT HOLD mode till G/S capture
-111	GEAR DOWN
-108	stabilised on GS at appr. 1 800 ft/AGL with IAS = 190 kt, Flaps 20, sel. Speed appr. 170 kt
-103	A/T disconnect, Power idle
-77	fully established at ALT 1 200 ft/AGL, except Final Flap Setting, a/c is coming slightly below G/S, Power Setting 63% N1
-48	At ALT 800 ft/AGL Flaps setting from 25° to 30 °, a/c is coming up above G/S, a/c increased sinkrate
-17	At ALT 400 ft, a/c crossed the G/S with sinkrate of 1 200 ft/min, IAS = 160 kt, Power Setting 48% N1
-10	The Ground Proximity Warning System (GPWS) has been activated, the computer voice announced 8 times „SINKRATE“

-6	Alt 120 ft, Sinkrate 1470 ft/min
-2	Sinkrate 992 ft/min, Power Setting 55% N1, Fuel Flow coming up Target Value
-1	Sinkrate still 728 ft/min
0	Touch Down with 1,7 g, G/A initiated (TOGA)
+1	A/T Throttle moving forward
+3	A/T THR REF
+9	Full G/A Thrust 96,8%, at RA 260 ft A/P ON

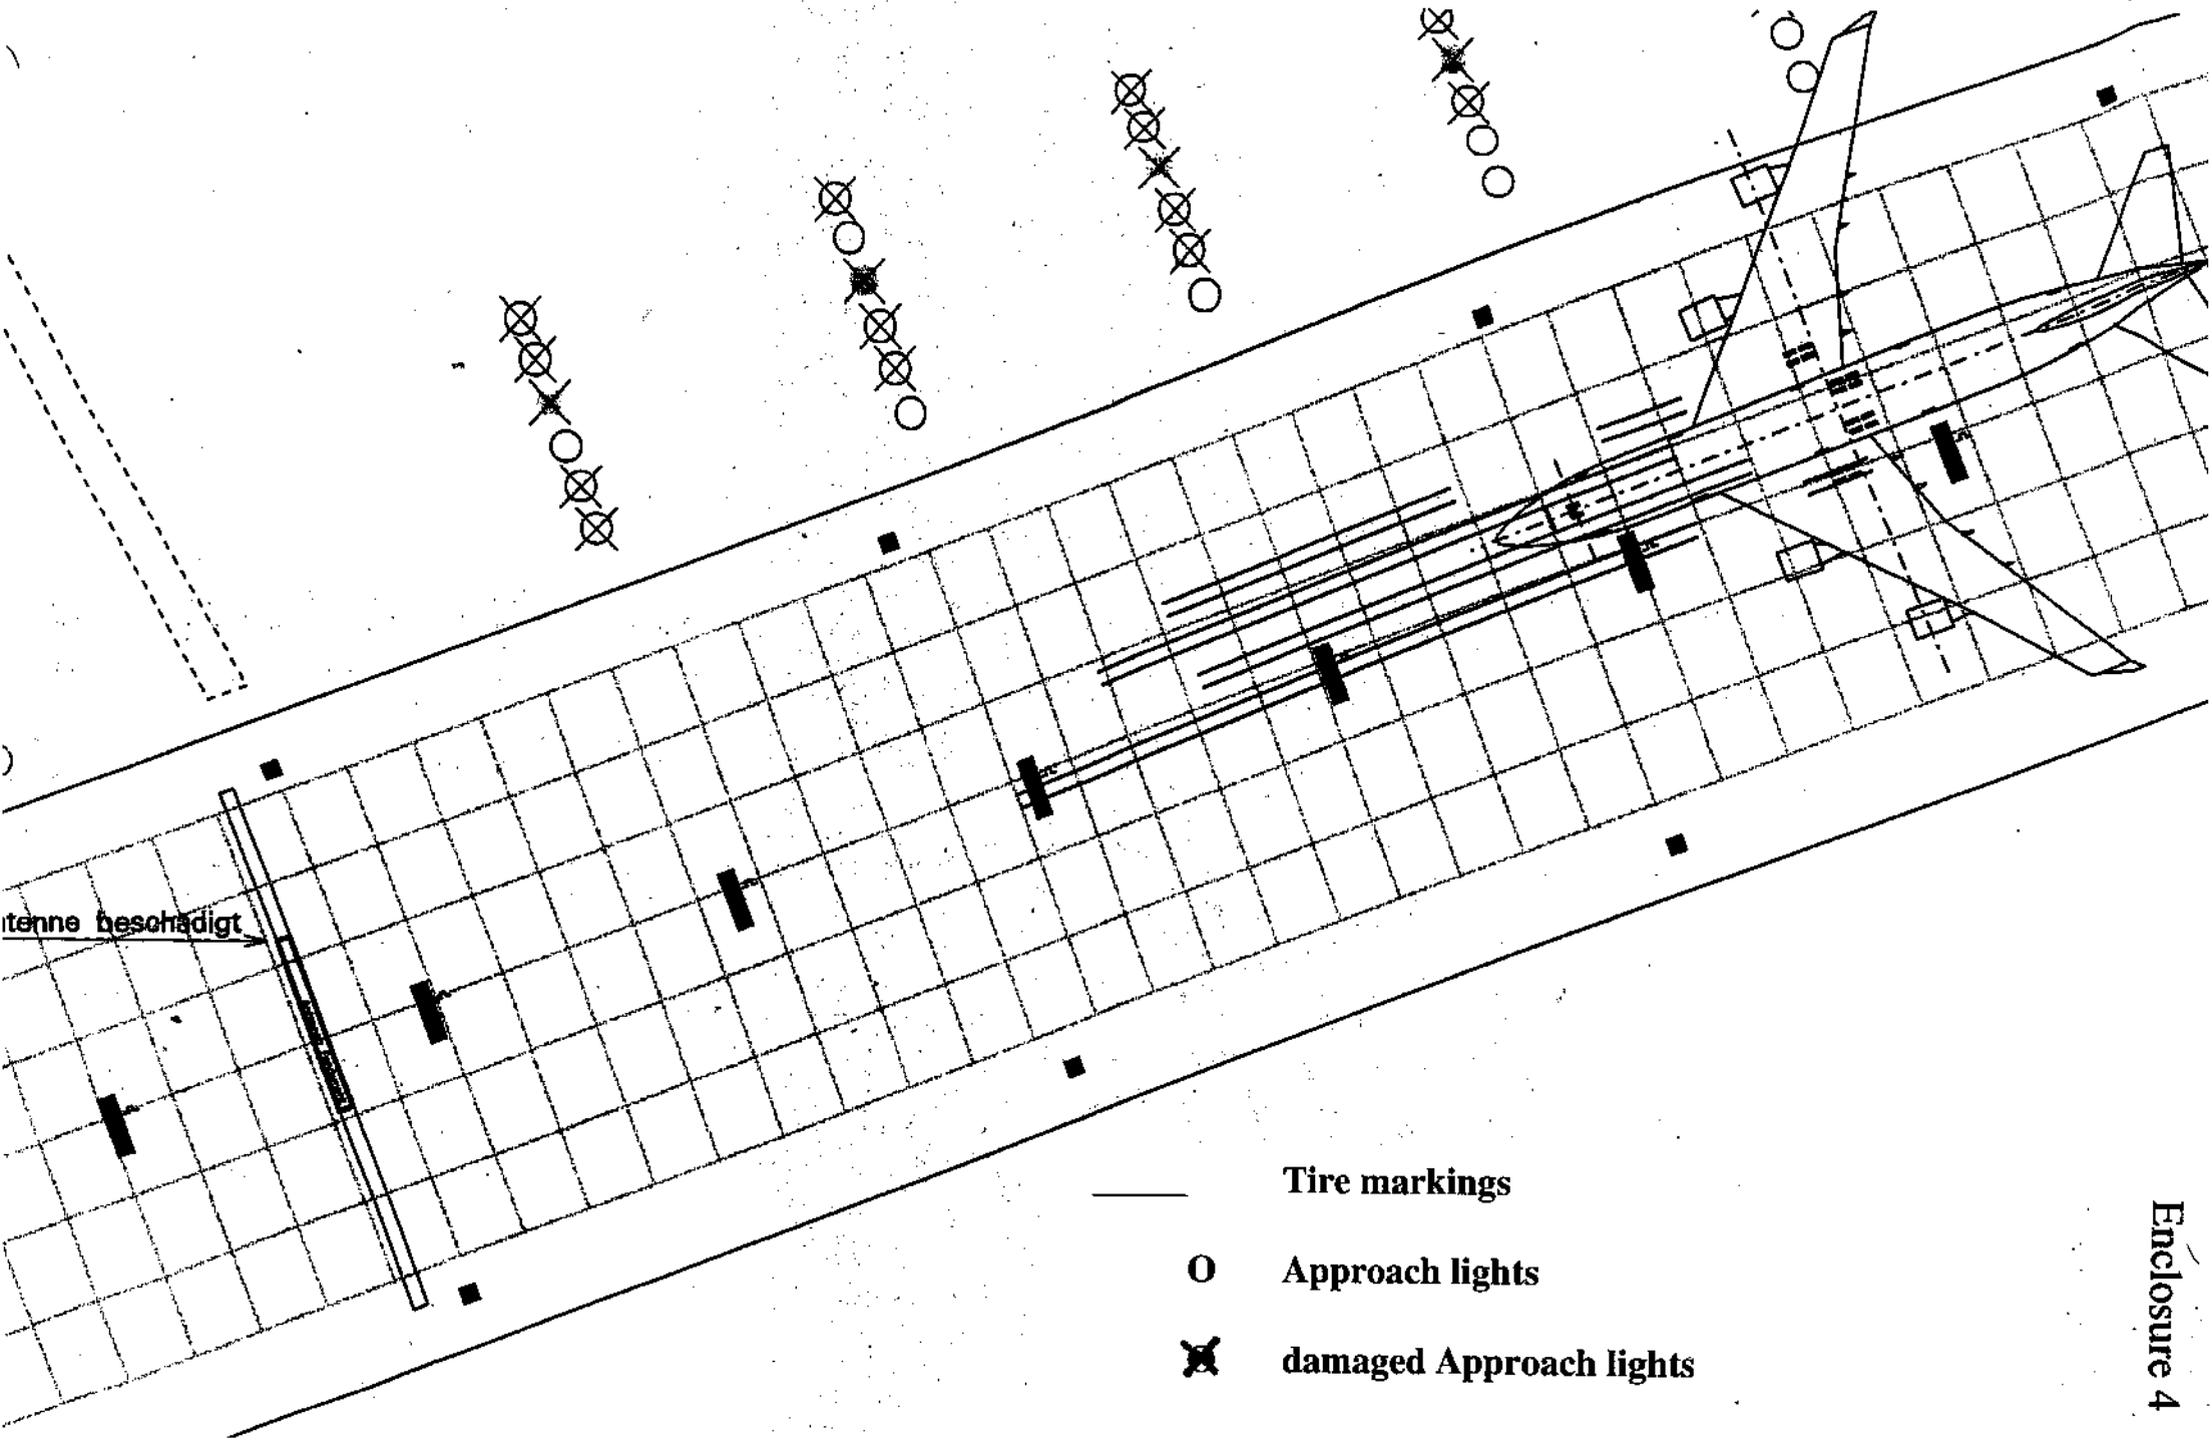
Tire marks with a length of 85 m maximum were clearly visible - 22 lights of the approach lighting system were damaged or destroyed (Enclosure 4). The localizer antenna for Runway 07 R was broken out at a width of about 16 m. So the approach lighting system 25 L and the ILS 07 R of the southern runway were unservicable until further (Enclosure 5).

Antenne beschadigt

Tire markings

O Approach lights

X damaged Approach lights

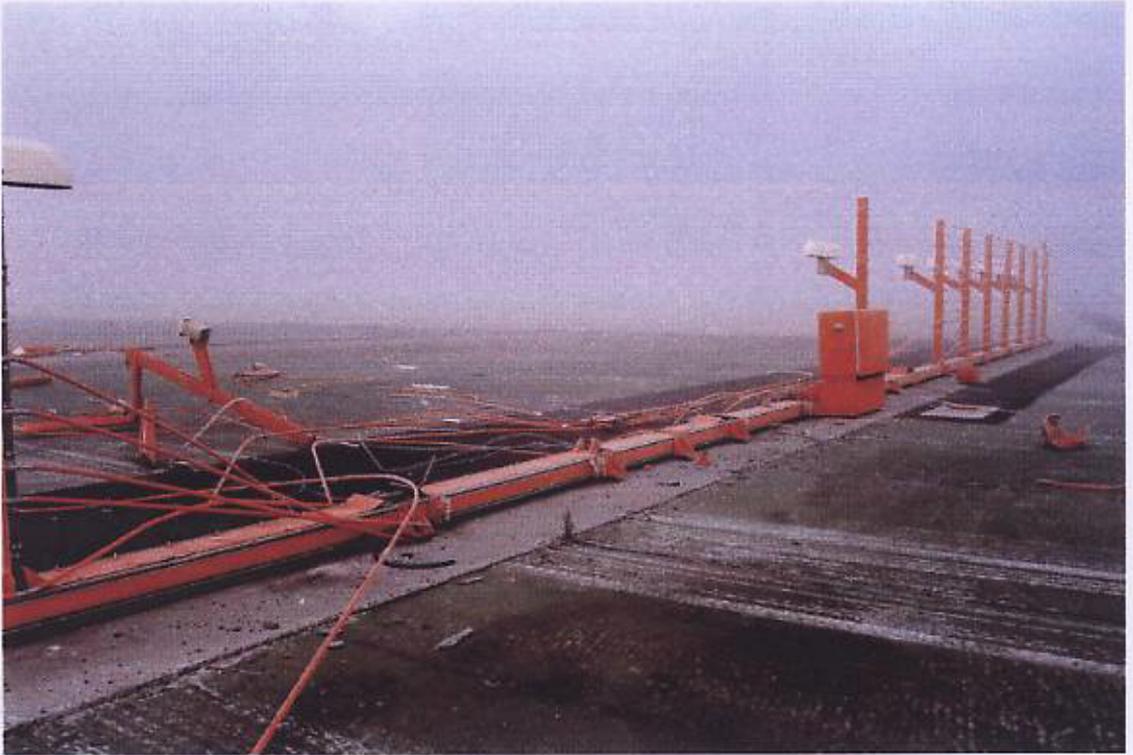
Destroyed localizer antenna of RWY 07R

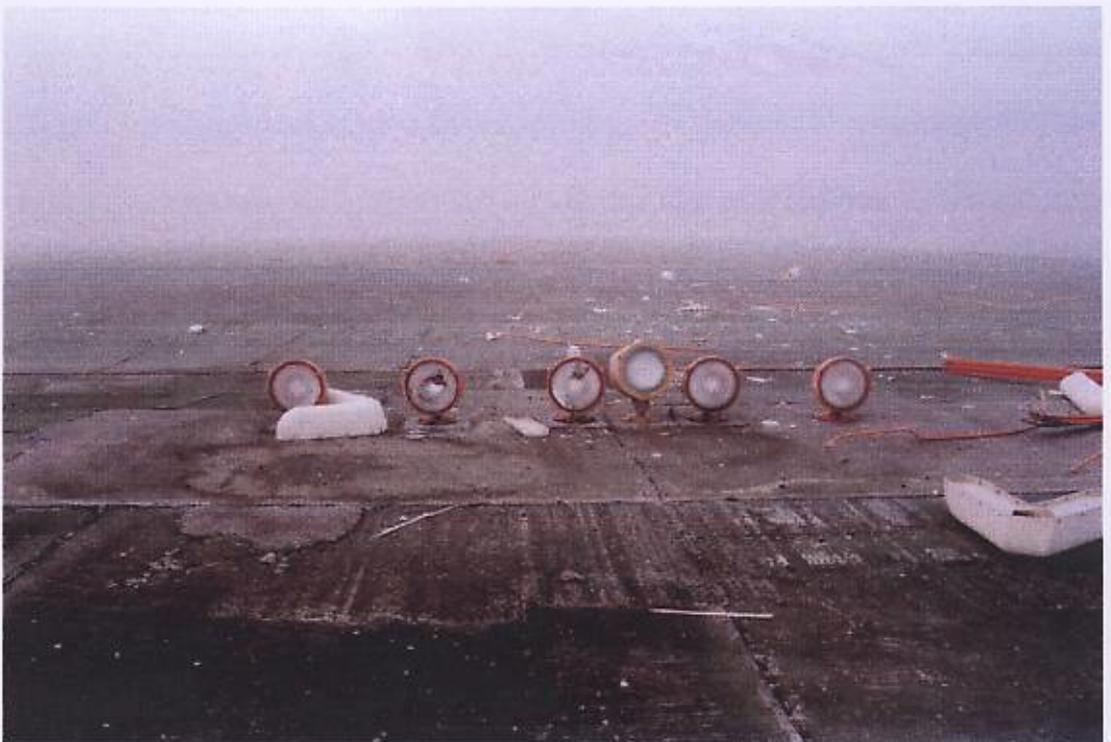
Parts of localizer antenna between the approach lights

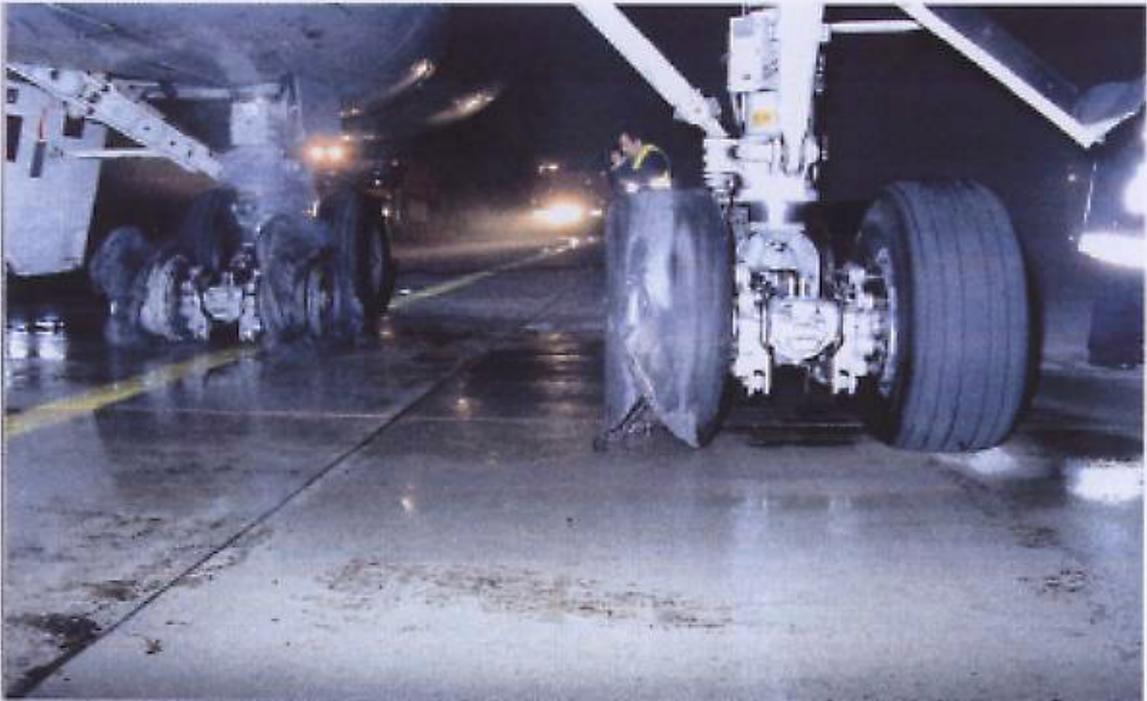
The B747 suffered damages to the main gear because of the collision with the surface equipment, its far spread debris causing damage to two engines and the fuselage as well (Enclosure 6).

The damaged L/H Main Gear and L/H Body Gear

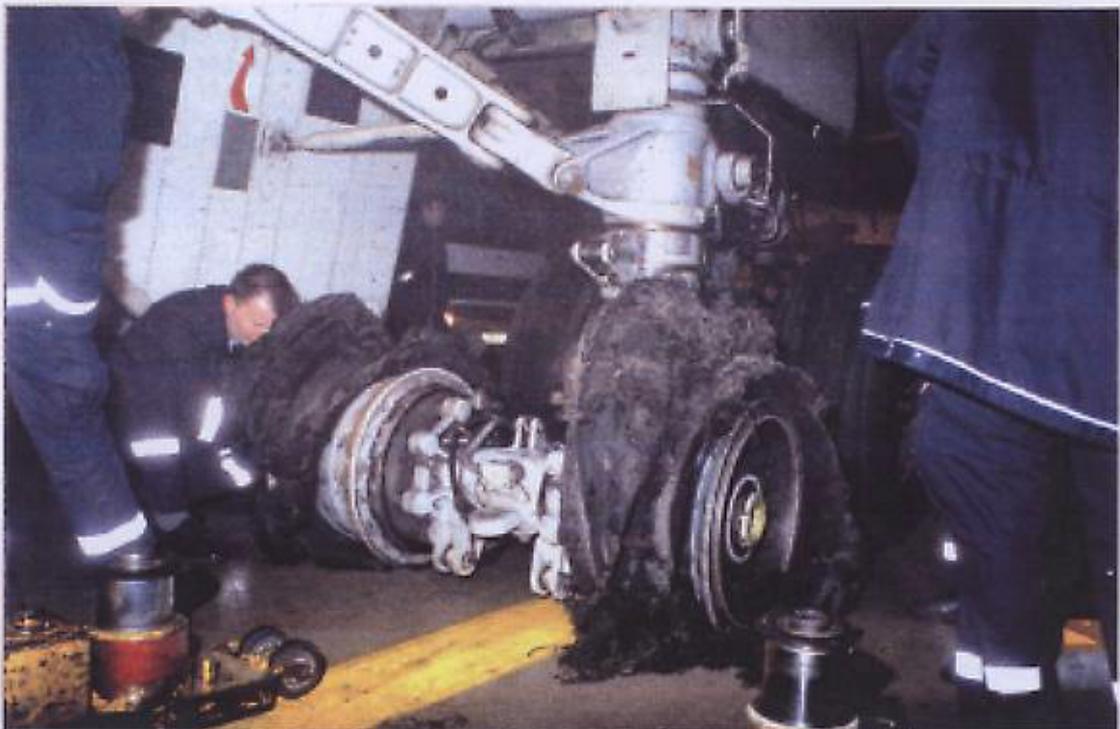
Meanwhile the RVR decreased so that at 16:50 UTC CAT II and from 16:54 UTC CAT III was in force. The second landing was performed at 16:58 UTC on runway 25 R as an automatic landing under CAT III conditions. Some of the previously damaged main landing gear tires started to burn, but were quickly extinguished by the fire brigade standing by. The fire

Details of L/H Body Gear, burned tires
