## Collision with runway edge lights, Serious incident occurring 18 December 2000 at Dresden Airport to a Saab 2000.

# Final Report

EX007-0/00

Kind of occurrence:	Serious incident
Date:	18. December 2000
Location:	Dresden Airport
Aircraft:	Transport category aeroplane
Manufacturer/type:	Saab AB / Saab 2000
Injuries to persons:	no injuries
Material damage:	Aeroplane slightly damaged
Other damage:	airport installations

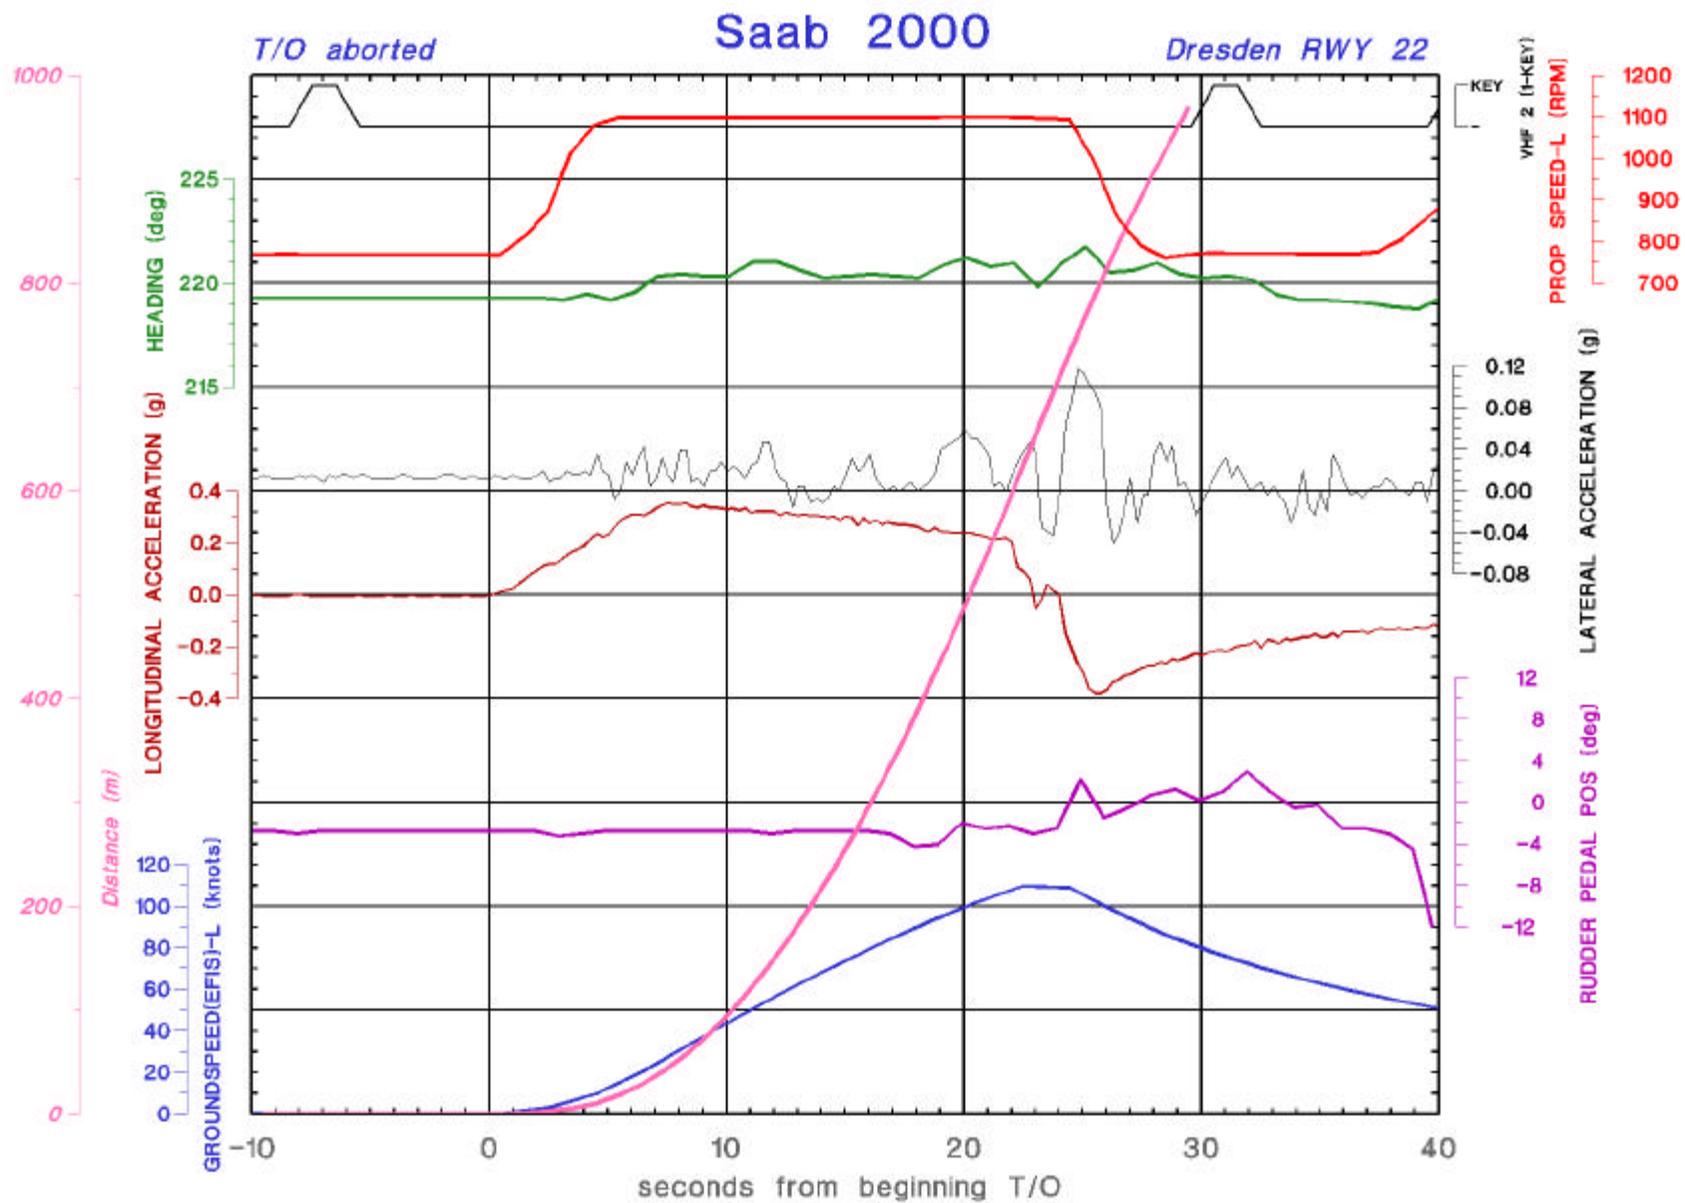
Excerpt from the flight data recordings (take-off phase)

A graphic prepared on the basis of the DFDR parameters taxiing speed and heading and showing the turning from taxiway E onto the runway indicated that close to the left edge lighting the aeroplane had left the green centre line lighting leading to the centre line of runway 22 and aligned parallel to the centre line lighting for take-off.

After a waiting time of 106 s in the take-off position (scheduled departure time slot was 20:13 hrs) the take-off run was started on the runway edge lighting. During the take-off run the nose wheel collided with the edge lighting. Following this collision the crew aborted the take-off. Nothing in the recording of the DFDR indicates that the crew had tried to clear the runway edge lighting by changing the direction.

The aborted take-off was initiated appr. 20 s after take-off power had been set. The speed was 102 kt and the distance travelled on the runway was 510 m (see attachment).
