Tailstrike on takeoff, Serious incident occurring on November 29, 2002 at Dortmund Airport involving a Boeing 737-800

Investigative Body: Federal Bureau of Aircraft Accidents Investigation (BFU), Germany

Investigation Report

EX007-0/02
April 2004

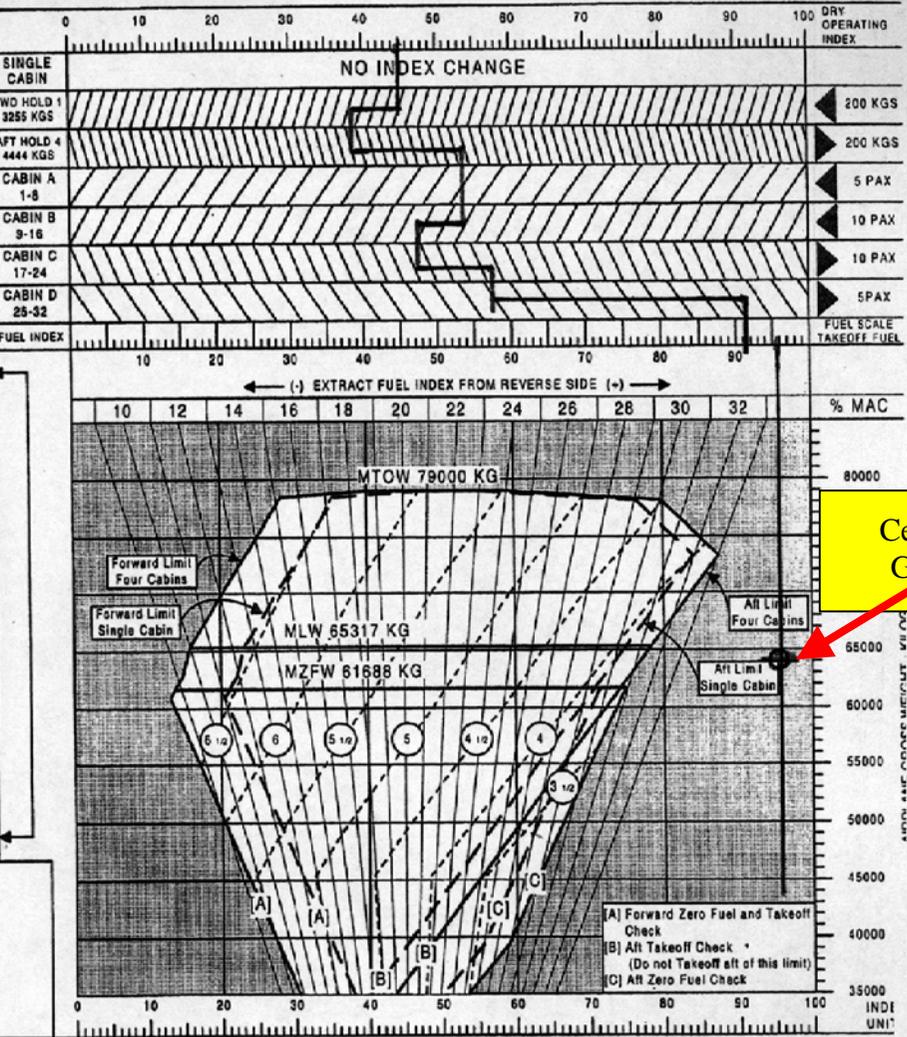
LOAD AND TRIM SHEET - FLAP SETTING
B 737-800

Following the return to the terminal the loading and the mass and balance of the airplane were examined under the direction of the BFU Field Investigator. The examination revealed that the loading, the masses and the centre of gravity position as indicated in the Load & Trim-Sheet were not correct.

The centre of gravity position thus was $39.92+1.9$ (missing spare wheel) $+2.516$ (correction for the catering) = 44.336

While preparing the Load & Trim-Sheet with the values transmitted by the crew, the ramp agent realized that the centre of gravity position would be outside the rear operational limit and therefore planned to move 5 passengers each from the compartments D and C into the compartment A.
 The ramp agent incorporated this move into the Load & Trim-Sheet in the 'INDEX' section, i.e. 10 passengers were entered for the compartment A. With the correction performed the centre of gravity position thus was within the allowable range.

The ramp agent did not inform the cabin crew that passengers had to be moved to compartment A. The 10 passengers were not moved.

From the Load & Trim-Sheet enclosed the actual masses, the corrected DOI, and the actual passenger distribution in the cabin are to be seen.
