Engine vibration, Accident occurring 5 January 2004 near Munich Airport involving a Fokker F28 Mk0070 (Fokker 70)

Investigative Body: Federal Bureau of Aircraft Accidents Investigation (BFU), Germany

Investigation Report

AX001-0/04
November 2005

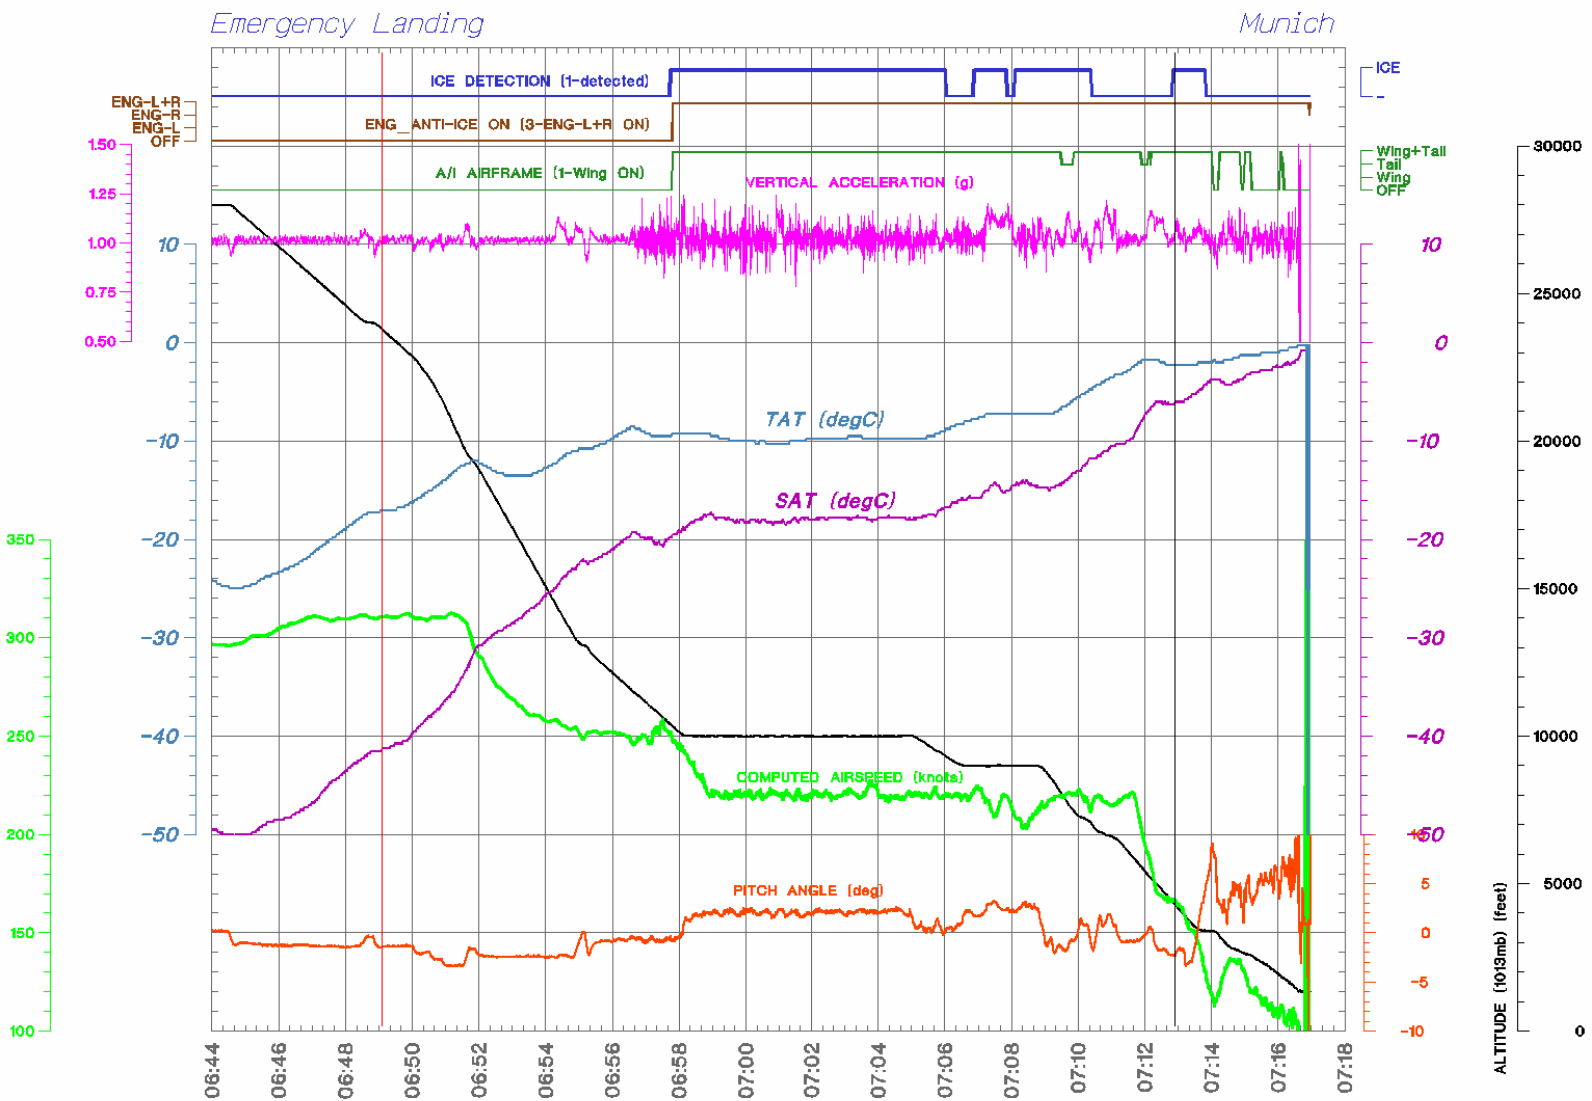
Attachment 2: Approach profile (times indicated in UTC)

The ice detection system was triggered during descent to FL 100. Engine and airframe anti-icing systems were switched on simultaneously (see attachment 2). FL 100 was reached at 07:59:58 hrs. The pilots stated that they encountered icing conditions when the airplane entered the clouds. At FL 100 ice is reported to have formed at the windscreen edges. The inspection of the black stripes on the wings showed no ice accretion. Vibrations on the RH engine increased temporarily after a flight time of six minutes at FL 100. While the crew checked the fuel quantity on the multifunction display because of the traffic density they noticed vibrations in the upper green range of the display.

Attachment 2 shows that from 08:06 hrs on the ice warning switched off several times for periods of up to 2 minutes. This suggests that, from this time on, the aircraft was subject to light icing conditions, at the most.

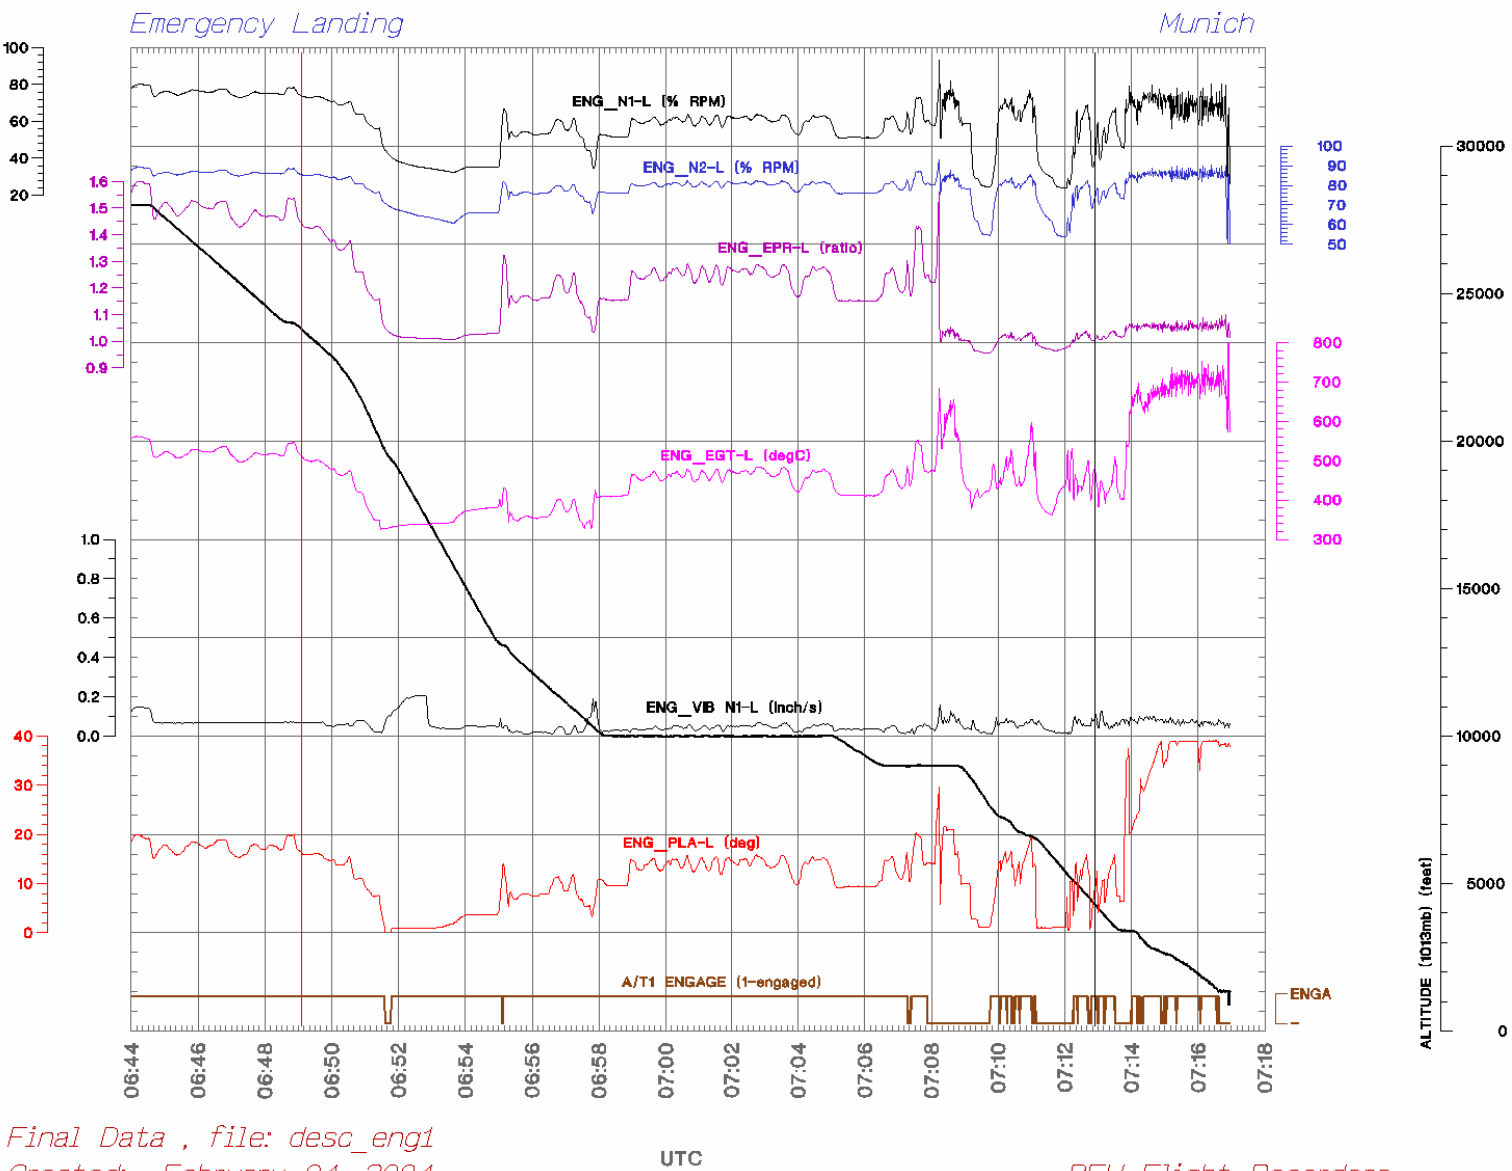
Attachment 3: Changes on the LH engine at 08:08:14 hrs (07:08:14 UTC)

In addition to the conversations between the pilots, the CVR also recorded radio communications and cockpit ambient noises. At 08:07:14 hrs, a short humming noise, which reoccurred at 08:07:31 hrs, was recorded. At 08:08:10 hrs, the CVR recorded a clattering noise and the co-pilot asked for the causes of this noise. After the declaration of an emergency at 08:08:22 hrs the flight attendant notified the flight crew at 08:08:48 hrs of a clattering noise in the cabin ("... there is a super rumble on the left ...").

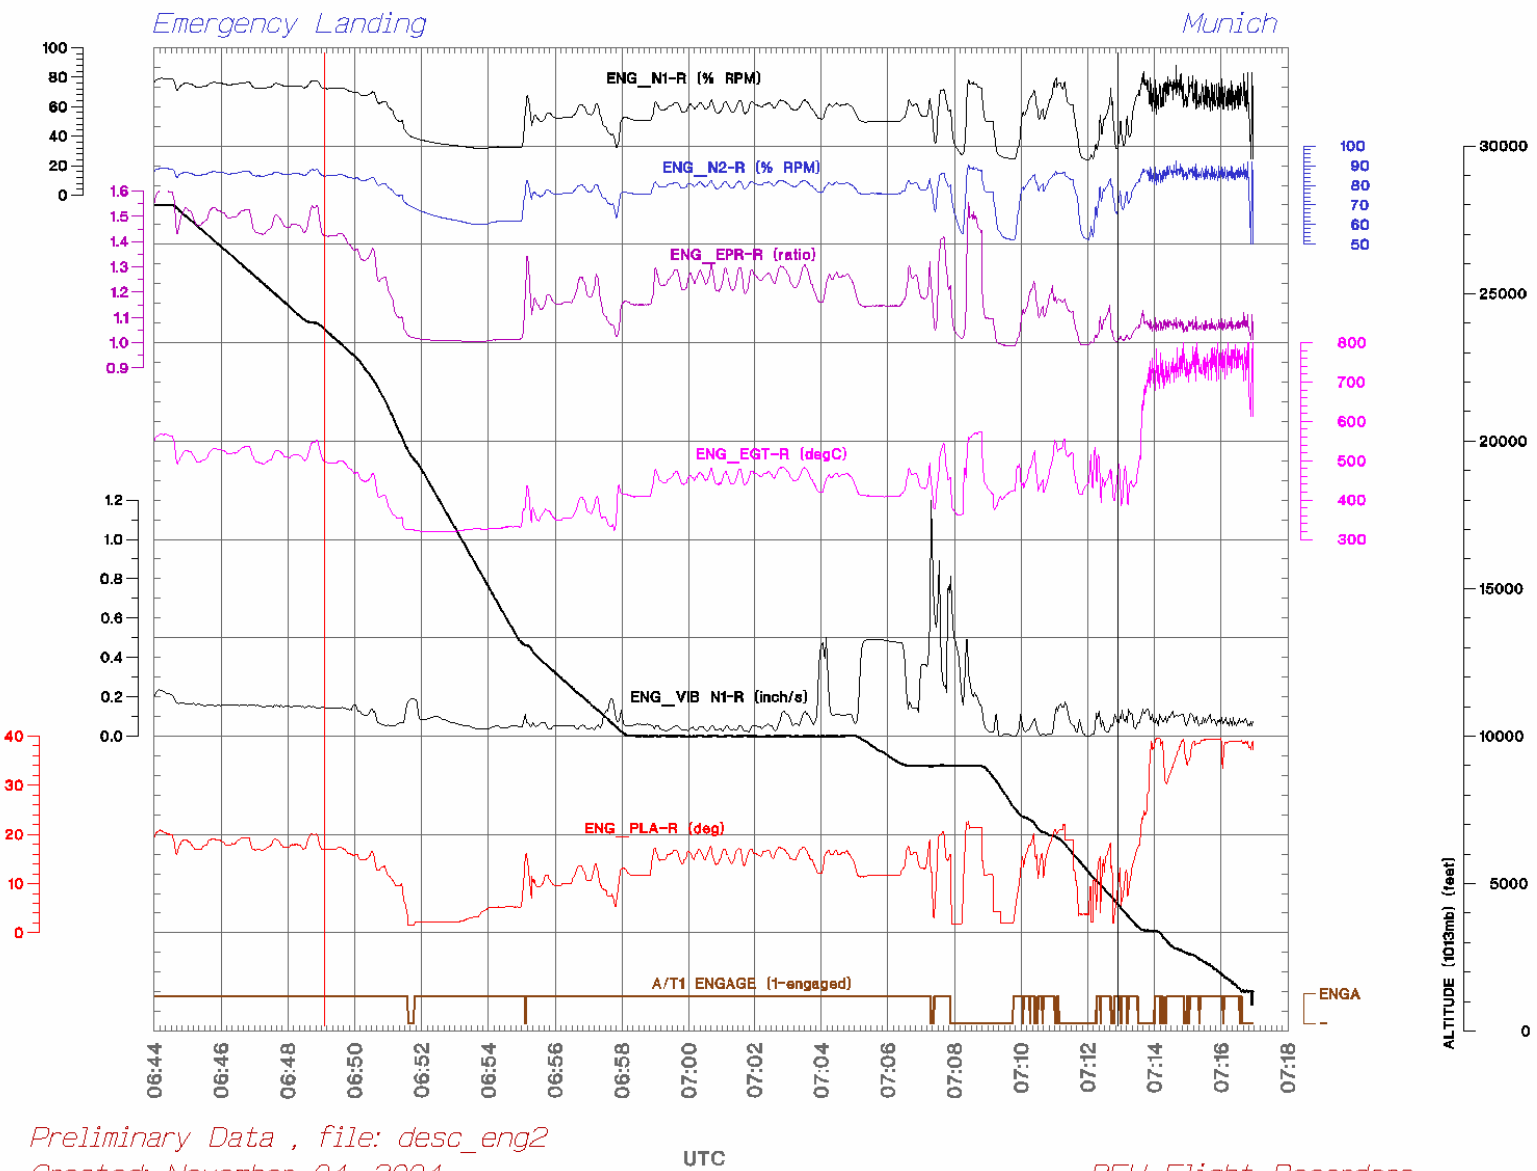
Attachment 4: Changes on the RH engine from 08:08:40 hrs (07:08:40 UTC)

As the airplane was approximately 12.5 NM south of Munich airport, the crew was instructed to descend to FL 90 and to change heading to 020°. Heavy vibrations on the RH engine occurred during descent. According to crew statements, the airbrakes were extended in order to increase thrust setting on the engines without increase in airspeed. Immediately afterwards the warning VIB HIGH ENG2 was triggered at FL 90. The actions of the Abnormal Procedure Vibration High checklist indicated on the multifunctional display were carried out. However, the RH engine was not shut down for lack of other failure indications. Afterwards no more problems for the RH engine were indicated.

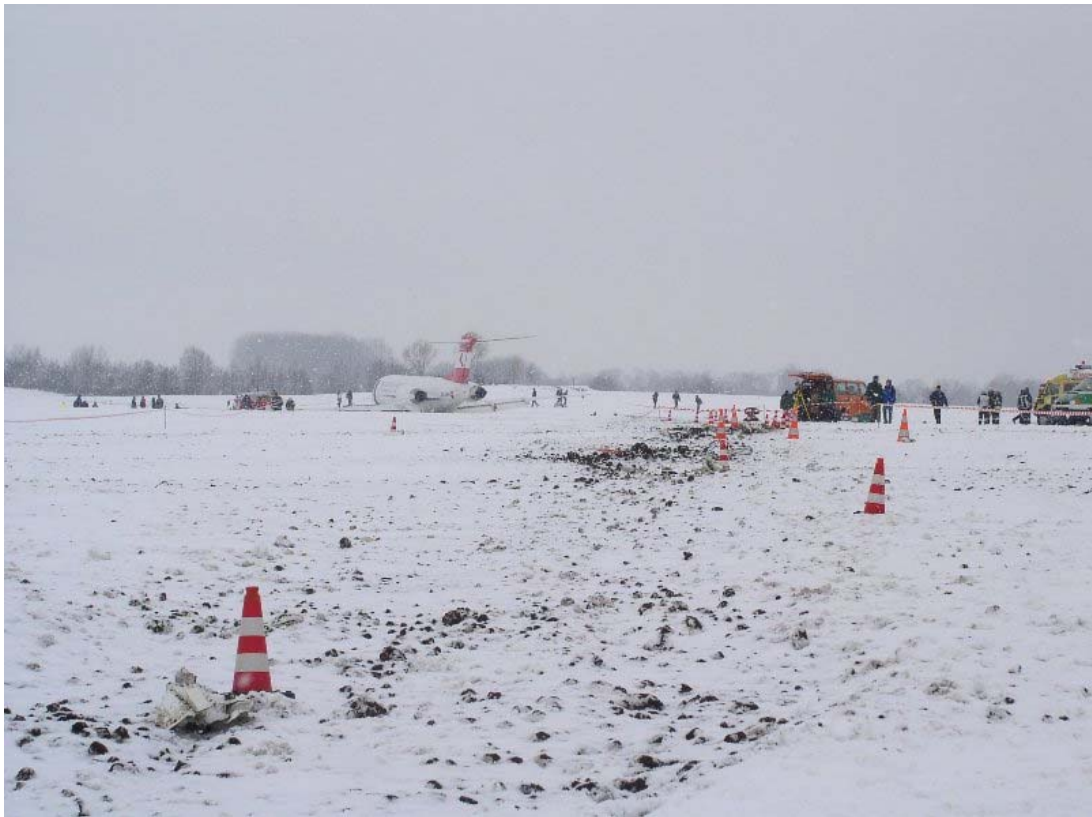
Attachment 7: Accident site

The airplane lay on its fuselage. The nose landing gear which had been torn off lay at a distance of approximately 120 m from the airplane in the skid mark described above. The nose landing gear doors were damaged. The main landing gear was retracted but not locked. The main landing gear doors had been torn off. The flaps were extended in a position between 25° and 40°. The flaps on the left-hand side were damaged. The inner flap on the right-hand side was slightly bent and the outer flap was undamaged. The wing fuselage transition fairing was severely damaged on both sides. The ailerons were in neutral position, the rudder was slightly deflected to the right and the elevator was deflected downward. The horizontal stabilizer trim was set to -4.5° (ANU).

Except for the severe damage to the wing fuselage transition fairing on both sides, the airplane fuselage did not show any further deformed areas. This shows that the damage to the airplane was not due to the impact load but to the characteristics of the ground. The switch settings found in the cockpit basically corresponded to the condition one would find after completion of the Ground Emergency Checklist.

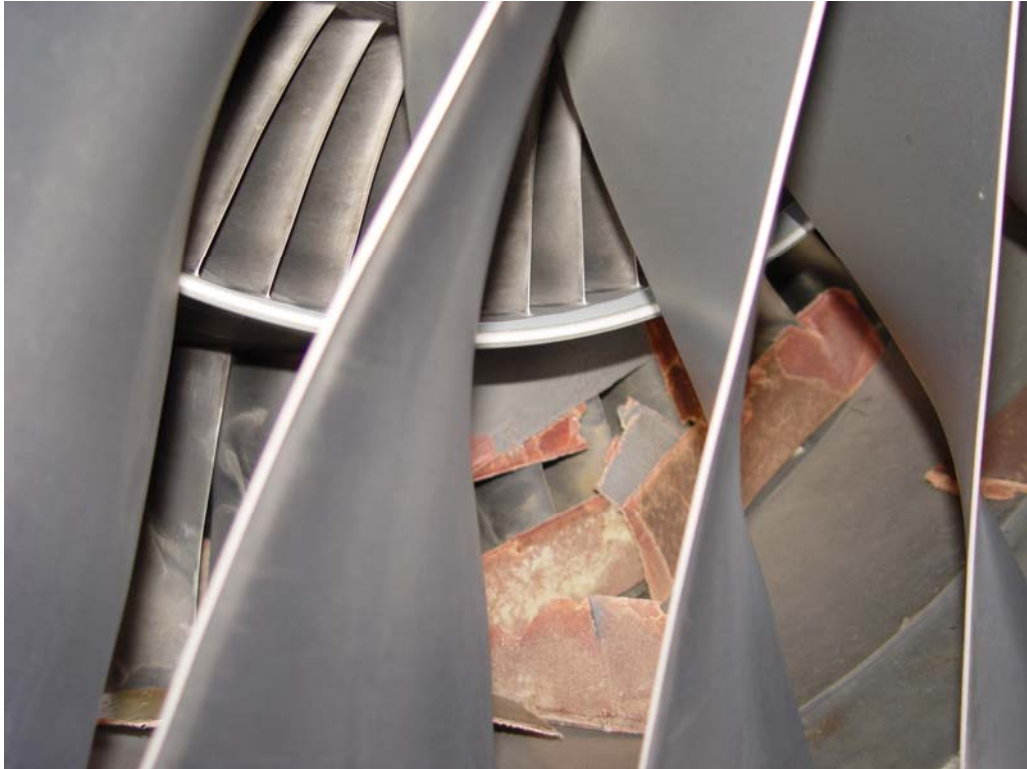
Attachment 9: Loose ice impact panels in the LH engine intake

On both engine fan casings all six ice impact panels had detached. Almost all of the loose panels were lying crossways in front of the outlet guide vanes of the low pressure compressor (see attachments 9-12). They matched the version described in the SB 72-1326 of January 1998 consisting of six segments made of glass-fibre reinforced foam. Further mechanical damage on the engines was not found.

The fan case of the LH engine (S/N 17116) had been modified in July 2001 pursuant to SB 72-1326 in one of the organisations of the engine manufacturer in Great Britain. Since this modification the engine had been in service for 5,823 hours and 4,221 cycles. According to the technical report of the manufacturer ice impact damage in the area of the acoustic liner had not been found. The bonding surfaces of the ice impact panels in the fan case did not show any residual adhesives. The surface was very smooth. A few brown patches on the steel surface of the fan case were found. At the lowest point there was a semicircular dark patch. The metal surface of the case behind the ice impact panels showed some smear markings. The bonding surface of the ice impact panels was almost completely covered with adhesive. The surface of the adhesive was very smooth. On three panels, clearly defined areas with brown discoloured adhesive were found.

The investigation of the ice impact panels and the associated bonding surfaces on the engines clearly showed an adhesion failure. This means that neither the adhesive nor the materials to be bonded failed but that the bonding between the adhesive and the materials was insufficient. In this case the reason for it could only be an insufficient preparation of the bonding surfaces.

The smooth surfaces on the fractured surface of the LH engine's fan case and of the adhesive on the panels prove that the fan case was not prepared correctly prior to the application of the adhesive. The brown discolorations on the bonding surfaces of the fan case and on the surface of the adhesive indicate that the bonded joint had separated some time ago and that ingress of moisture had taken place.

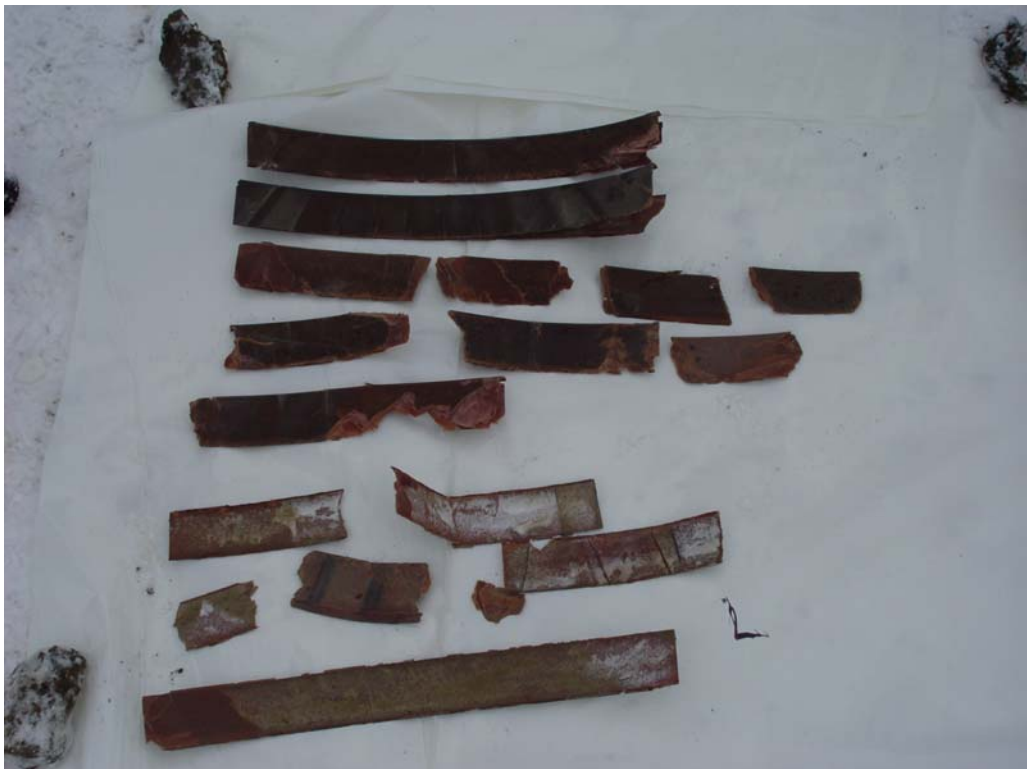
Attachment 10: All loose ice impact panels of the LH engine

The panels of the LH engine were generally more heavily fragmented than those from the RH engine. Most of the fragments were still present and could be assigned to their original positions. The panels did not show any damage caused by foreign objects.

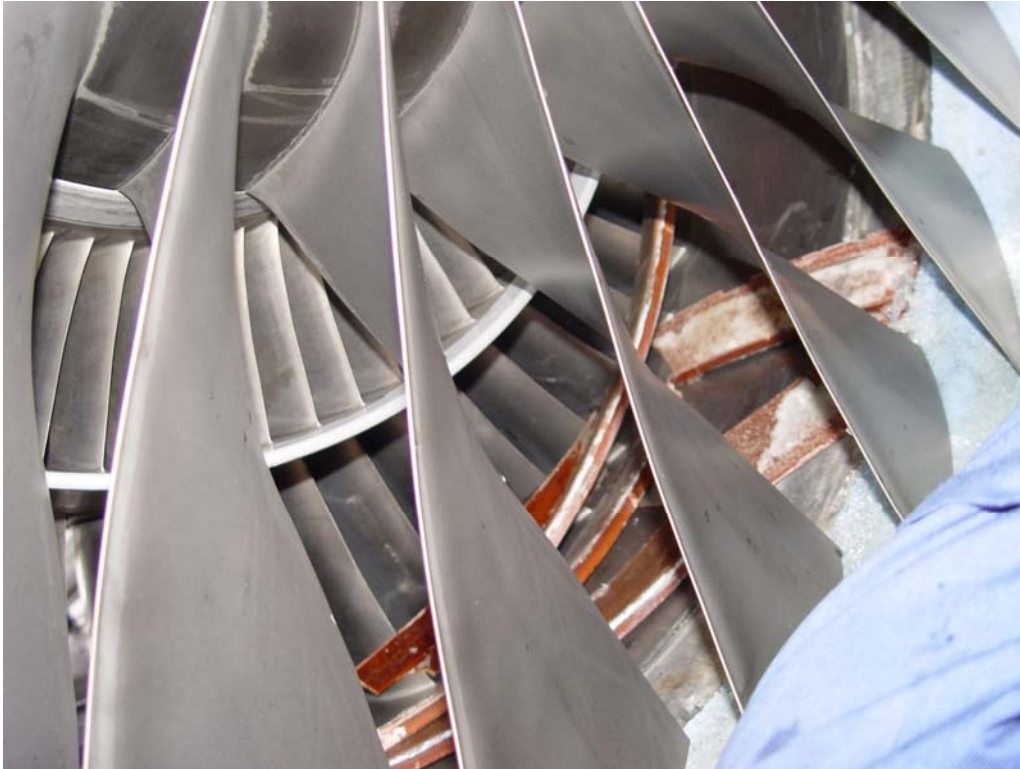
Attachment 11: Loose ice impact panels in the RH engine intake

The fan case of the RH engine (S/N 17103) had been modified in August 1999 pursuant to SB 72-1326 by an organisation in the USA. Since this modification the engine had been in service for 9,224 hours and 7,825 cycles. According to the technical report of the manufacturer ice impact damage in the area of the acoustic liners were not found. The bonding surfaces of the ice impact panels in the fan case showed adhesive residues in a few locations. The steel surface was very smooth and showed marks produced by a rotating abrasive wheel in some places. Some isolated brown patches were found on the steel surface of the fan case. The bonding surfaces of the panels were very smooth without any residual adhesives.

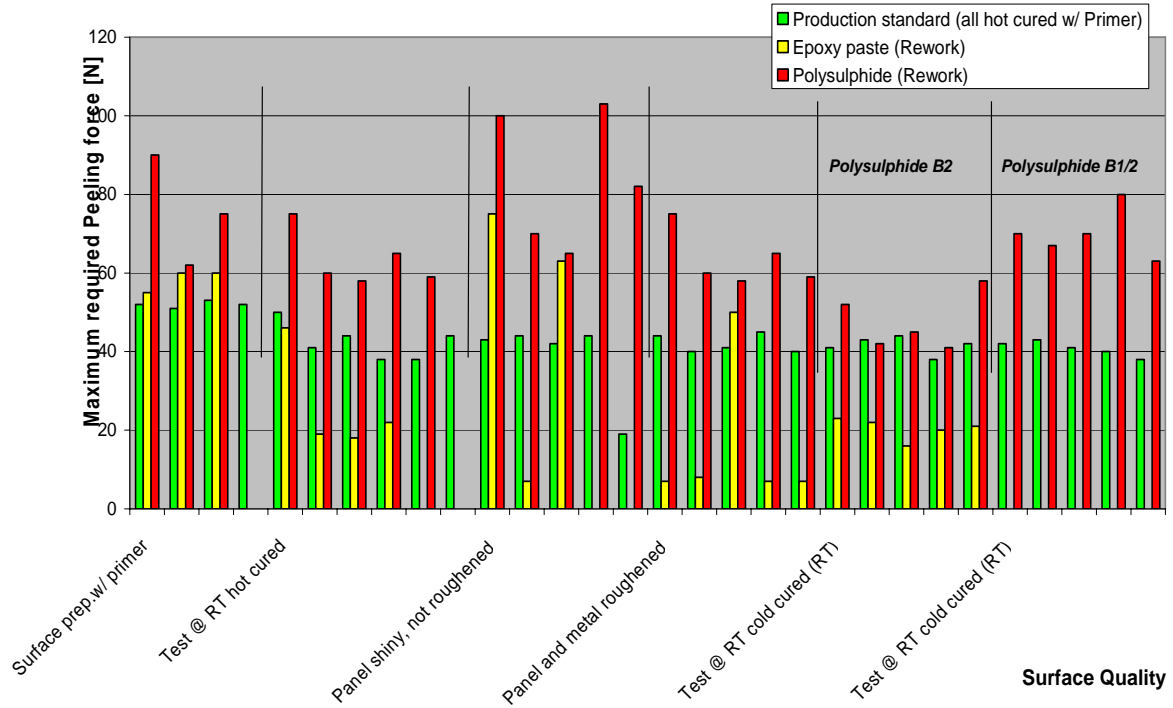
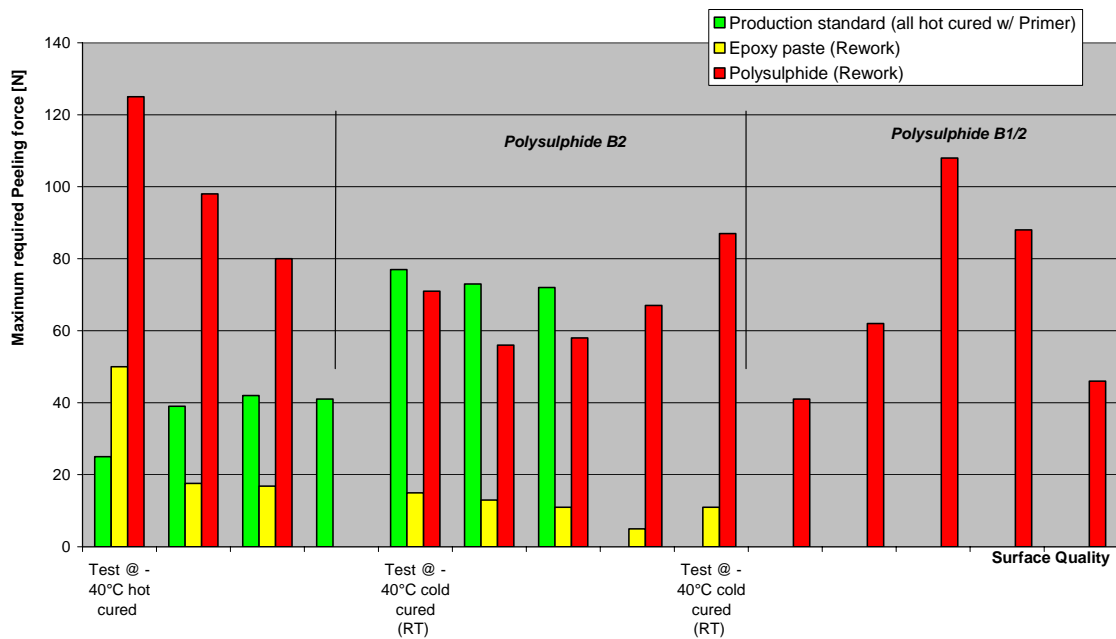
Attachment 13: Peel drum test results

Vibration stress of the fully cured adhesive and the ice impact panels with the frequencies which had occurred in flight did not result in significant changes of the storage modulus of the adhesive. According to the explanations of the Fraunhofer Society for the Advancement of Applied Research in Bremen the frequency is not the cause for the failure of the bonding of the ice impact panels. For the most part, the ice impact panels showed signs of loss of adhesion between the bonding surfaces of the engine and the adhesive, indicating errors in the preparation of the bonding surfaces.
