Runway overrun, Serious incident occurring January 19, 2004 at Frankfurt-Hahn involving a DC-10-40F

Investigative Body: Federal Bureau of Aircraft Accidents Investigation (BFU), Germany

Investigation Report

EX001-0/04
August 2005

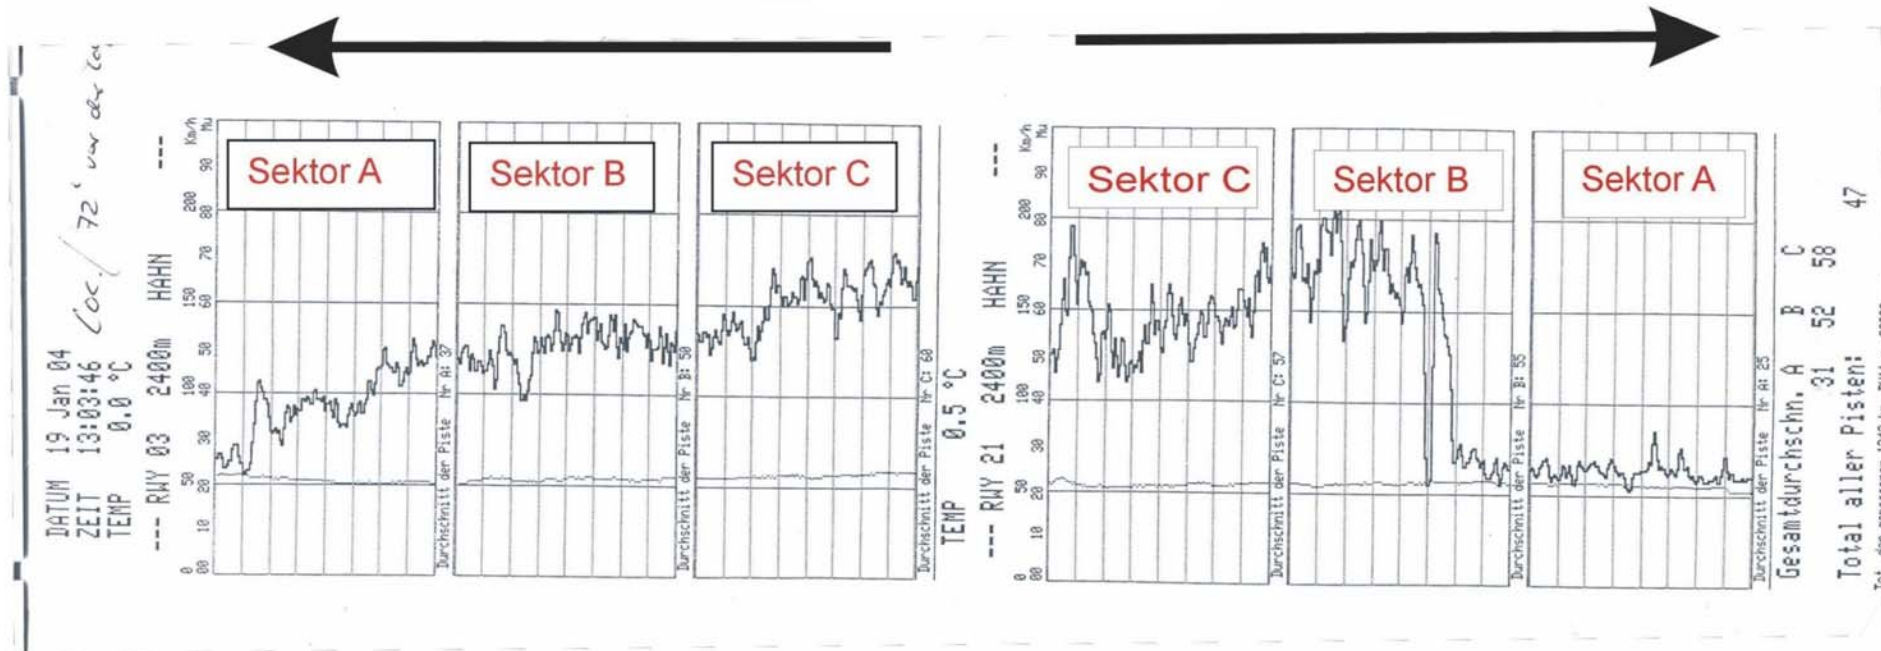
Appendix 1. Skiddometer B11 measurement strip

The measuring records for both sides of the runway, when compared to each other, are acceptable up to 1,400 m. Results between 50 and 60 (Good) suggest that the measurements took place on contaminations, e.g. slush, wet snow.

Somewhat peculiar is the fact that after a test distance of approximately 1,400 m, the friction coefficients abruptly drop to 25 (Poor) on the right-hand side. On the left-hand side of the runway, the measured values drop only moderately (Appendix 1). The reason for the difference was obviously the reduced concentration of the chemical de-icing agent to 20 g/m². Therefore the snow in this section could not melt as much as it did in other areas of the runway thus leading to an increased slush and wet snow contamination.

This high degree of friction coefficient variation between the two runway sides, i.e. left and right of the centre line, may become critical for the stopping and manoeuvring performance of an airplane. As this is of flight operational relevance, the runway condition would have had to be improved by winter services, at least this condition would have had to be made known to the aviation system.

Measurement strip of Skiddometer BV-11

last measurement 72 minutes before landing

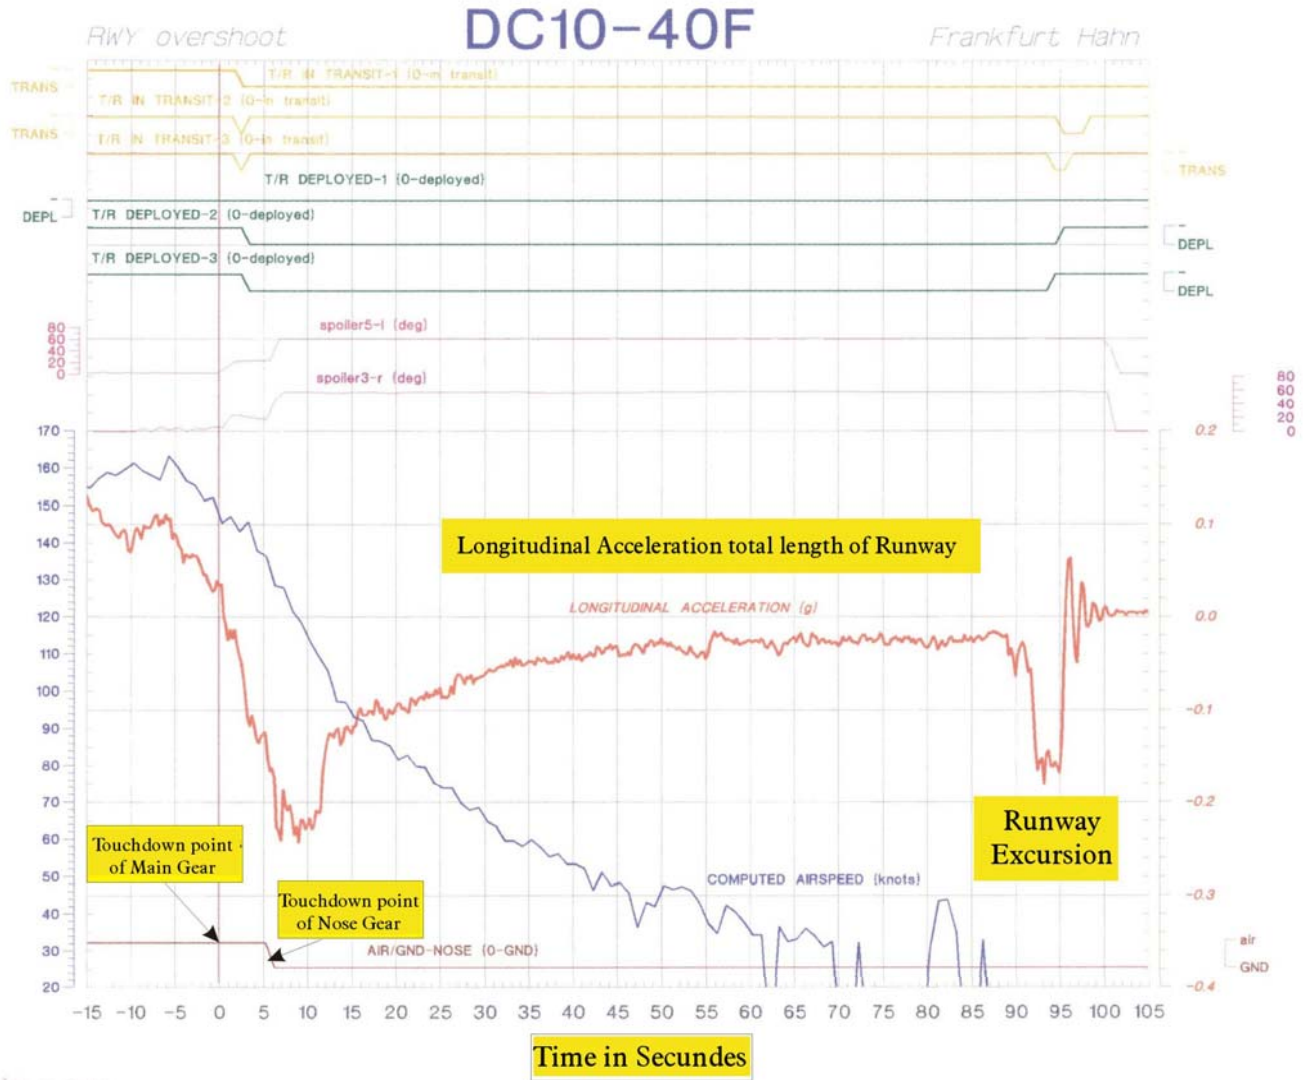
Appendix 2. Evaluation of the flight data recorder

After touchdown, deceleration of the airplane reached approximately 2.2 m/sec^2 , which was maintained for 4 seconds. Afterwards, deceleration abruptly dropped by half and continued to drop. 55 seconds after touchdown (approximately 2/3 of the braking distance) deceleration dropped to almost nil (Appendix 2).

Braking action of the Aircraft
