Final report of the accident investigation, Flash Airlines Flight 604, Boeing 737-300 SU-ZCF, Red Sea off Sharm El-Sheikh, Egypt, January 3, 2004

FINAL REPORT OF THE ACCIDENT INVESTIGATION

Flash Airlines flight 604

Boeing 737-300 SU-ZCF

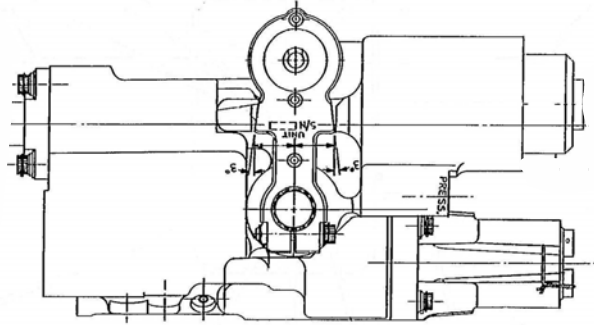
65-44761-21 Aileron PCU

Rod end fitting missing
Main ram fractured

Tailstock
missing

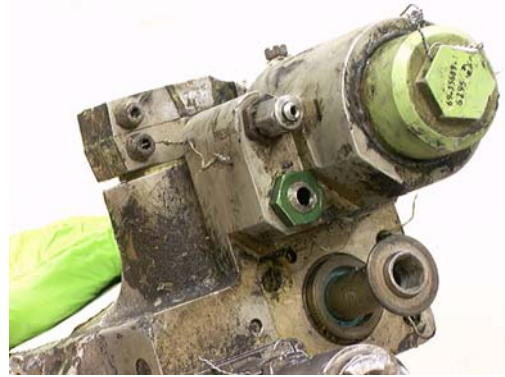
Hydraulic Fittings

- Hydraulic fittings found broken
- Provides a path for sea water and other contaminants to enter the actuator

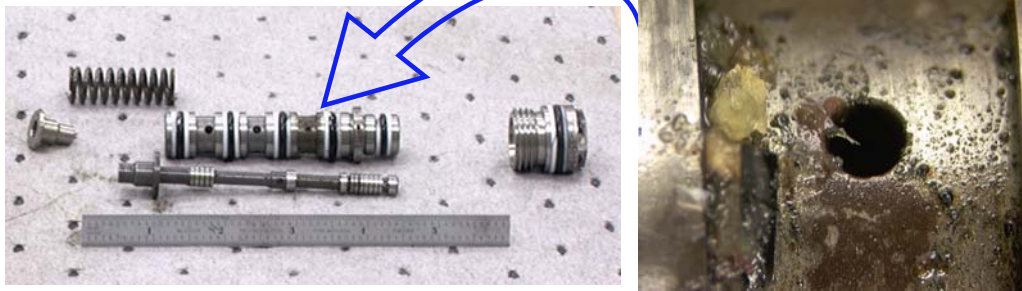
Bypass Valve

- Some corrosion and contamination on bypass valve sleeve
- Samples retained for chemical analysis

- Metal sliver found on outside of sleeve
- Origin uncertain, retained for chemical analysis

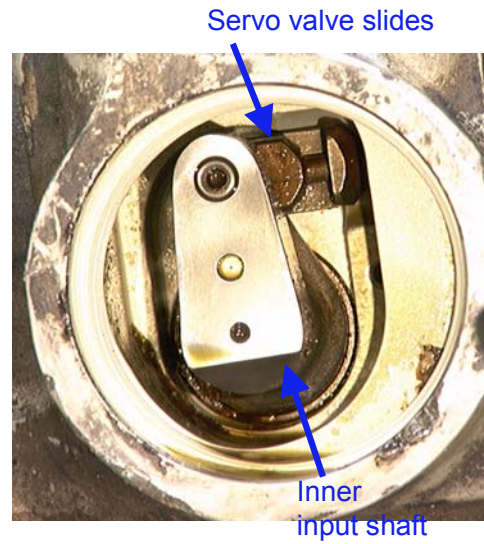
Input Shafts

- Linkage cavity cover removed
- Some contamination noted in linkage cavity – samples taken for analysis
- View shows end of inner shaft and shaft and mating ends of servo valve slides

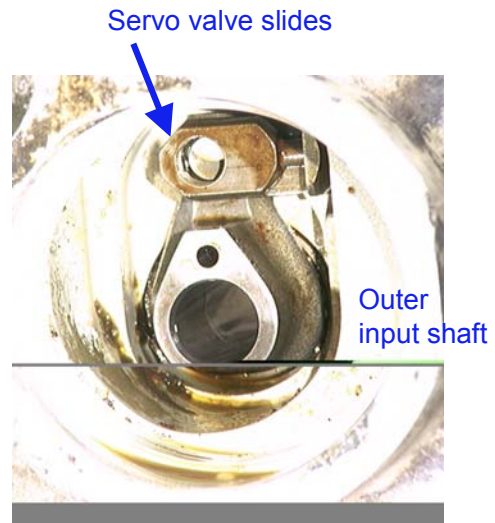
Input Shafts

- Inner input shaft pressed out (required removal force much higher than normal)
- View shows outer shaft and mating ends of servo valve slides (inner shaft has been removed)

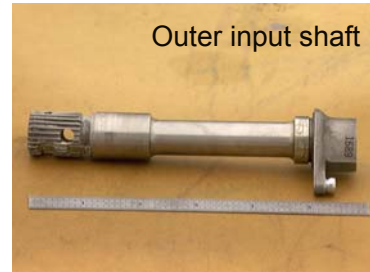
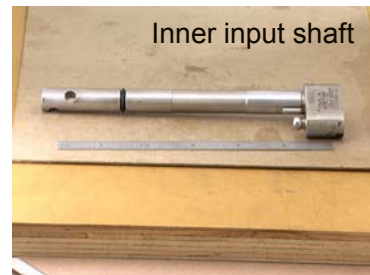
Input Shafts

- Both shafts found to be bent
- Some corrosion found on shaft bearings, but none on shafts
- Deformed shafts consistent with high removal forces

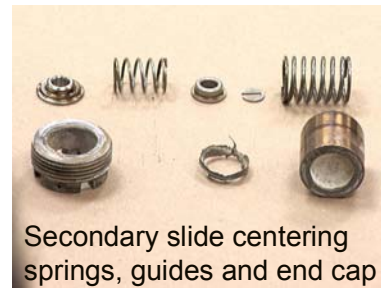
Servo Valve

- Outer shaft rotated to allow removal of servo valve
- Axial load of 29 lbs applied to primary sleeve – no movement noted
- After removal, slides remain jammed

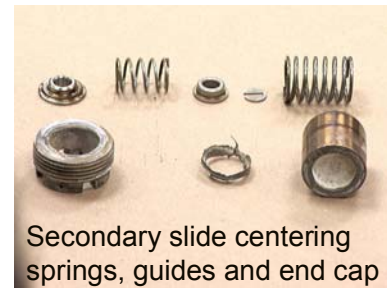
Servo Valve

- Decision made to discontinue disassembly of servo valve (driving out slides could cause damage to surfaces)
- If deemed necessary, servo valve can be sectioned by electro-machining discharge (EDM).

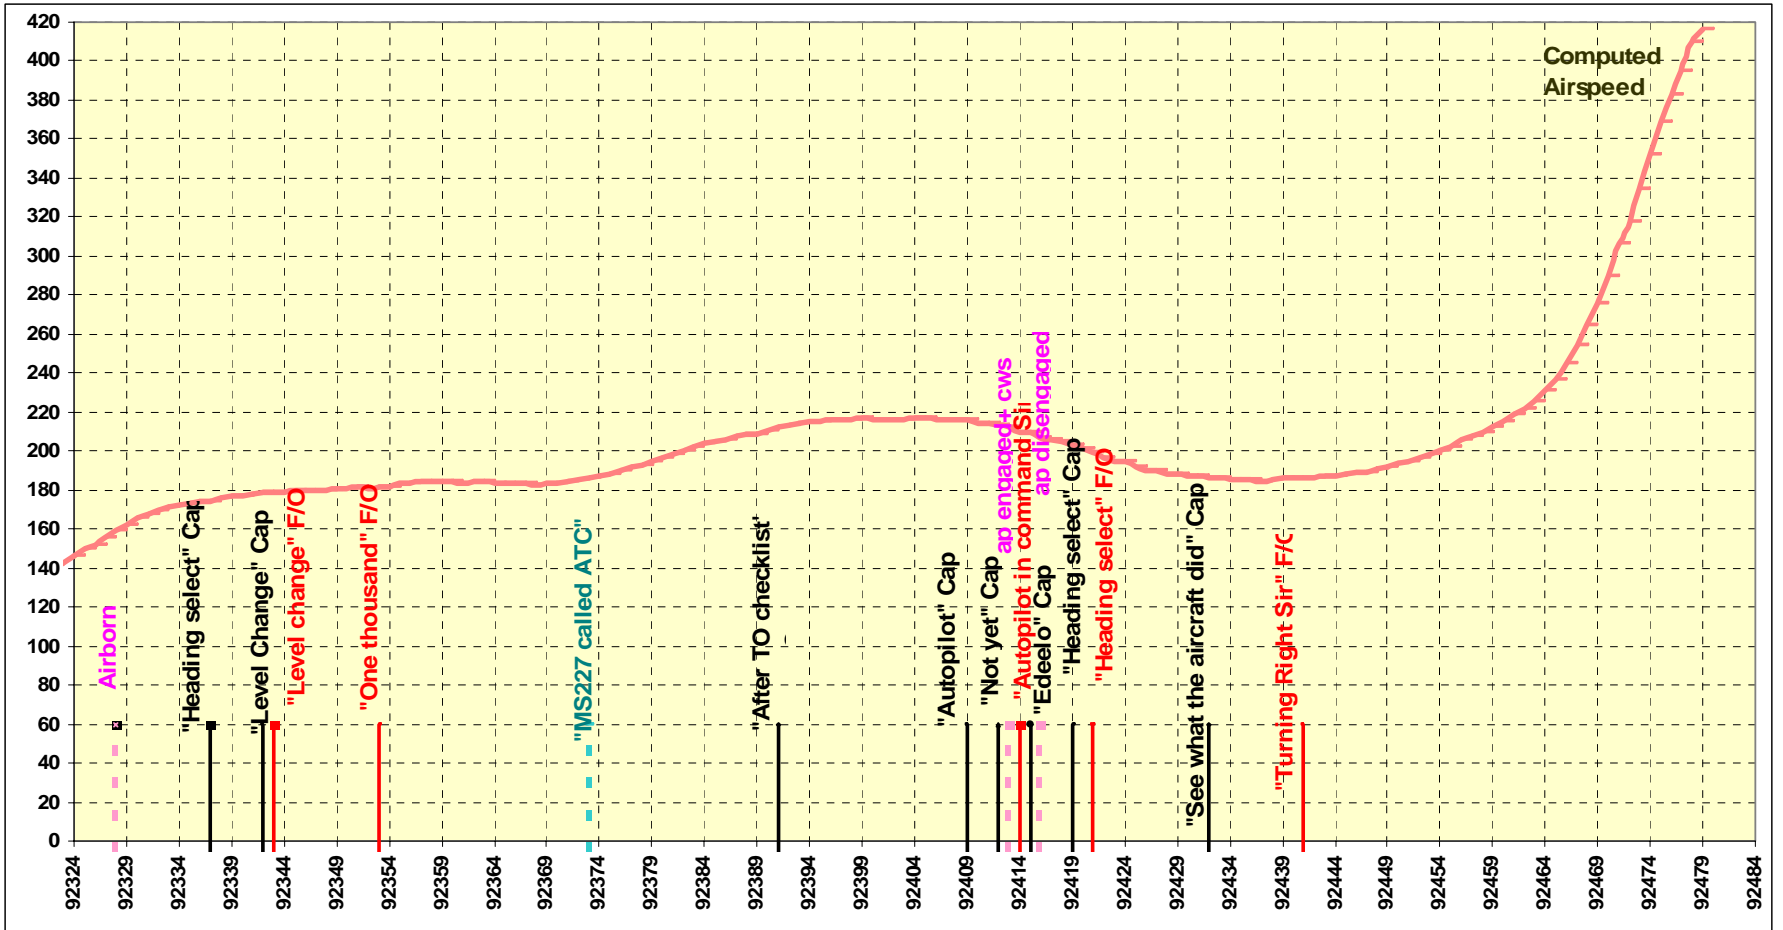
Figure 2.5.6.1 Pitch up and airspeed decay

Based on the FDR data the speed reached 217 Kt at time frame 92405 (seconds), but the speed decreased to 184.5 Kts at 92437.

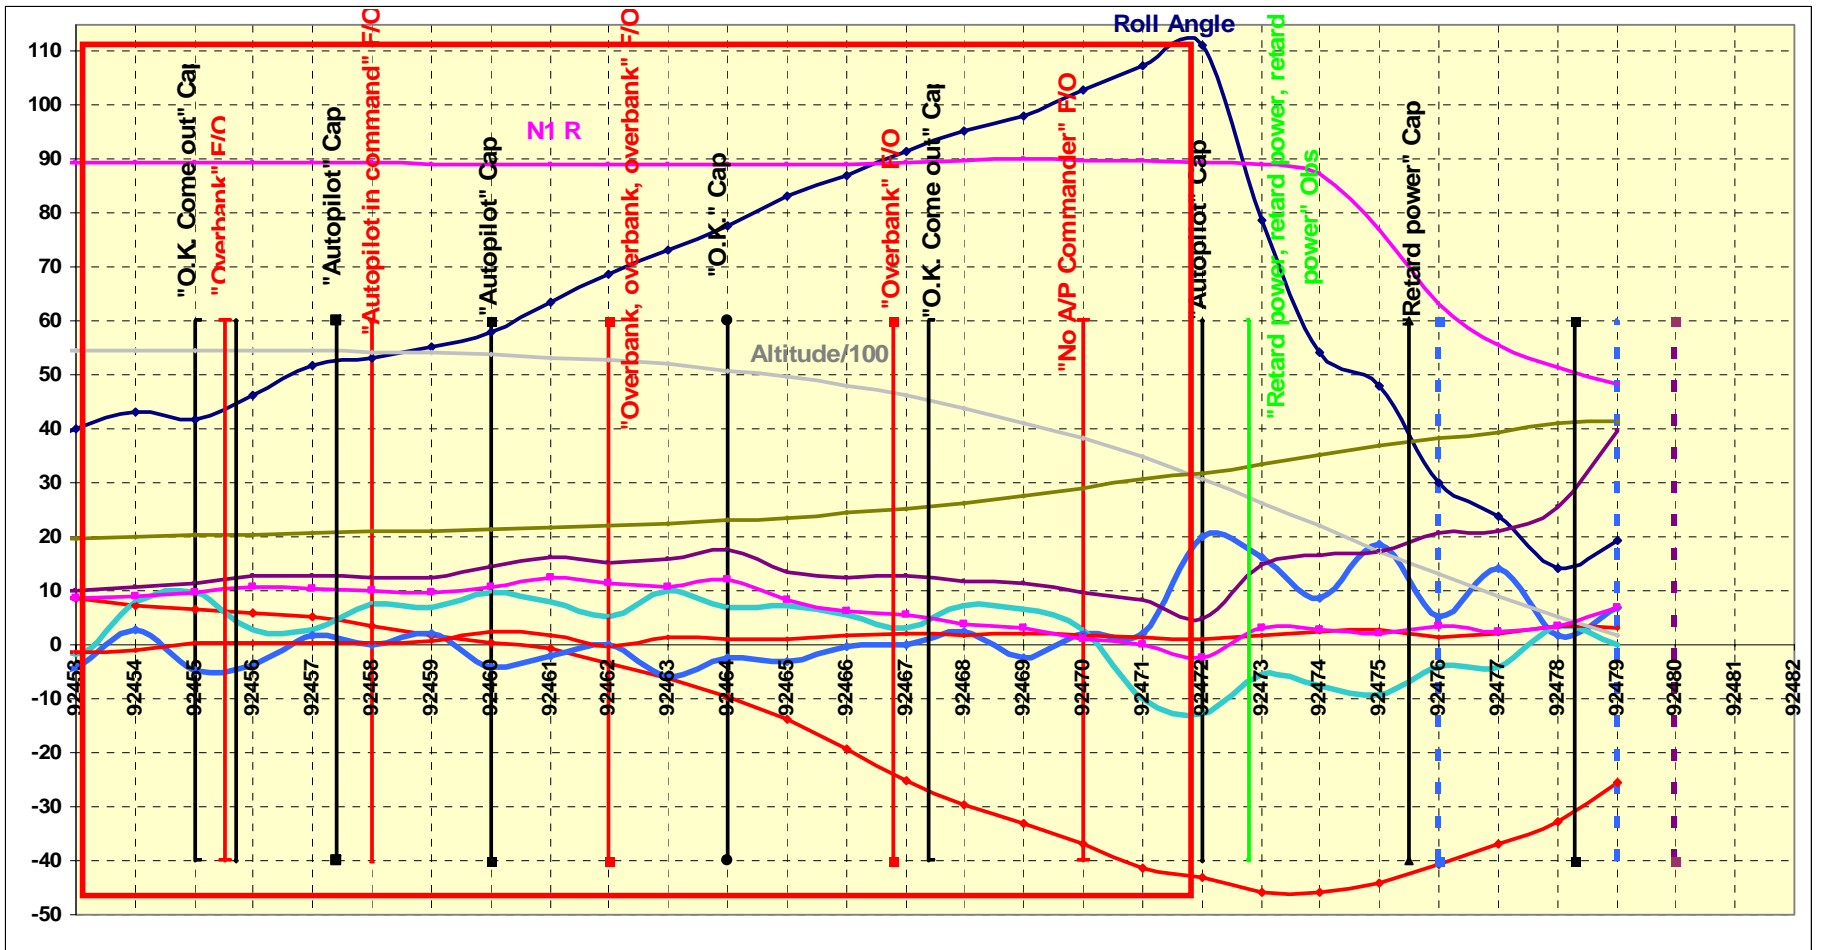
Figure 2.5.13.1a Right roll continues to overbank with ailerons activities

Based on the FDR and the CVR data, the airplane continued the right overbank until a maximum of 111 degree at about 92472.

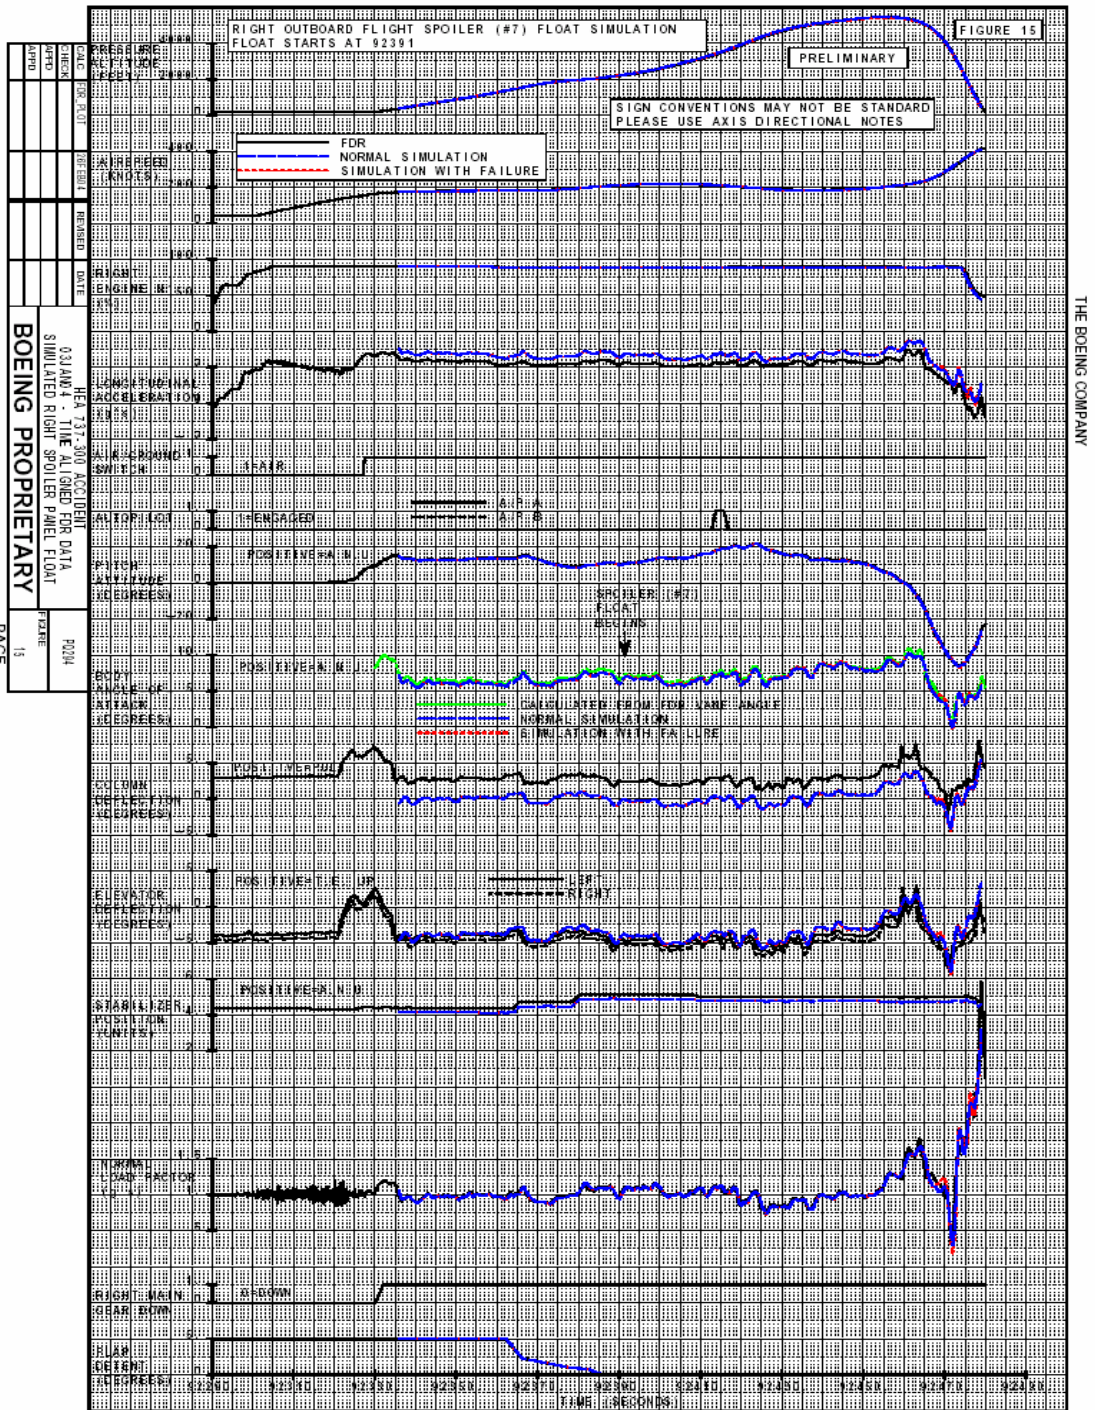
Figure 2.5.13.10a Right outboard flight spoilers (#7) Float simulation (floats starts at 92391) (Longitudinal)

Based on the M- Cab results (Simulator match to FDR, Faults Simulations, results of spoilers' float conditions are shown hereafter), this condition shows inconsistency with the accident scenario. Therefore, this fault could be ruled out.
