Part One of the Spanish Report

KLM, B-747, PH-BUF and Pan Am B-747 N736 collision at Tenerife Airport Spain on 27 March 1977

Report dated October 1978 released by the Subsecretaria de Aviacion Civil, Spain, in both Spanish and English

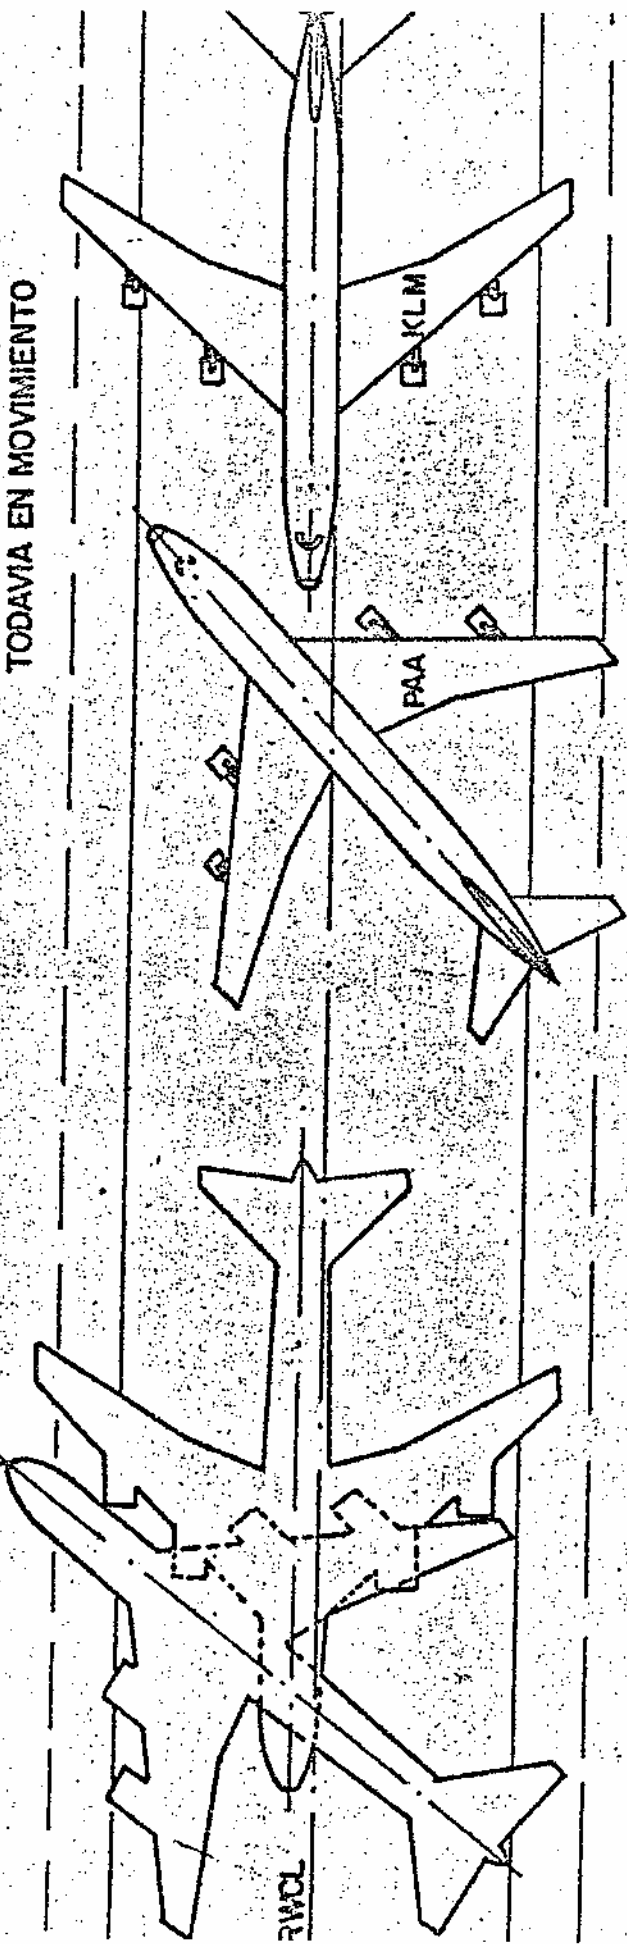
TENERIFE
PA/KLM
3-27-77

IMPACTO INICIAL

AMBOS AVIONES
TODAVIA EN MOVIMIENTO

NOTA: La marca del perfil de cola del KLM en la pista,
comienza aproximadamente 100m, antes del impacto
y unos 3m. a la derecha de la línea central de pista.
La longitud de la marca de cola mide unos 20m.
