Flat spin, Accident occurred on 25 June 1997 to Aircraft SUKHOI 26M, registration RA01295, in Barberá del Valles (Barcelona)

TECHNICAL REPORT

A-033/1997

Accident occurred
on 25 June 1997 to
Aircraft SUKHOI 26M,
registration RA01295,
in Barberá del Valles
(Barcelona)

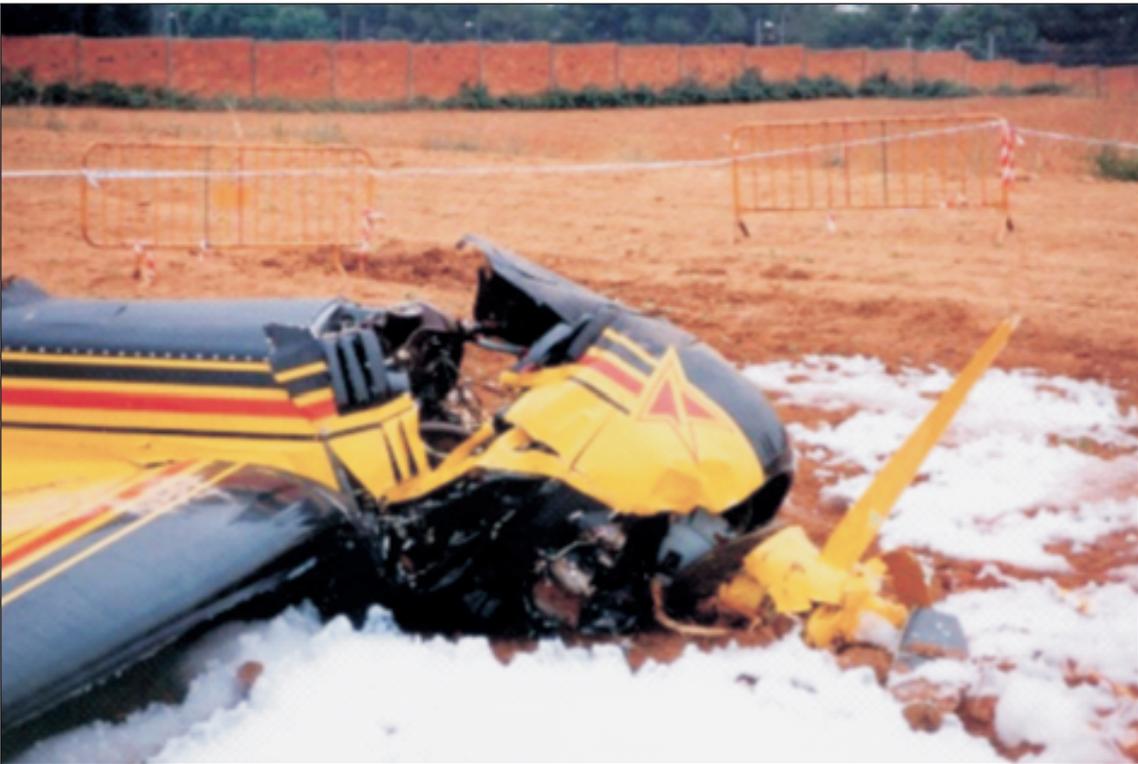
Photograph 4. *Powerplant detail*

During the impact, the engine mount broke. It was found split in two at the height of the firewall.

The three-blade propeller had two blades broken and laying on the ground while the third blade was practically intact, which indicates that it was not turning at the moment of impact.

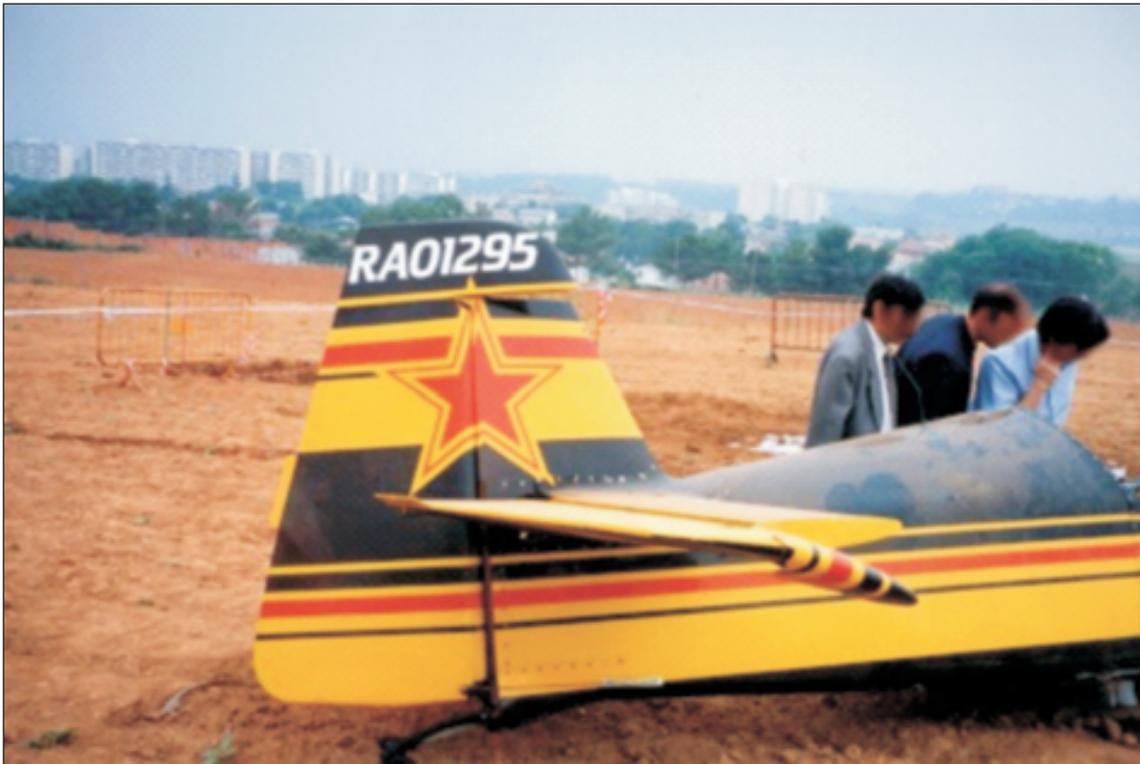
Photograph 5. *Aircraft wing detail*

The main landing gear had yielded until the wing hit the floor and the wing root area cracked through the upper side.
