## Ground collision following braking failure, Incident involving Boeing B-747-300 aircraft, registration TF-ATH, at Madrid-Barajas Airport on 14 September 2002

**IN-069/2002**

**Incident involving BOEING  
B-747-300 aircraft,  
registration TF-ATH, at  
Madrid-Barajas Airport on 14  
September 2002**

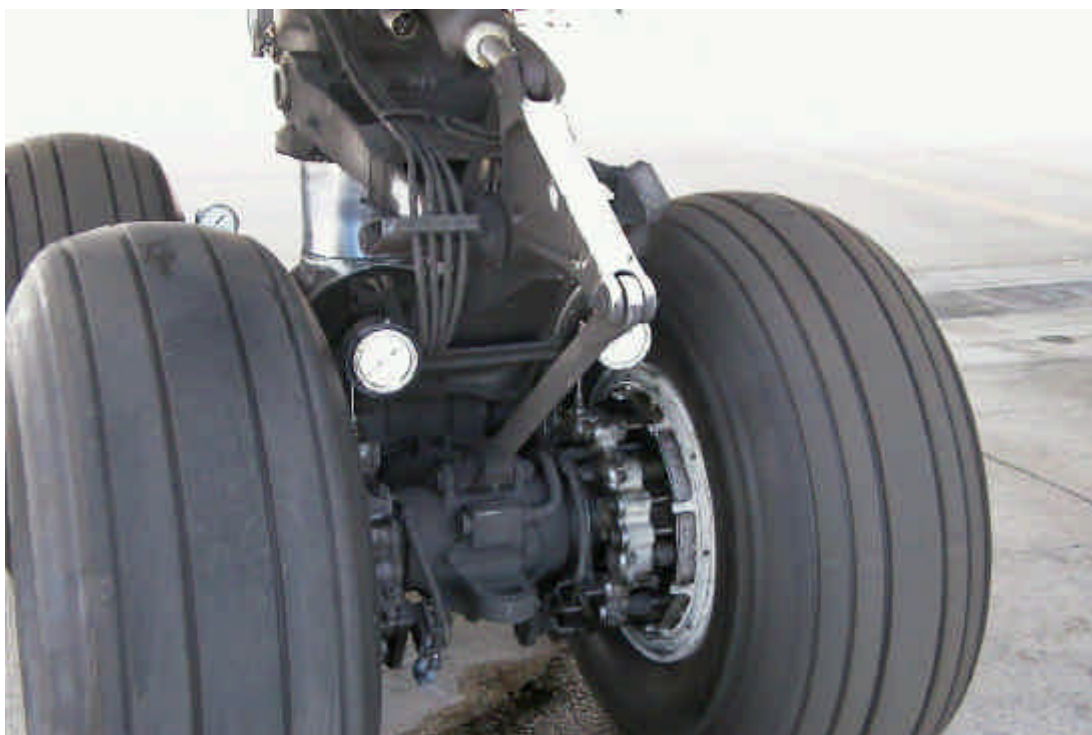
*Gauges installed on the brakes of TF-ATH*

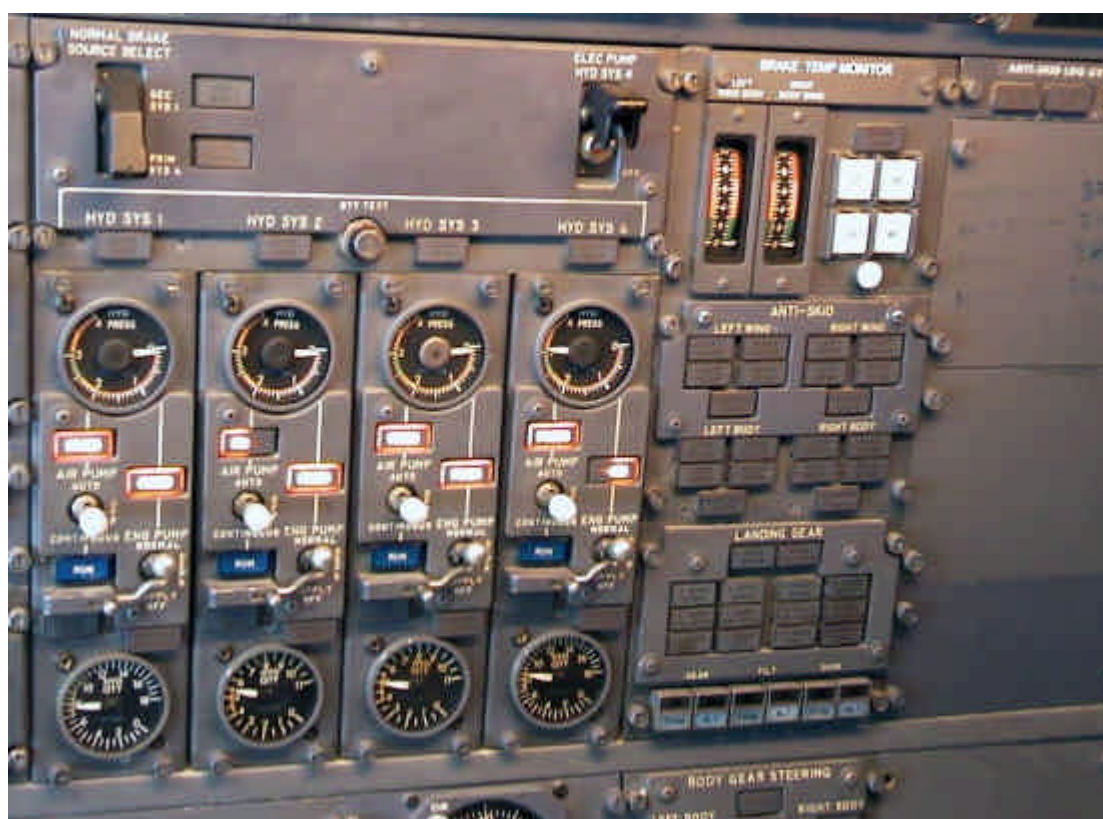
*CM-3 Panel. ACP switch (labeled "ELEC PUMP HYD SYS 4", cover lifted) noted. Pressure gauge of Hyd. System No. 4 shows 3100 PSI.*

Additionally, it was noted that the electrical pump (ACP) was immediately and automatically disconnected at the very first crank of engine four.

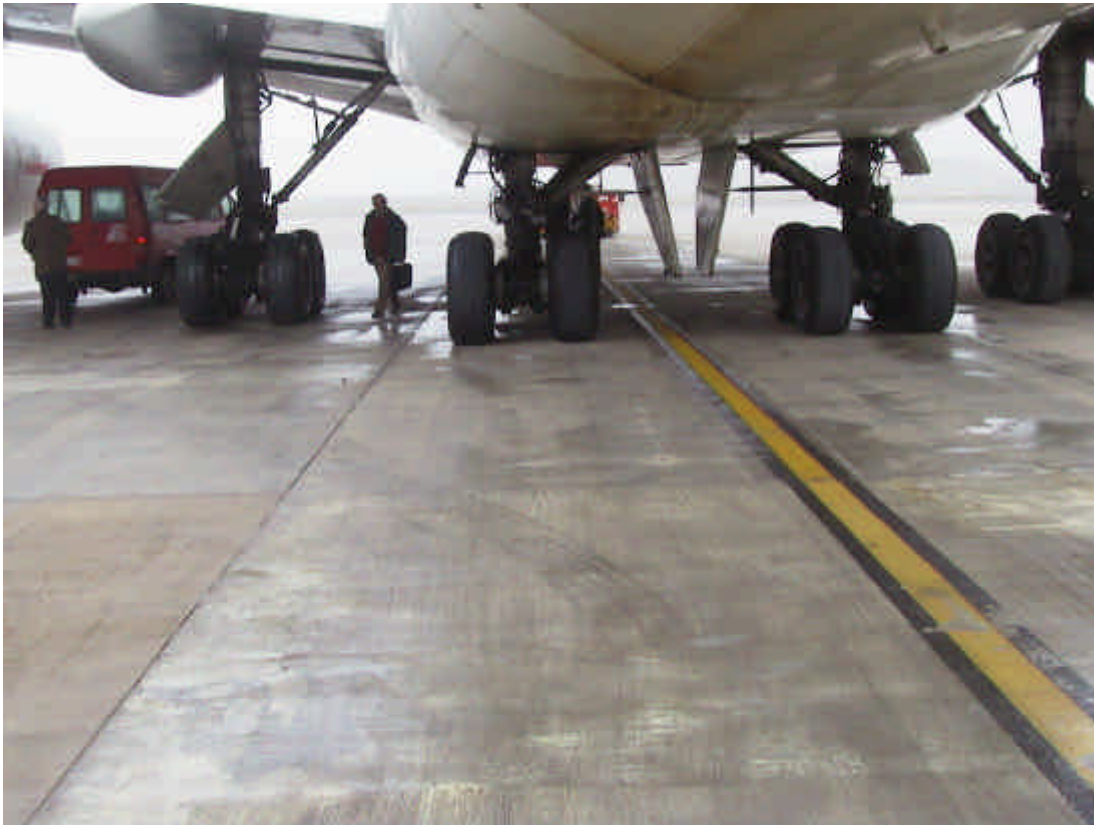
*Ground marks during the taxi tests (continuous and lightly marked)*

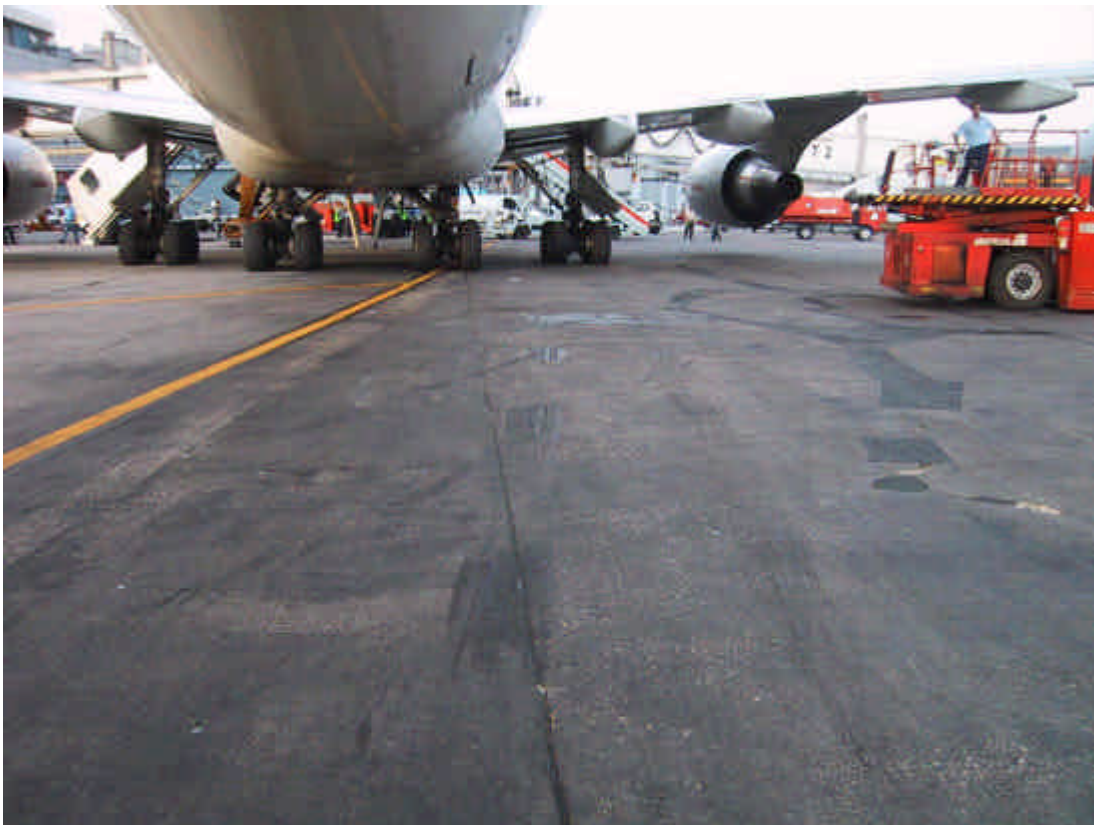
Several tire marks were clearly noted on the ground. The marks clearly led to the wheels of the RH wing landing gear. Additionally, the marks, that extended for a length of around 10 m, had an intermittent nature regularly spaced that was more noticeable for the inboard wheels of the RH wing landing gear. The marks of the outboard wheels were more continuous. The marks were arranged in a more or less straight line that showed an angle with the yellow guidance line similar to the final angle that the fuselage had with that line, indicating that the turn against the finger had taken place previously.

*Ground marks the day of the incident (intermittent and strongly marked)*

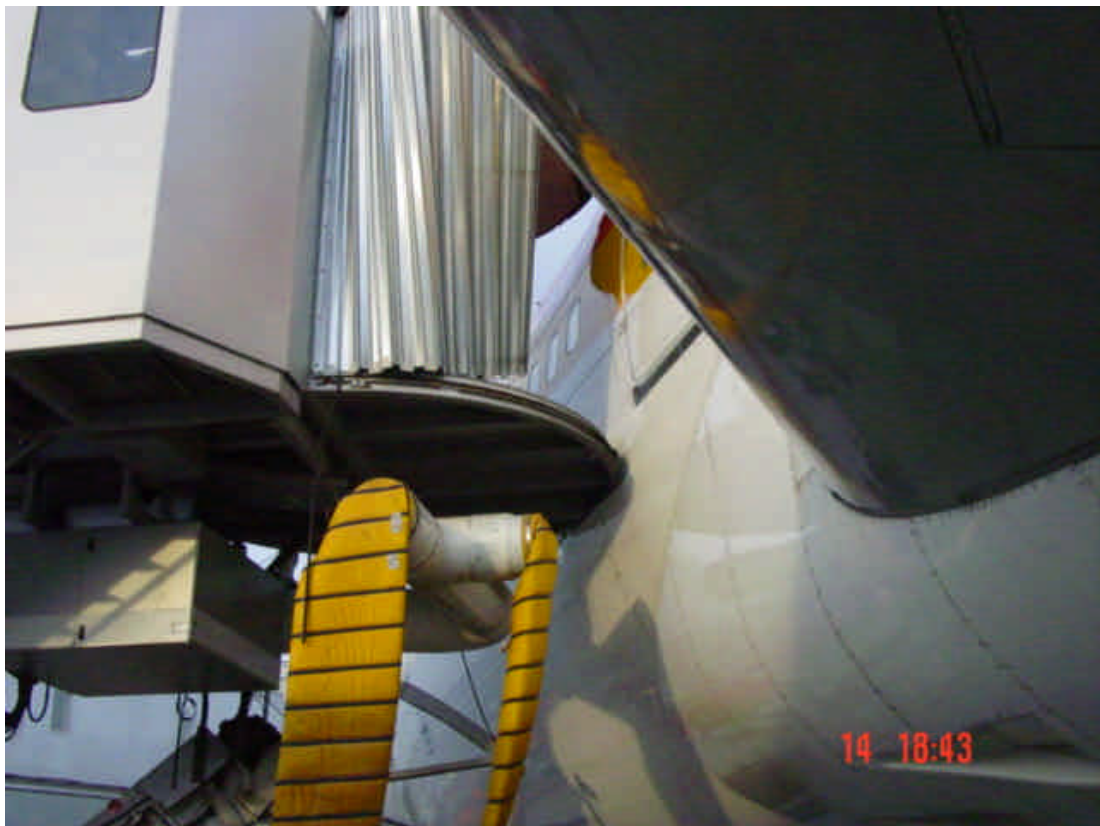
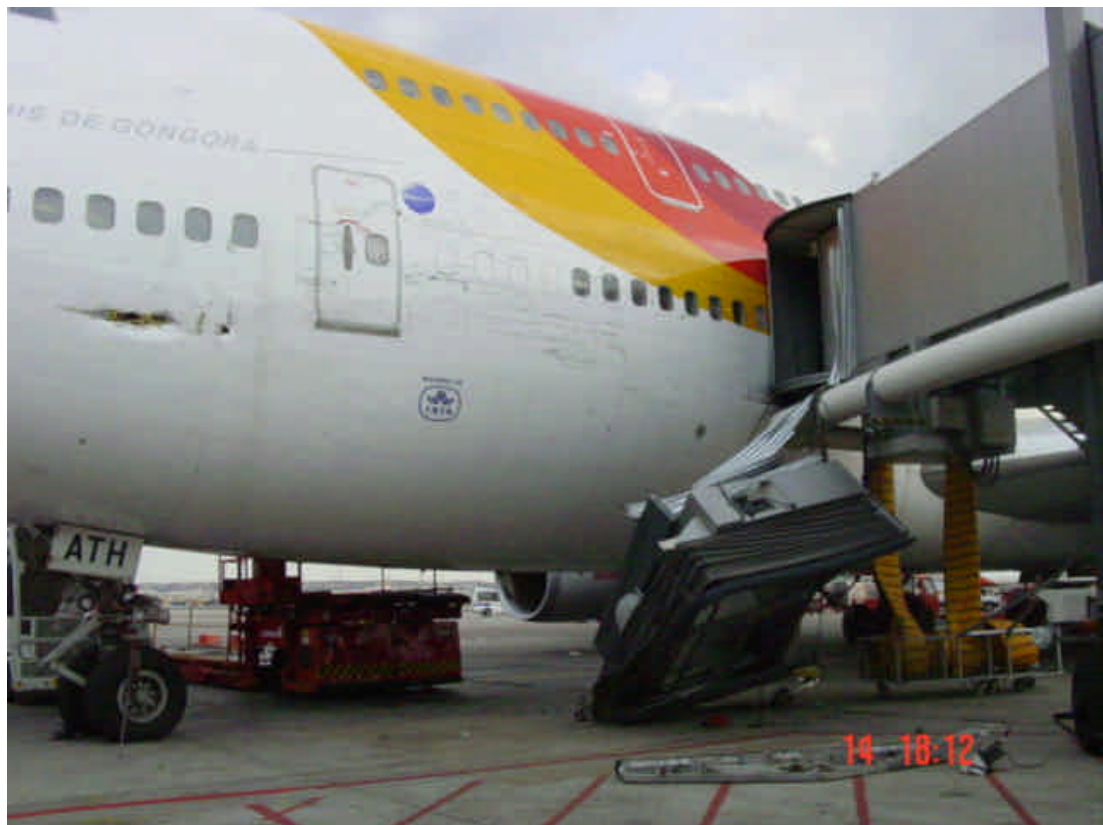
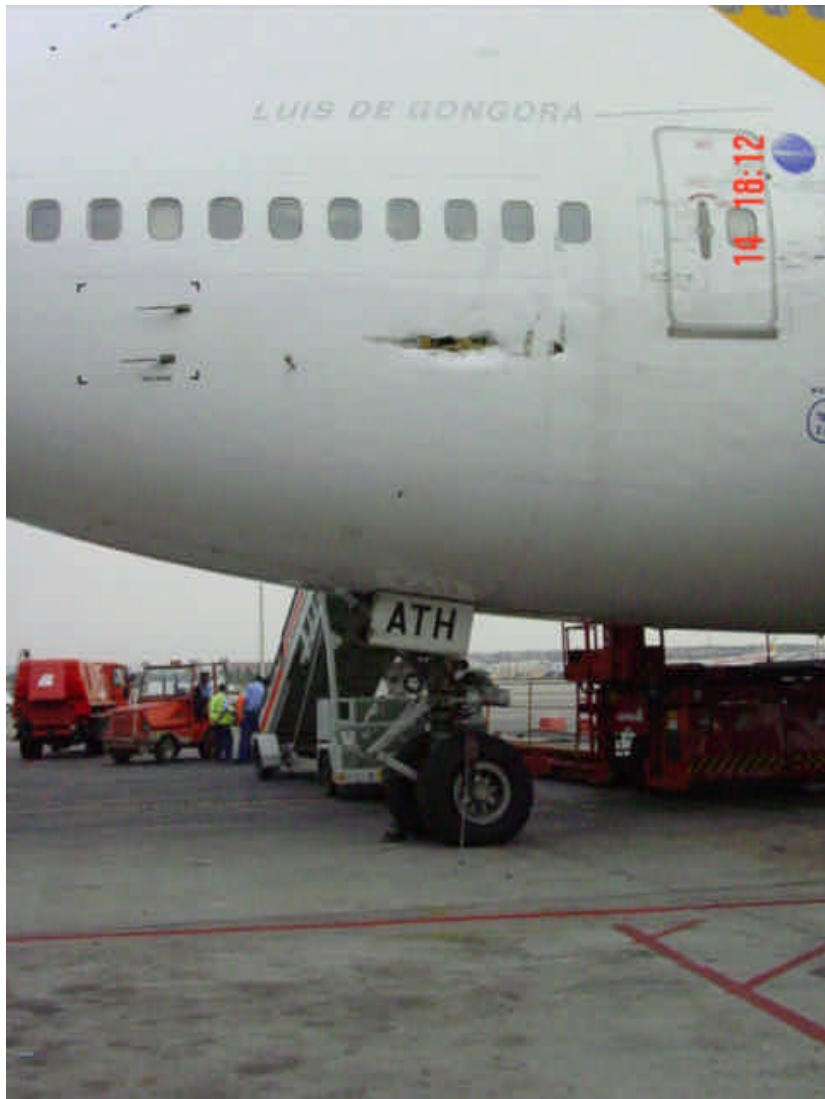
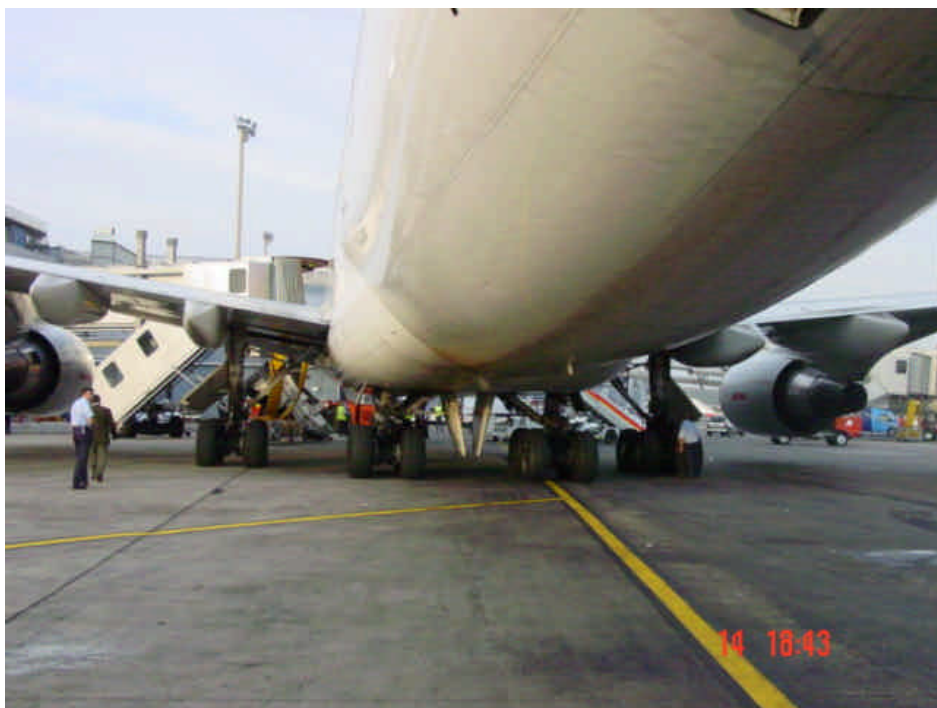
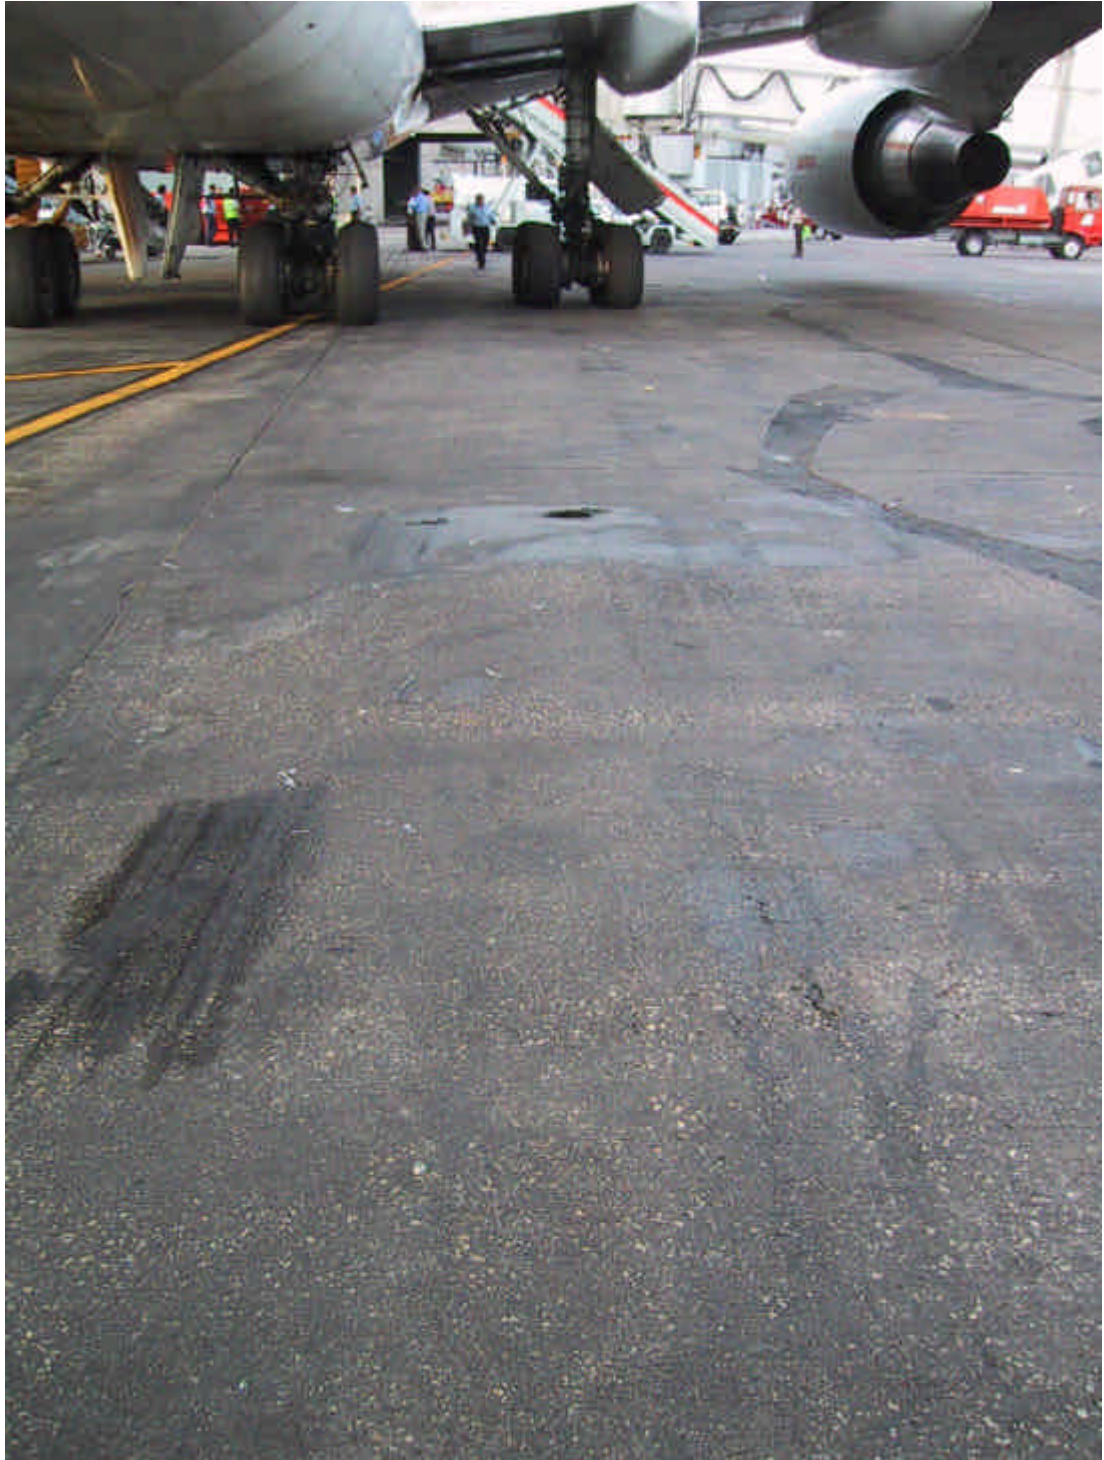
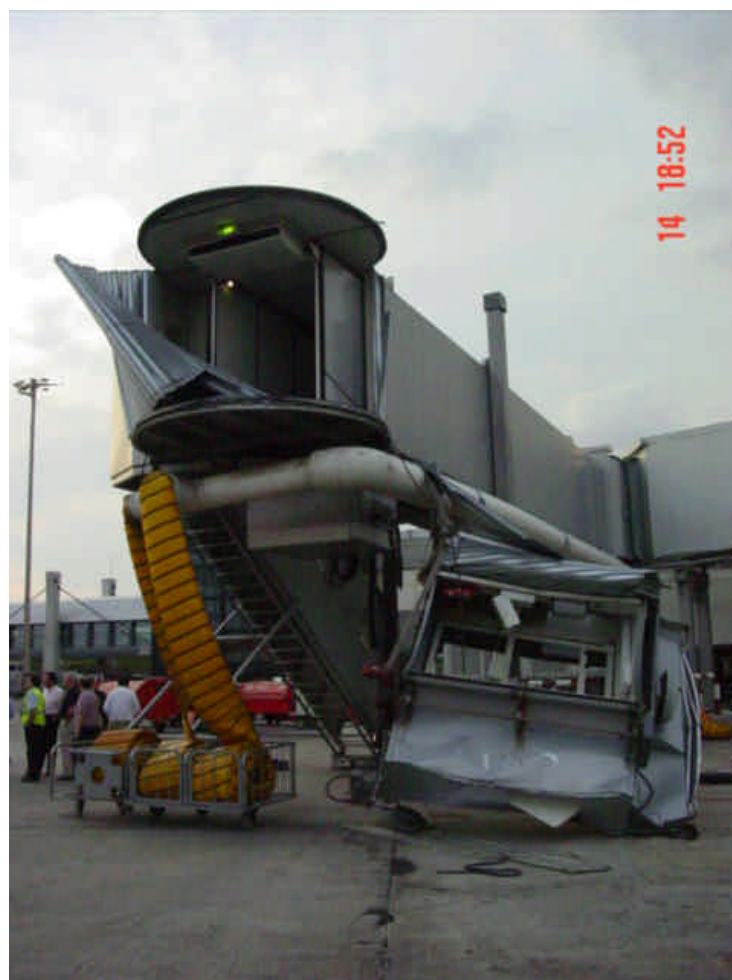
## **PHOTOGRAPHS**

The aircraft suffered major damage on the left forward part of its fuselage. There were four major punctures of the fuselage skin, with damage to the several fuselage frames. There was a puncture of around 60 inches between Station 350 and Station 410, at the height of stringer 27A, and tears and punctures between doors 1L and 2L. Photos of the damage are presented in Annex A.

The cabin of finger T-1 at Barajas Airport was detached from the main part of the finger and was left hanging from the left part of the finger. It was later on deliberately separated from the finger and left on the ground by support personnel, to eliminate the hazard to ground people and vehicles. There was major damage to most of the components of the finger cabin: tilting floor, rotating system, command stand, leveling system, and also to the air conditioning tube.

The aircraft had crashed into the finger suffering major damage on its left side and breaking the cabin of the finger in the process.

The first mark of the fuselage was in a point situated horizontally in the vertical of the nose landing gear and vertically at the height of the middle between both pitot tubes. The marks ended just at the beginning of the frame of door 2R, where the rotating roof of the finger was embedded in the fuselage. That means that the aircraft moved for twelve meters after the initial contact with the finger. During that movement, rubbing and scratching happened and appreciable horizontal forces were applied to the aircraft by the finger structure, as noted by the damage and deformation produced.
