Ground collision, Incident of the aircraft Airbus A-340-313, registered EC-GPB, at Salamanca Airport on 8 November 2002.

Investigative Body: Civil Aviation Accident and Incident Investigation Commission (CIAIAC), Spain

IN-076/2002

Incident of the aircraft
Airbus A-340-313,
registered EC-GPB,
at Salamanca Airport
on 8 November 2002

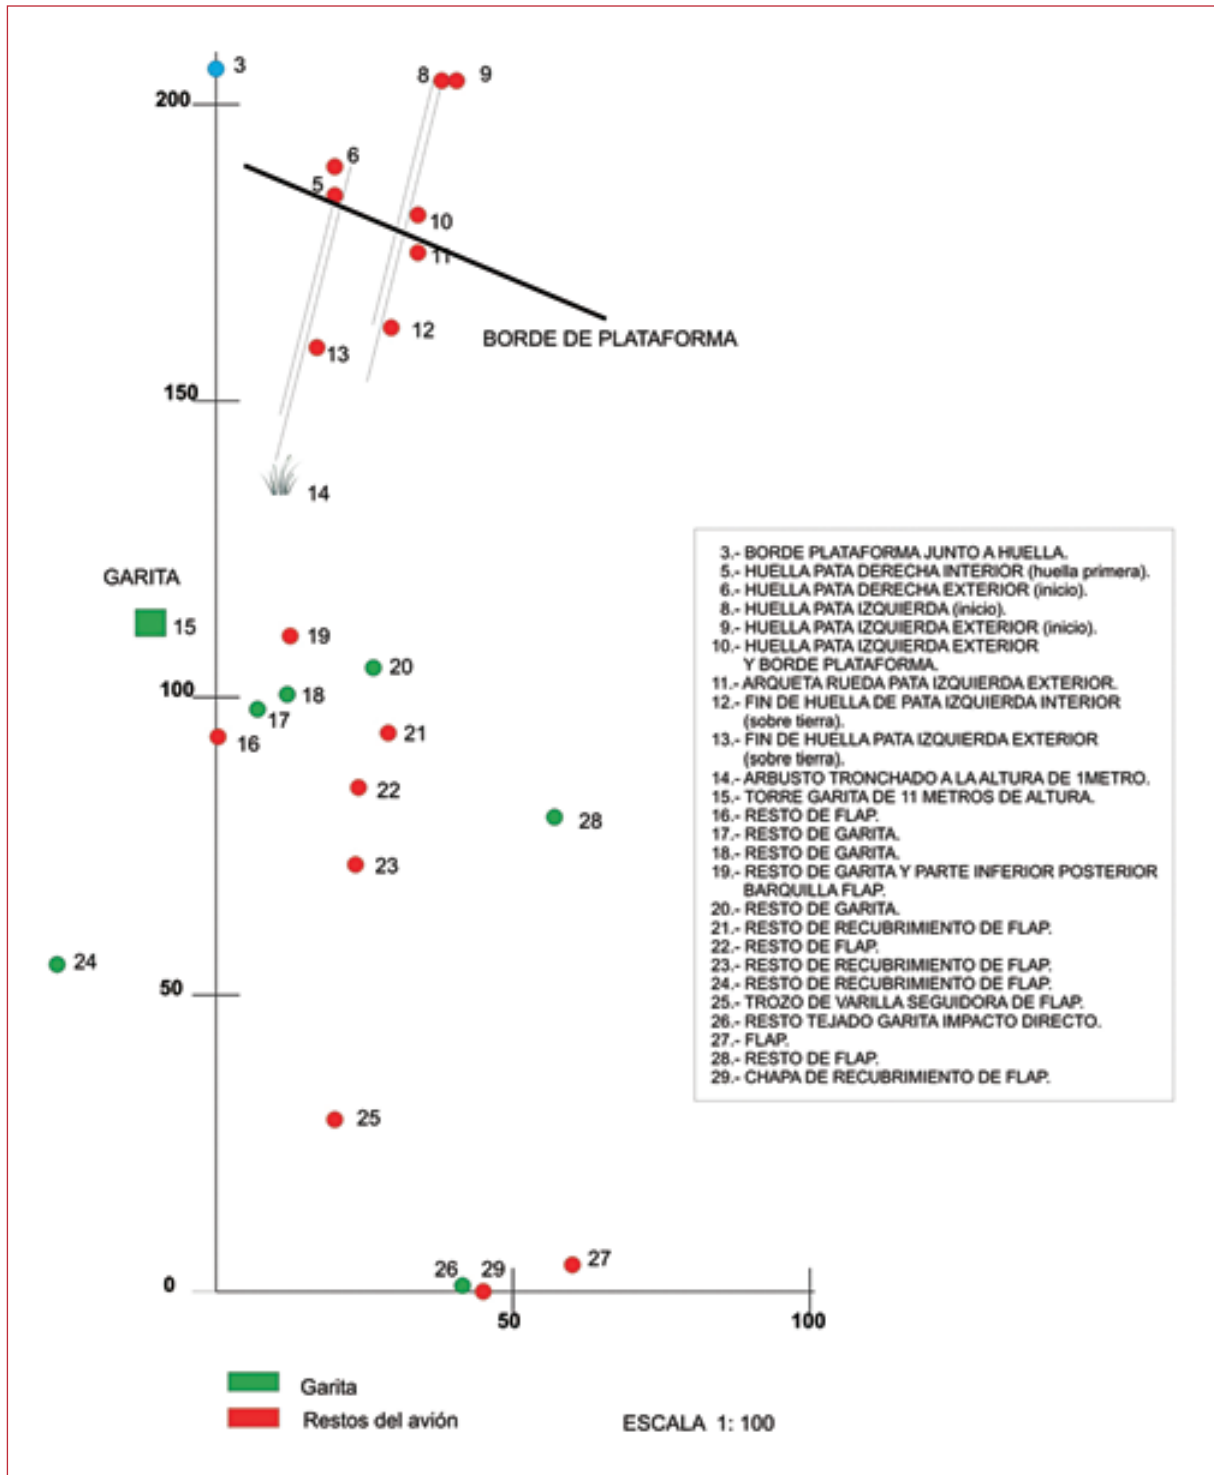
APPENDIX A
Debris diagram and tracks
over the terrain

Then the aircraft hit with the outboard flap pylon a sentry box of approximately 11 m of height. The hit cut the upper part of the box and wreckage from it were found up to approximately 50 m away from the sentry box.

Remains from the aircraft were found along approximately 120 m. They were found a part of the flap bar fairing, of 1.15 m of length, with a part of the guiding bar still attached, and a rectangular piece of the right outboard flap of 3 m per 0.9 m and a part of the flap skin, of 3.85 m per 0.42 m.

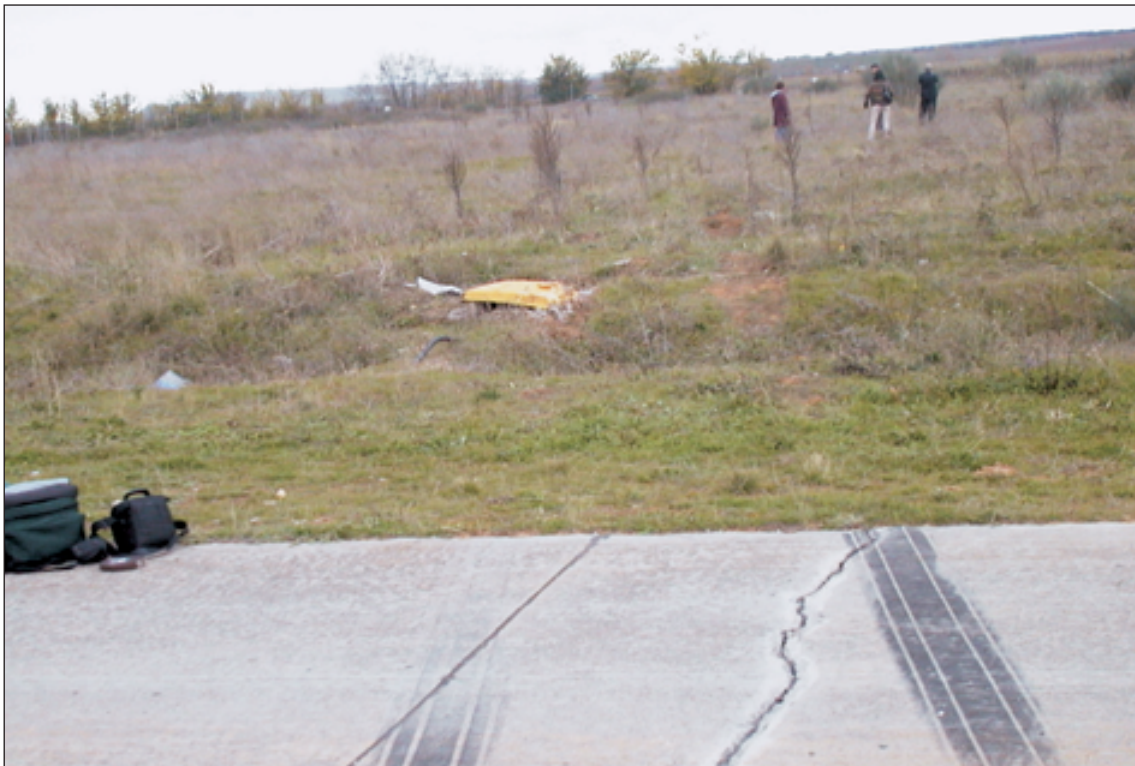
The aircraft, after touching down with the main left and right landing gear legs on the parking apron and the adjacent terrain at 15:01:48 h, broke with the left leg an elec-

trical equipment well that was buried beyond the apron and hit with the fairing of the external fitting of the outboard flap of the right wing an abandoned sentry box of around 11 m of height that was located besides the fence of Salamanca Airport. The sentry box had a metallic structure, with crystal panels that formed the sentry cabin and a roof of zinc of around 60 kg of weight. The upper part of the sentry box, with a length of approximately 3 m, was cut by the aircraft and fell to the ground together with the zinc roof.

Detail of the tracks and lights well
