## Aircraft accident at Kajaani Airport, Finland, 3. November 1994

## Major Accident Report

### **Aircraft accident at Kajaani Airport, Finland, 3. November 1994**

DC-9-83 (MD-83)

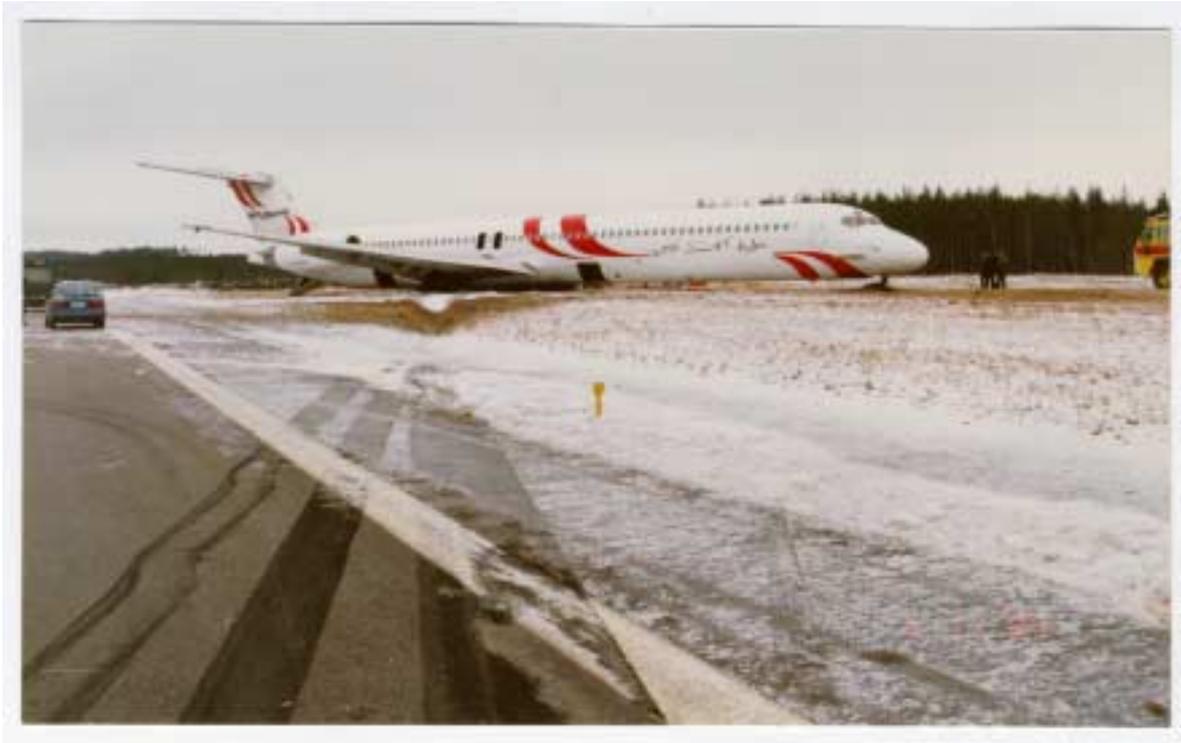
Figure 1. The aircraft has turned 140 degrees right from the runway heading and has stopped outside the runway. The tail is abeam the runway end.

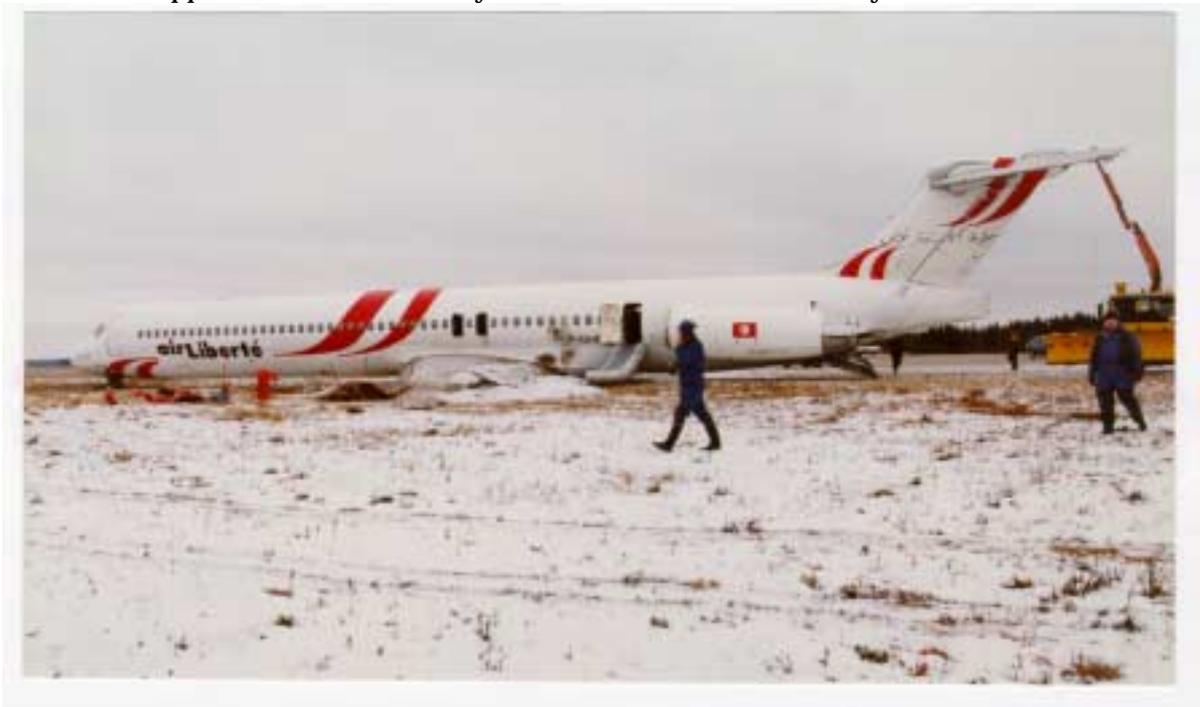
Figure 2. The left main landing gear has folded inboard into wheel well and the left wing has been damaged. Left wing fuel tank has got a leak. The evacuation took place through the aft galley service door and the left overwing emergency exits excluding two passengers who came out through the right overwing emergency exits.

Almost the whole left wing was on the ground. The flap hinge supports had broken and the outboard flap had bent upwards. Also the leading edge slats were bent. The cable pulley bracket had torn apart from the wing front spar at the midwing. There was a two centimeter diameter hole in the spar. Fuel had leaked through the hole.

The left main landing gear downlock had broken and the gear had collapsed into the bay and pushed the door in. The door had broken some accessories and structures in the bay. The actuator piston rod of the gear had cut. Both tires had bursted. The thread of the landing gear torque link Apex bolt had sheared, the nut was missing and the torque link was open. The wheel pair had turned 180 degrees. All four brakefluid hoses and the electrical wires of the wheel speed transducers in the wheel axle had been severed.

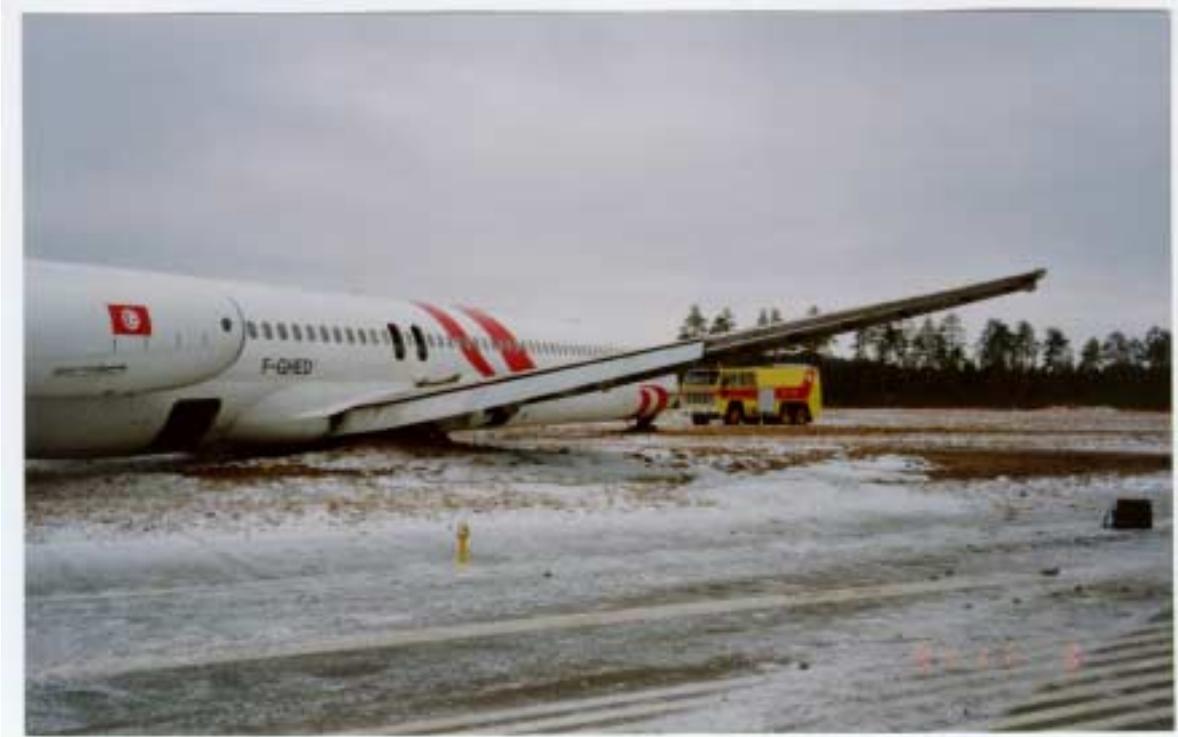
Figure 3. The right main landing gear has dug into the ground. The fuselage is lower than normal.

The right main gear was down and locked. The wheels of the landing gear had pushed in front of them a lot of sand which had filled the landing gear bay. The inboard tire had bursted and the outboard tire had worn almost through in two locations. The outboard tire was pressurized. The thread of the Apex bolt of the

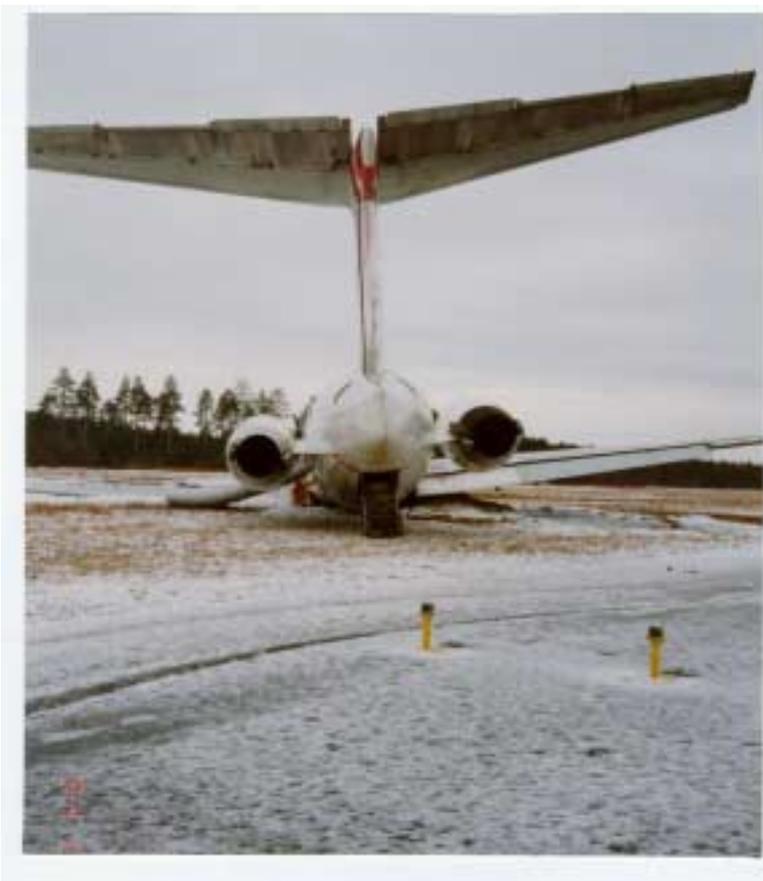
Figure 4. The evacuation of passengers through the aft stairs was not possible because the stairs did not have enough room to extend. The aft fuselage was lower than normal. The aft emergency exit would have been usable for evacuation.

The aft stairway had not had enough room to extend completely because the fuselage was lower than normal. The tail cone, which is part of the aft emergency exit, had not been released. The service door between the left wing and the left engine was open and its escape slide had been released and had inflated properly. The overwing exits were open. There were deformations on the left side fuselage skin behind the trailing edge of the wing from the window level down to the wing. The deformations had been caused by the flexure of the fuselage.

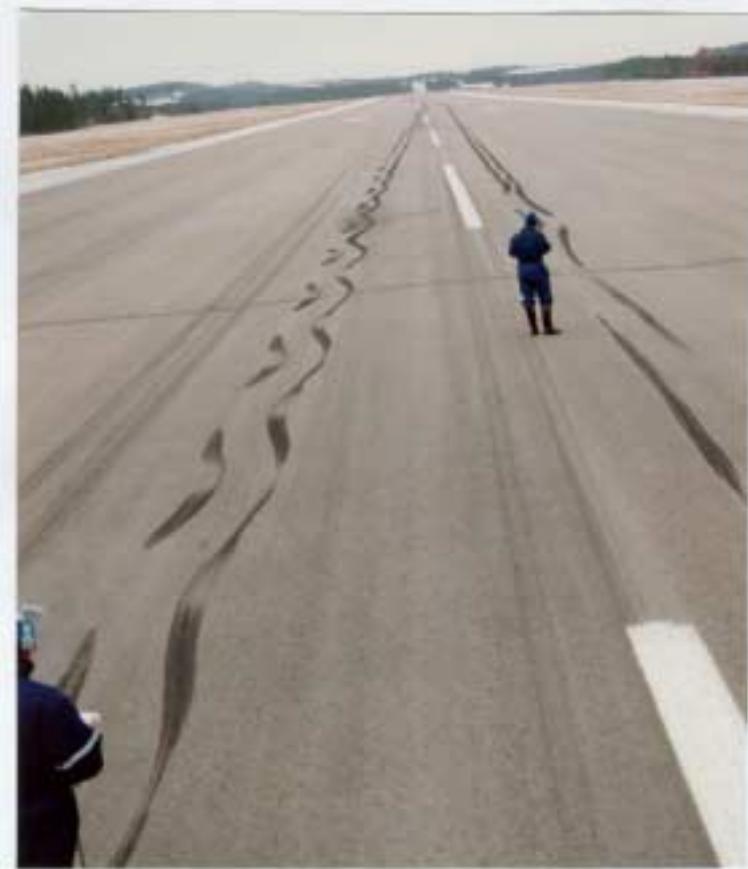
Figure 5. Both main landing gear marks seen to the landing direction. The marks of the left main gear shimmy started at 190 m and the right main gear at 260 m from the touchdown.

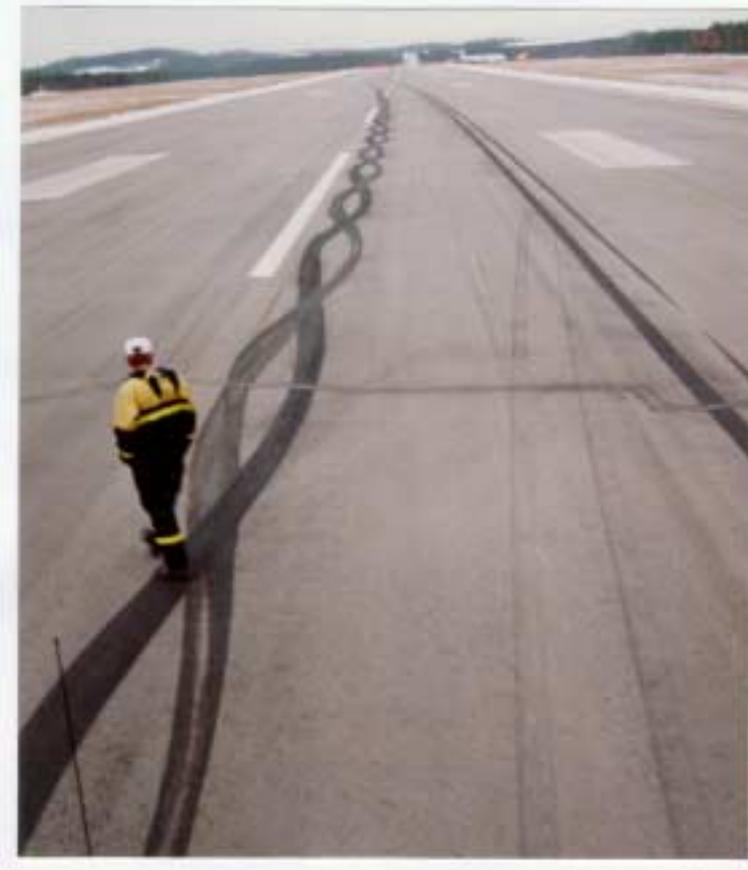
Figure 6. As a result of main landing gear shimmy both main gear torque links broke. The left wheel pair turned 180 degrees in the shock strut for the first time at 670 m from the touchdown. 18 similar turns occurred thereafter.

The lower left torque arm clevis area had torn. The both main gear torque link Apex bolts and nuts had failed in the threads by ductile overload. The damage was caused by the overload from main gear vibration. No material or processing discrepancies were noted in the inspected landing gear parts.
