Engine failure, Aircraft incident at Kajaani airport, Finland 1. October 1996

Aircraft Incident Report

B 11/1996 L

Aircraft incident at Kajaani airport, Finland 1. October 1996

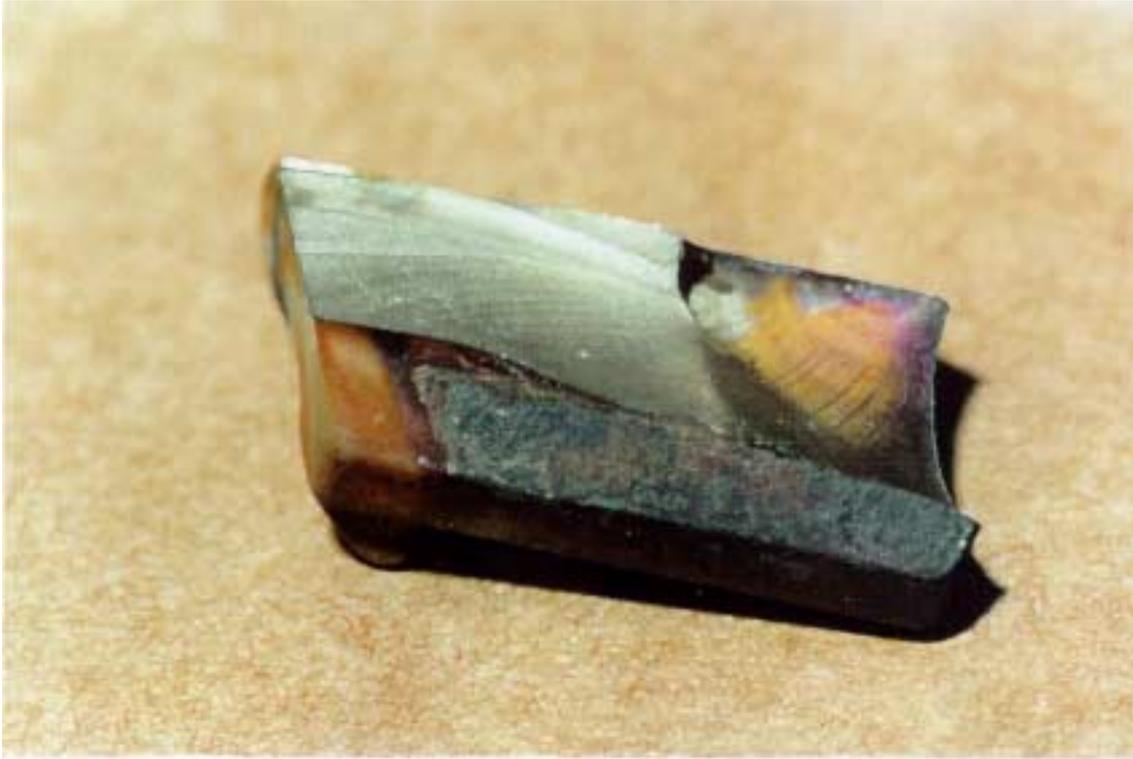
One 8th stage compressor rotor blade (p/n 802 808) had fractured from the root and only the root piece was remaining in the disc. The liberated blade part had caused the compressor damage. The rotor blades were severely damaged in the leading and trailing edges. The blade tips had tom and pieces were missing. Several blade roots had rough surface which looked like corrosion (ref galling). All the 8th stage rotor blades were scrapped (58 pieces).

Figure 1. The failed 8th stage compressor rotor blade root

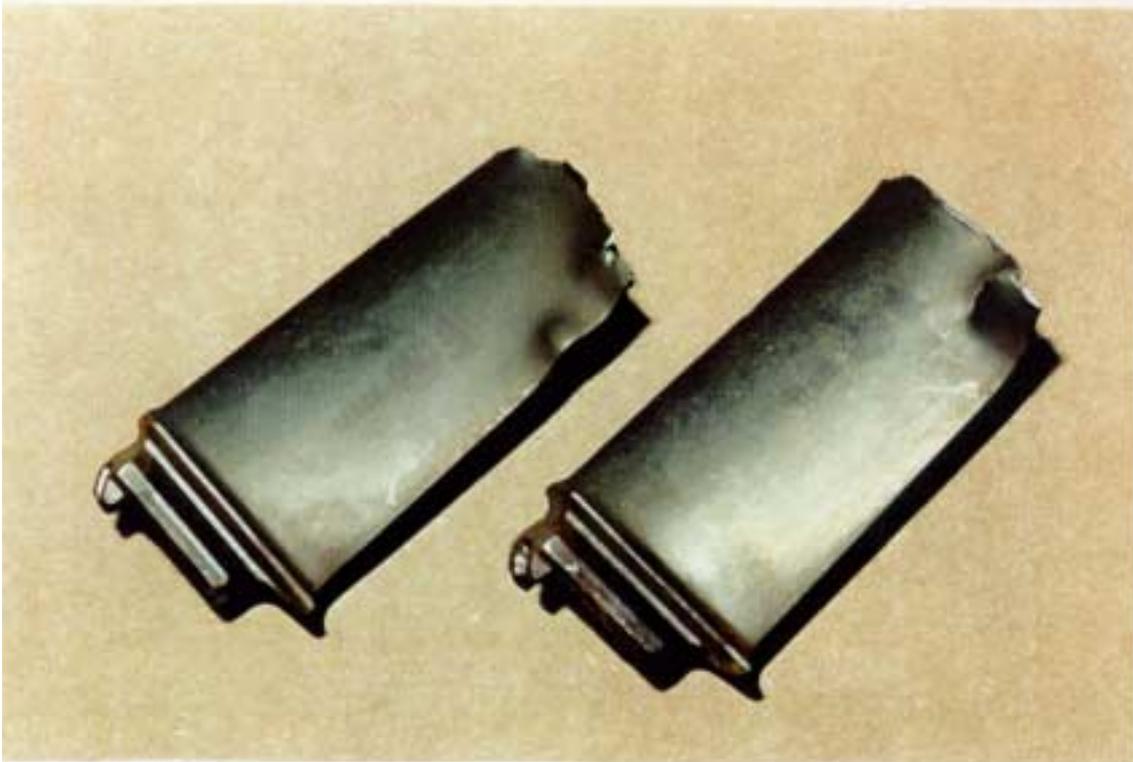
Figure 2. Two of the damaged 8th stage compressor rotor blades

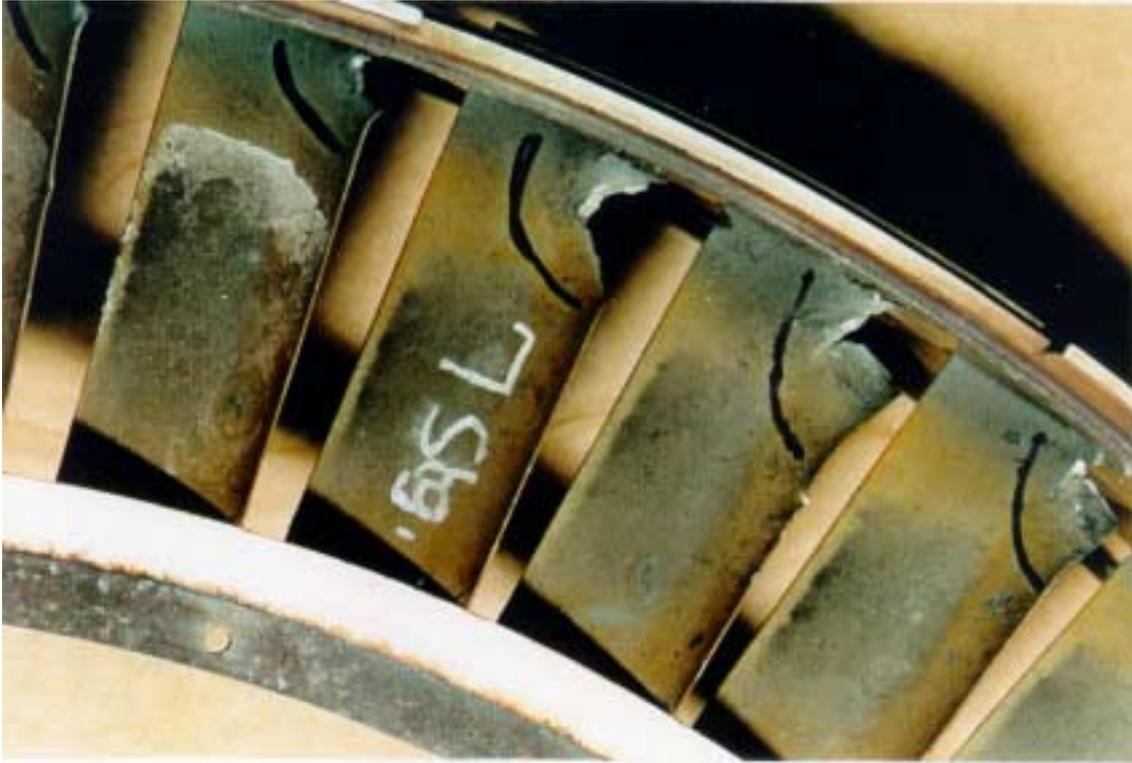
The 7th stage compressor rotor blades were in good condition. Trailing edges of all stator vanes had severely tom in the tip area. Pieces of the vanes had separated but leading edges were in good condition.

Figure 3. Some of the compressor 7th stage stator trailing edge damages

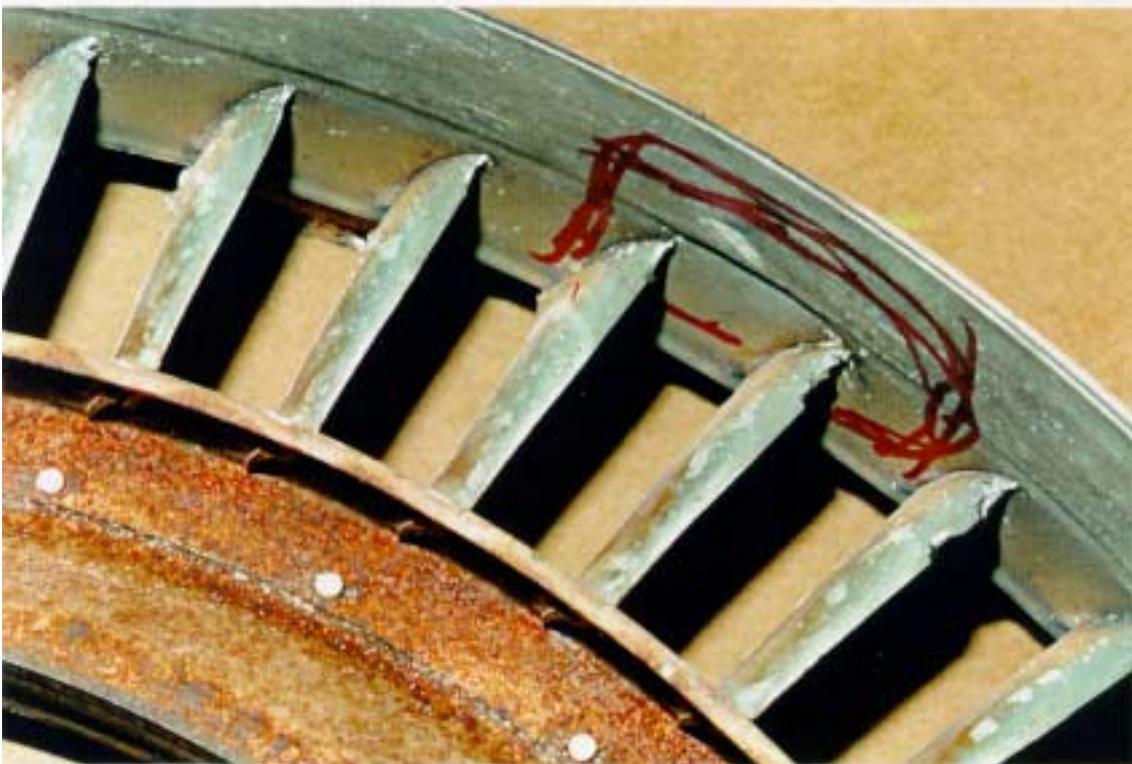
The 8th stage stator vane leading and trailing edges had strikes, nicks, deformations and fractures. Some vane material had separated. The damage was most severe at blade tips. The stator outer shroud had one deep dent, which was also visible on the outer skin of the outer shroud.

Figure 4. Some of the 8th stage stator leading edge damages

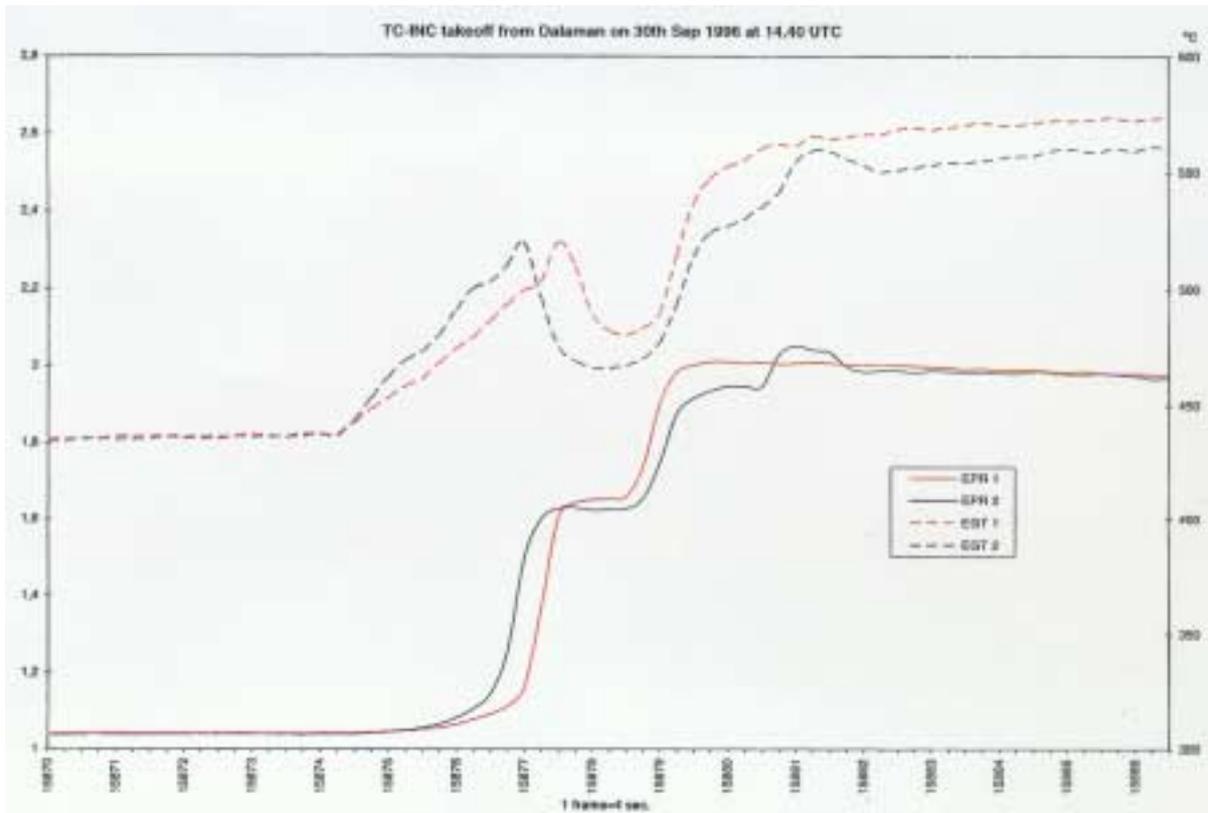
Figure 5. EPR and EGT during the takeoff in Dalaman

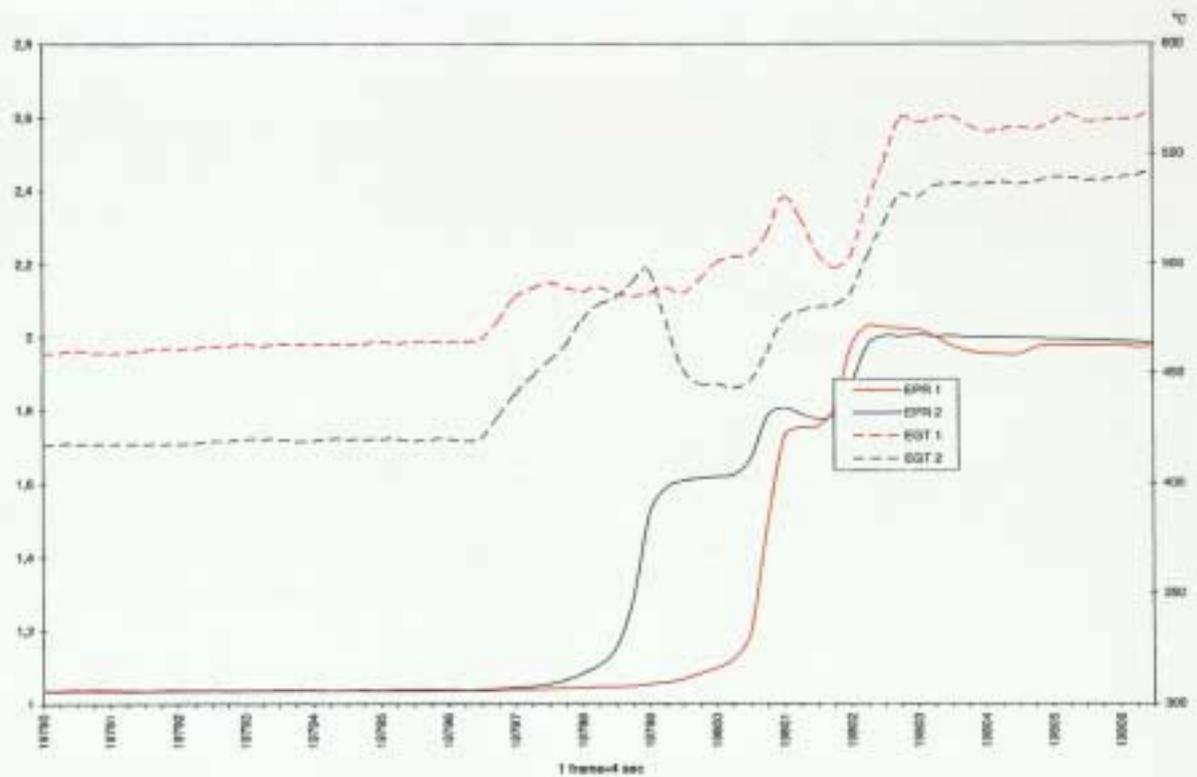
Figure 6. EPR and EGT during the takeoff in Cologne/Bonn

18. It was found out from the UFDR data that when throttles were manually advanced for spool-up in the beginning of the takeoff in Cologne/Bonn, the right engine accelerated normally to 1,6 EPR but the left engine responded slowly. When the throttles were further advanced, both engines accelerated to 1,75 EPR which after the autothrottle was engaged. The left engine accelerated from idle to 1,4 EPR approximately 8 s slower than the right. In Dalaman this difference had been only 2 s. According to the written statement of captain A no abnormalities in the left engine instrument indications were observed during the takeoff, departure and climb from Cologne/Bonn. During the interview in Kajaani the cockpit crew stated that the engine acceleration had been normal during the takeoff in Cologne/Bonn. A difference of 8 s between engine acceleration rates is easily recognizable.

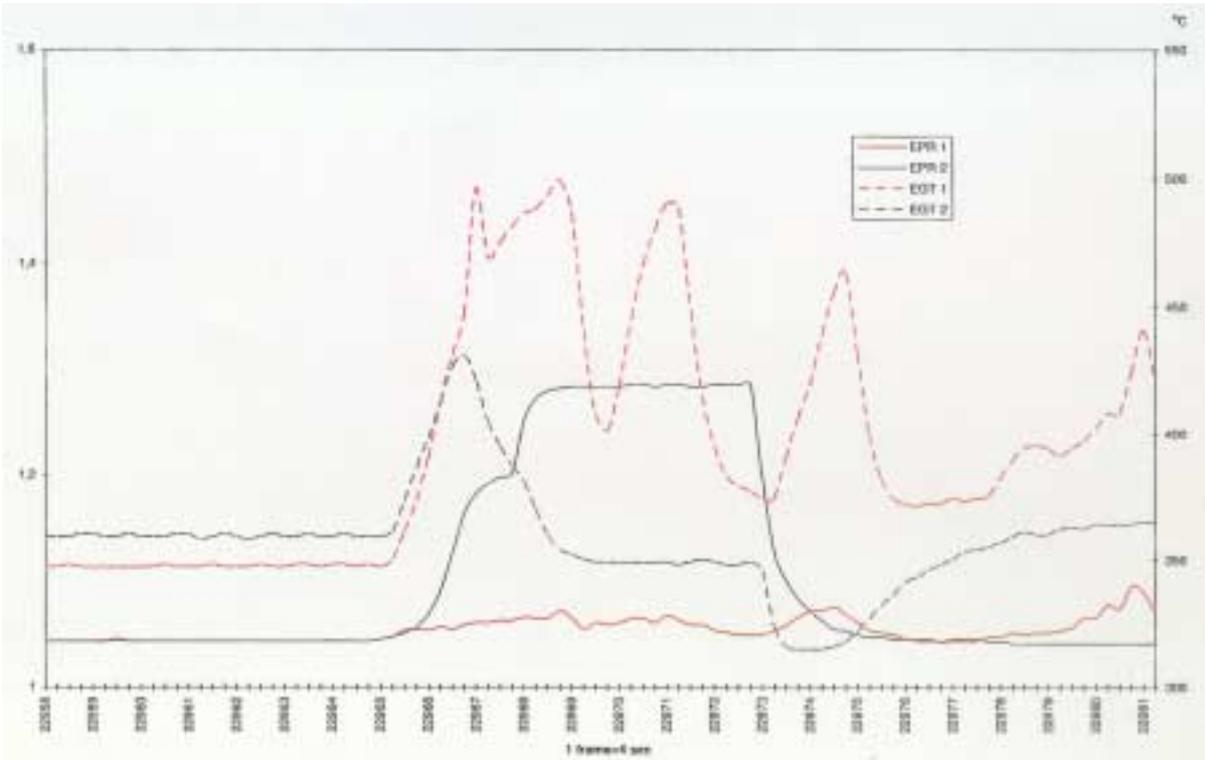
Figure 7. EPR and EGT during the attempted takeoff in Kajaani

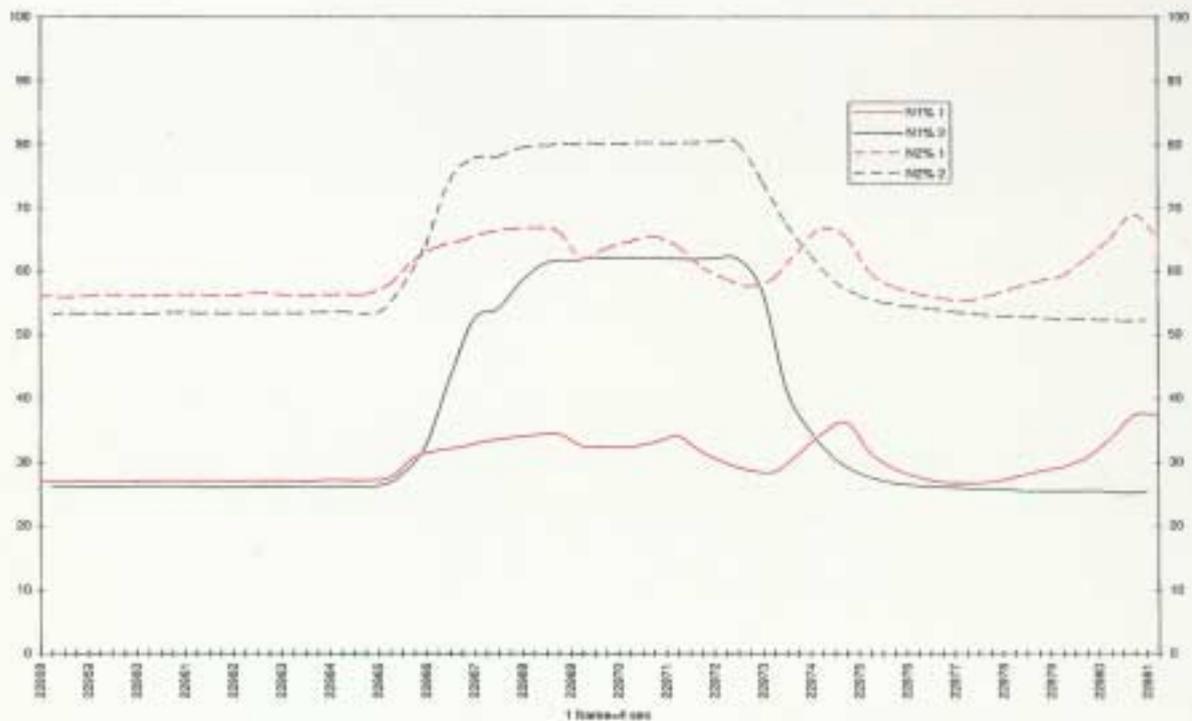
Figure 8. N1 and N2 during the attempted takeoff in Kajaani
