Incident Investigation Report

B 5/1997 L

Aircraft Incident at Joensuu airport, Finland on 11 April 1997

**TC-INC
DC-9-83 (MD-83)**

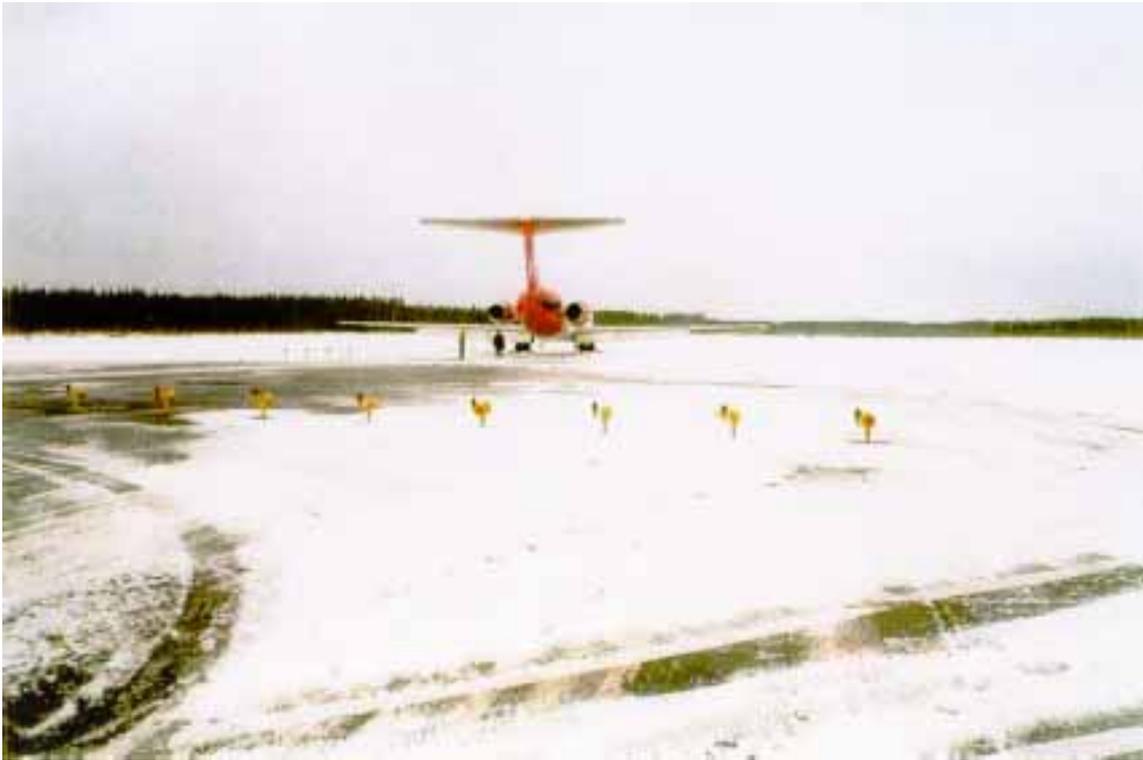
Figure 1. TC-INC 50 m beyond the end of the runway.

The aircraft stopped at 40 m after the end of the runway and the reverser buckets were stowed in 5 s. About 20 s later the captain attempted to taxi the aircraft and increased the engine thrust to nearly take-off thrust settings three times. The aircraft moved three times almost straight ahead for 20 m and came to a final stop at 60 m beyond the end of the runway on a gravel surface covered by 15-20 cm of hard snow, right of the second approach light row for runway 28 on a heading of 094°. The direction of runway 10 is 102°. The attempt to turn and taxi back to the runway was unsuccessful due to skidding of the nose wheel. Flight SWW 1022 had landed at 01.54.

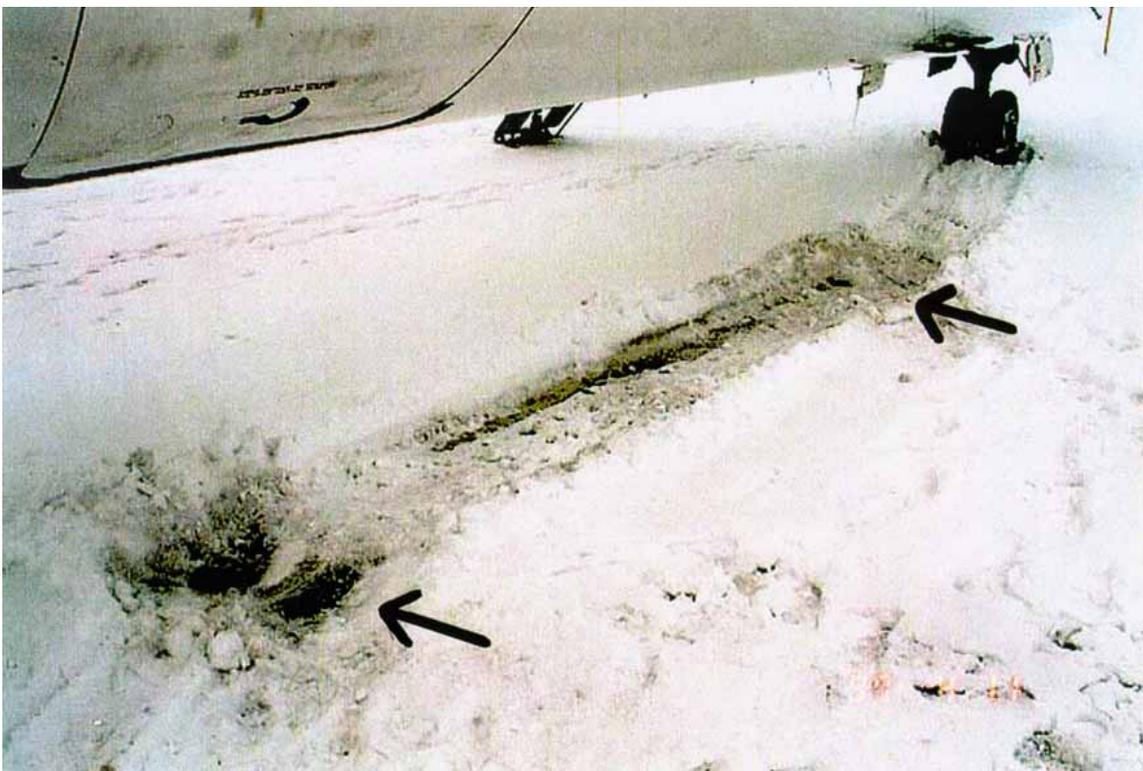
Figure 2. Stopping points on nosewheel track outside the runway.

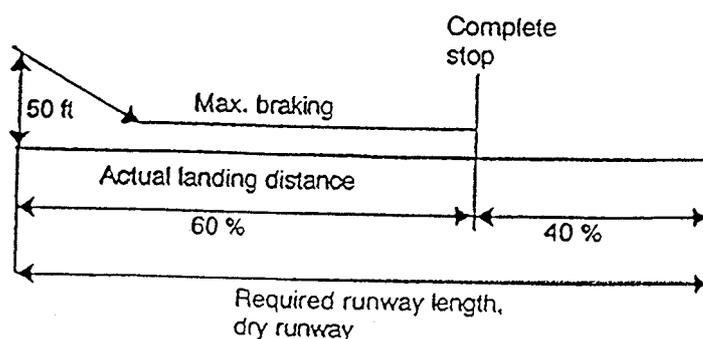
Figure 3. The runway requirement

The effect of the reverse thrust is not taken into account when calculating the runway requirement when the runway is dry. Only 60 % of the required runway length is used to stop the aircraft with maximum braking and the remaining 40 % is a safety margin required by aviation regulations. If the runway is wet or contaminated by ice, snow, slush or standing water, the safety margin requirement may be less than 40 % but according to JAR regulations it must be at least 15%.

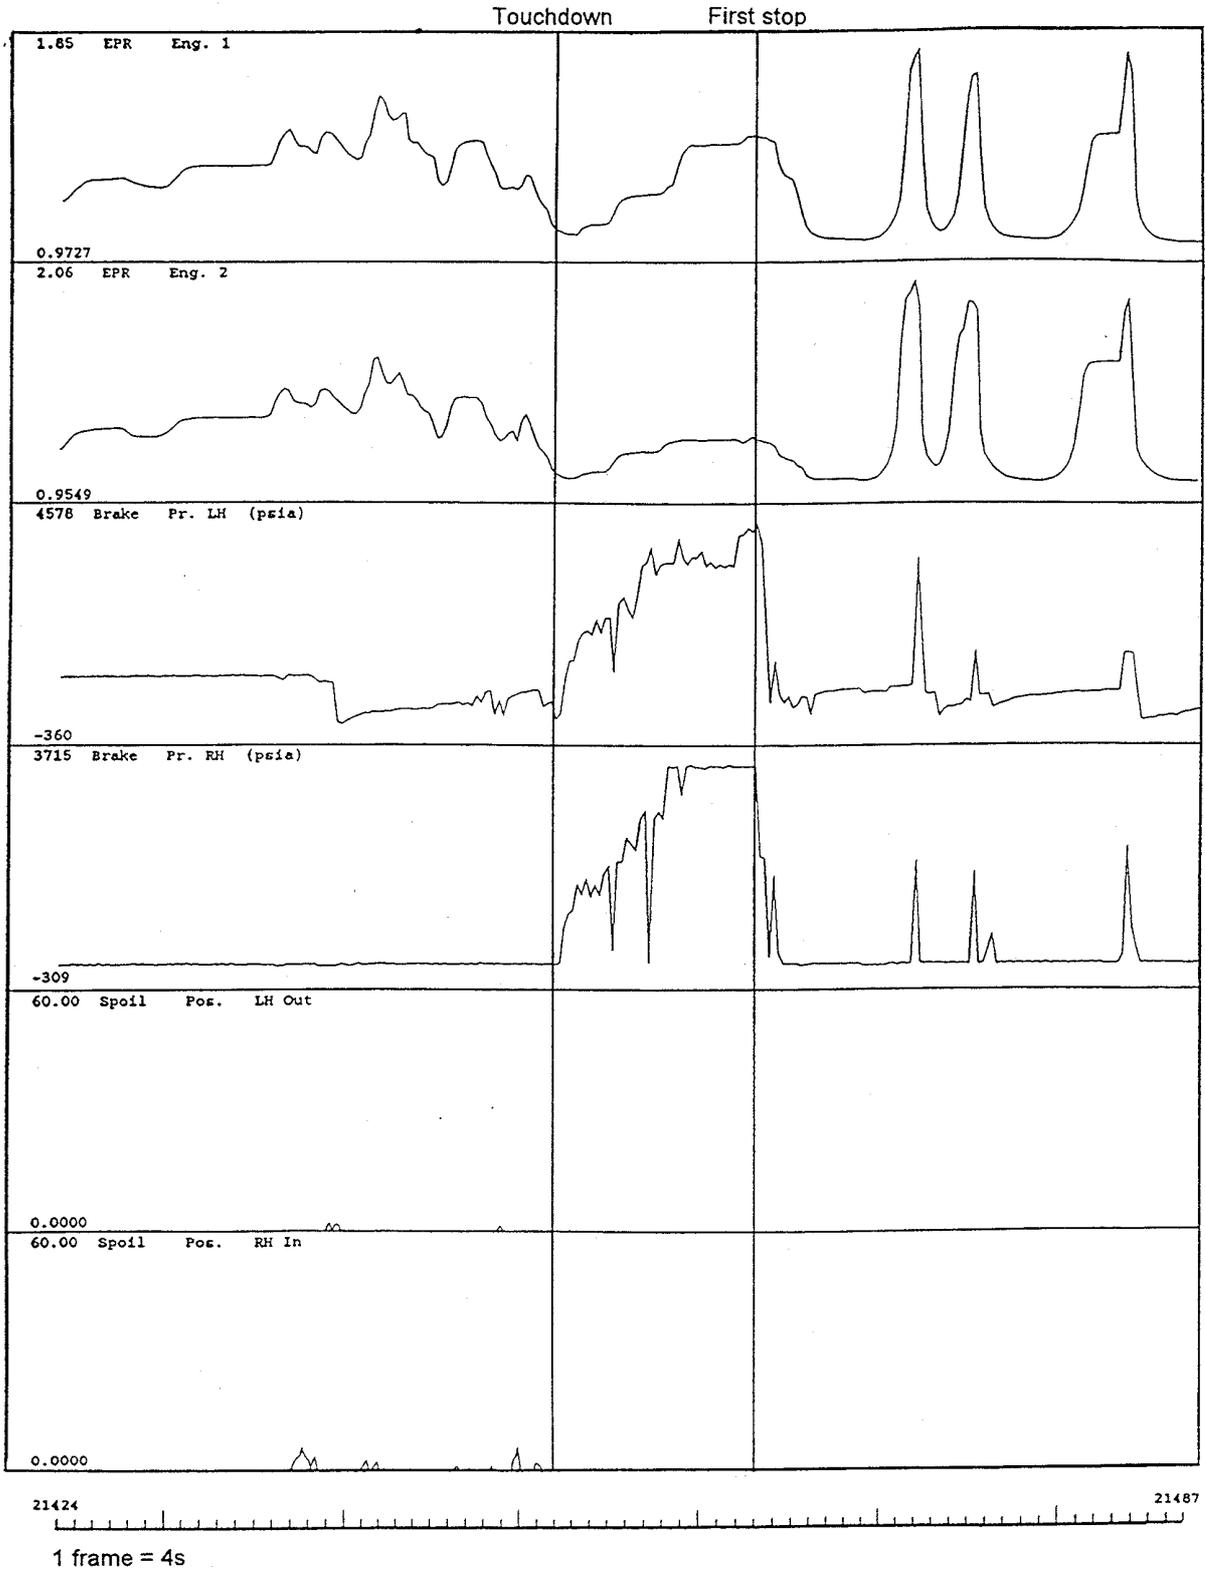
A graph of the most relevant parameters in the final phase of the flight (engine EPRs, wheel brake pressures and spoiler panel angles) are shown in figure 4. Factors contributing to the incident can be found in the graph.

The pilots claimed in the hearings after the incident that the spoiler/speedbrake lever had moved fully back as it normally does as the ground spoilers deploy at touchdown. According to the UFDR data and a passenger observation the spoilers did not deploy at touchdown. The spoilers had worked normally as flight spoilers until touchdown (figure 4) and also as ground spoilers on the previous landing in Jyväskylä. The aircraft manufacturer does not know of any case in the history of DC-9/MD-80 when the spoiler/speedbrake lever would have moved back to EXT position without ground spoiler deployment.

Figure 4. EPR, Brake pressure and spoiler panel position during landing in Joensuu

According to the UFDR data the engine reverse thrust settings during the landing roll were 1.10-1.25 EPR in the left and 1.10-1.22 EPR in the right engine until a speed of 65 kt, which after the settings were 1.24-1.41 EPR and 1.22-1.23 EPR. According to the FCOM reverse thrust of 1.3 EPR should be used on a wet runway. Under emergency conditions, maximum reverse thrust may be used to a complete stop. The captain told the commission and also in his report to the DGCA, Turkey that he applied a reverse thrust of 1.5 EPR after touchdown, increased it to 2.0 EPR and finally used the maximum reverse thrust setting. UFDR data and the captain's statement disagree.
