Aircraft incident at Turku airport, Finland on 30.12.1997

B 9/1997 L

DC-9-41

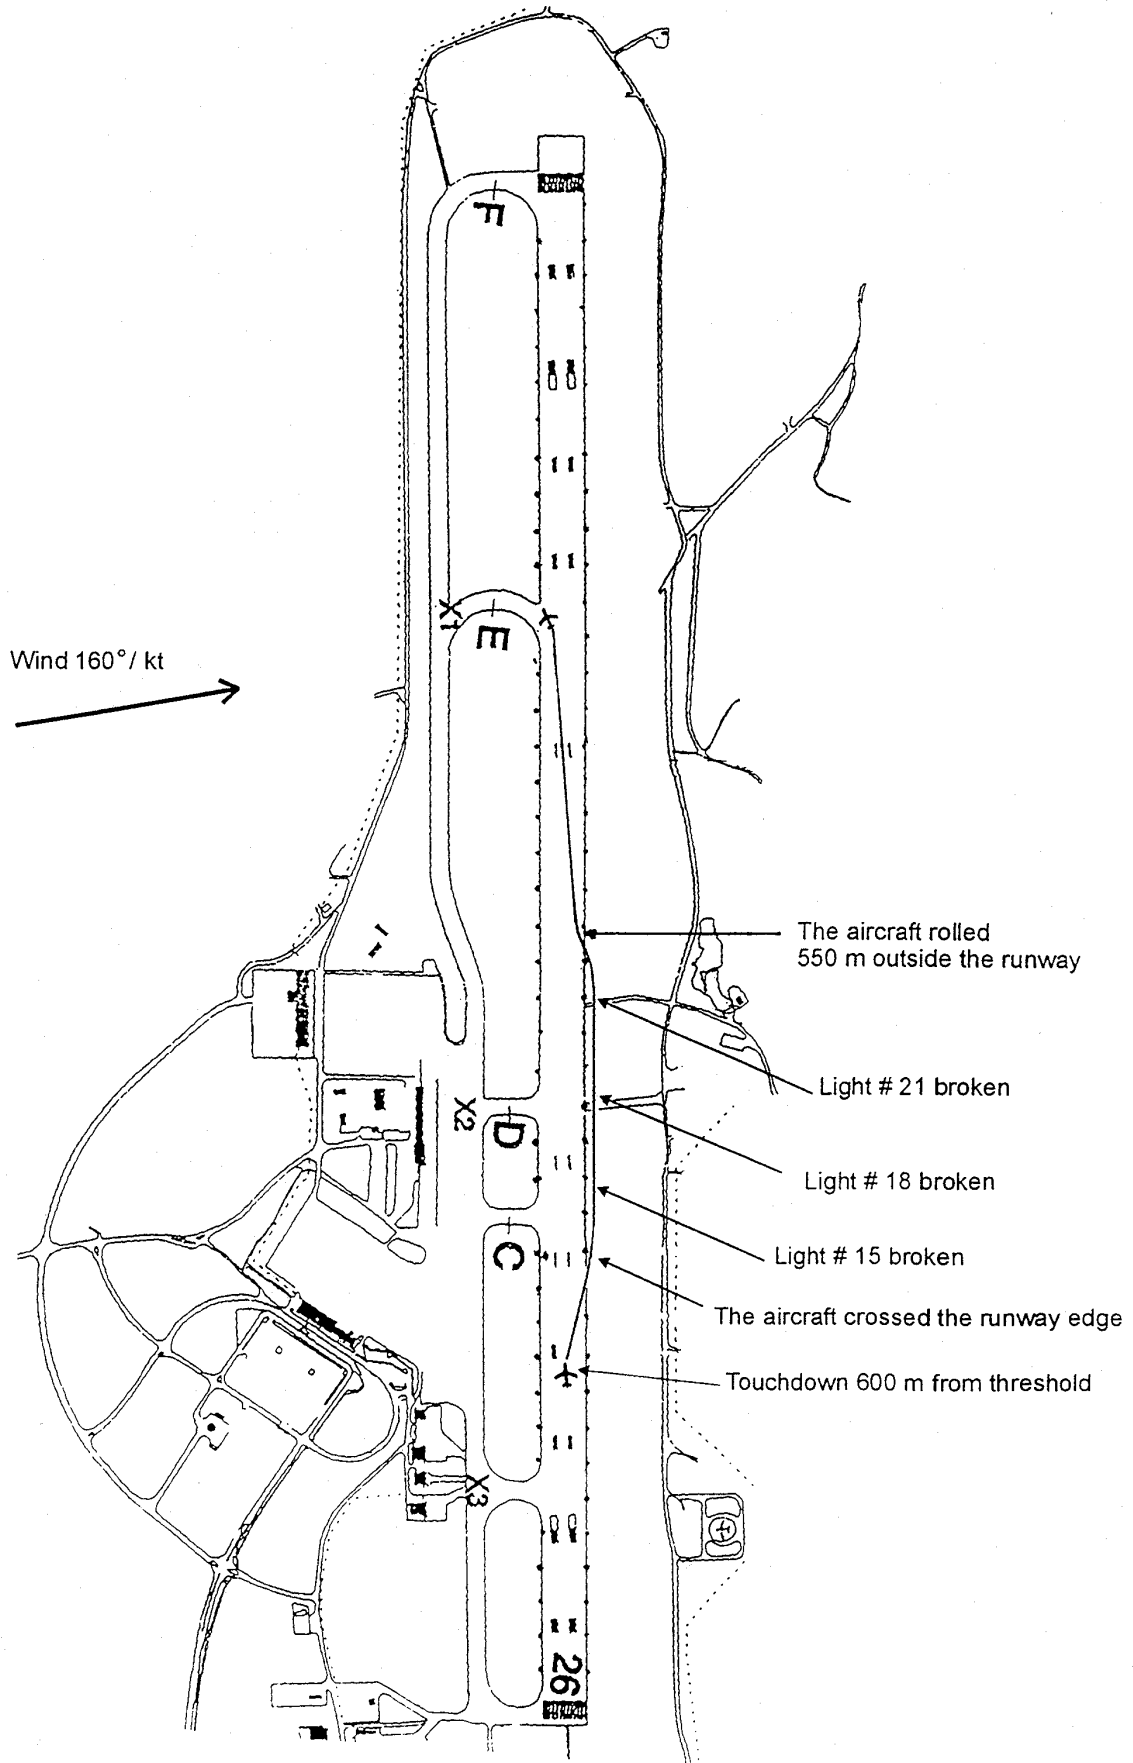
SK-720 TRACKS AT TURKU AIRPORT ON 30.12.1997

The aircraft touched down 600 m after the threshold. The right main landing gear wheels were 12 m inside the right runway edge line and the left gear wheels 13 m right of the centerline. The spoilers extended normally decreasing the lift of the wings. The aircraft touched down with a slight right bank and ran off the right edge of the runway 200 m after touchdown. The tracks of the main wheels could be seen on the snow covered runway and strip. No side slipping could be noticed. The nose wheel track began outside the runway edge.

A drawing of the aircraft's track during landing roll can be seen in figure 1.

The aircraft ran outside the runway for 550 m. The left landing gear damaged three runway edge lights (nos 15,18 and 21 from threshold 26). The aircraft came back to the runway between light assemblies no 22 and no 23. Outside the runway there was 10-20 cm of wet snow and slush.

On touchdown the right main landing gear was 7 m from the edge of the swept area and ran one second after touchdown outside the swept area. The left landing gear was 12 m from the edge of the swept area and ran two seconds after touchdown outside the swept area. According to the manufacturers FCOM (Flight Crew Operating Manual) the spoiler extension takes normally 0.8 second. Some delay may occur on reduced friction conditions. The right landing gear ran outside the swept area at the same time when the spoilers reached their full extension and the left landing gear one second later, which after the main wheels ran on a thick slush and snow layer. Even the aircraft fuselage was along the runway on touchdown the main wheel tires had not got firm grip on the runway surface before the aircraft ran on a thick snow and slush covered surface where the tires were probably slush planing. As the captain held the aircraft nose up had the wings, despite of spoiler extension, some lift which reduced the main wheel weight on the runway. For these reasons the aircraft movement continued until outside the runway edge.
