Risk of collision between two airliners southwest of Vihti VOR, Finland on 9 October 1998

C 24/1998 L

OO-DHW, B727-223F

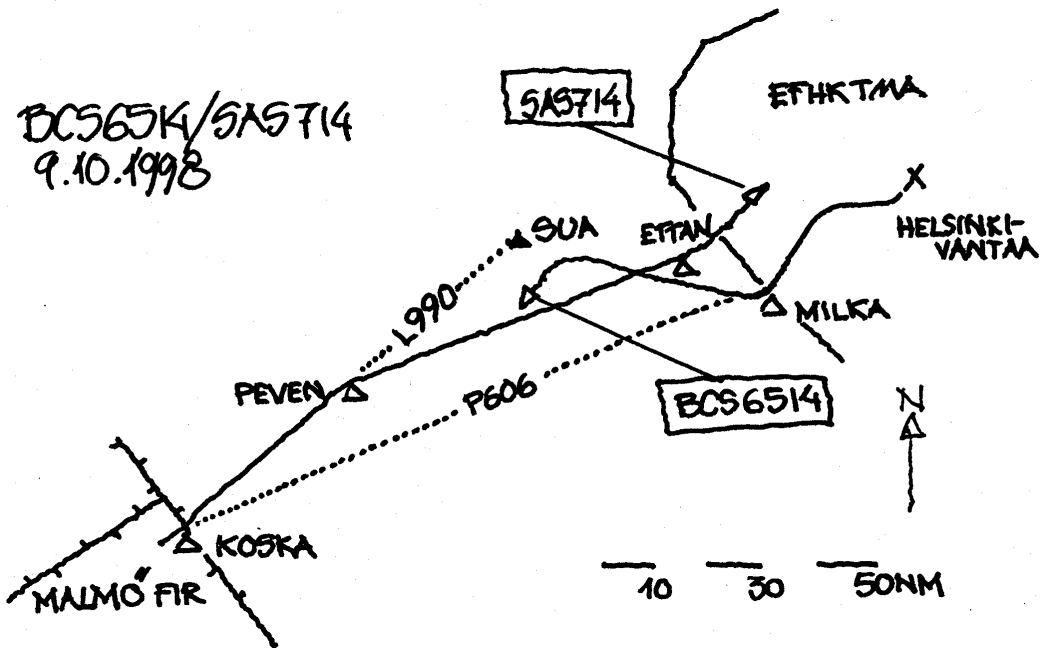
The aircraft passed each other on intersecting flight paths, by a horizontal distance of about 1 km and a vertical distance of 400 ft, so that the required minimum separation was lost. The incident occurred 50 NM west of Helsinki at an altitude of 6250 m.

Figure 1. The flight paths and flight altitudes of the aircraft intersected at the same point on airway T6.

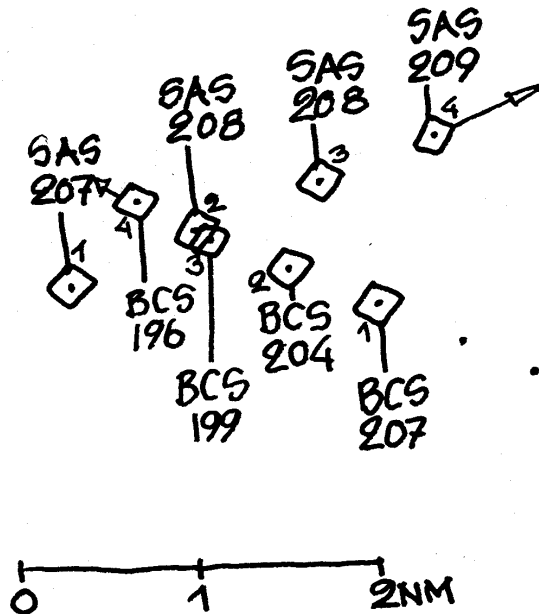
TUTKAN KORKEUSTIETO KOHTAUSTILANTEESTA
(PIIRRETTY VIDEOTALLENTTEESTA)

Figure 2. Radar altitude information at the time of intersection.
