Near-miss, Aircraft Incident at Lappeenranta TMA, Finland on 29 July 1999

Aircraft incident report

C 16/1999 L

Aircraft Incident at Lappeenranta TMA, Finland on 29 July 1999

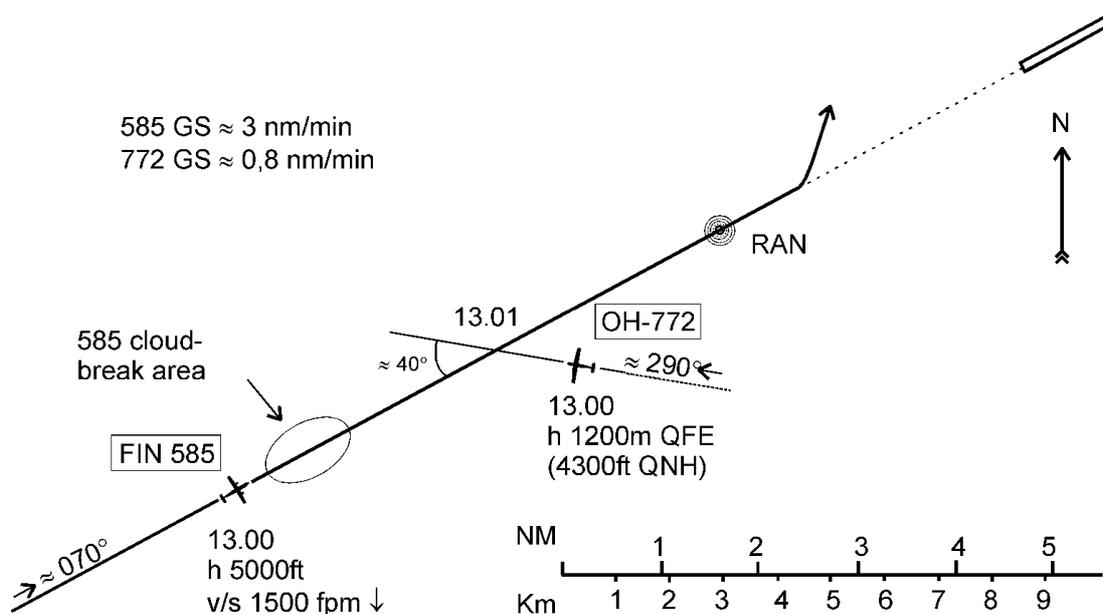
The glider pilot did not see the approaching passenger aircraft until it had passed, and saw it rather far away at the rear right and below of him. The pilot told having been surprised that the passenger aircraft was flying on such flight path and so high even so near the airport.

In the figure below are described the probable sequence of events and the reciprocal positions of the aircraft.

The incident took place approximately 11 km south-west from Lappeenranta airport on the extended centreline of runway 06 at an altitude of 4000 feet (1200 m).
