Near-miss, Aircraft incident at Vaasa airport, Finland on 16 August 1999

Aircraft incident report

B 3/1999 L

Aircraft incident at Vaasa airport, Finland on 16 August 1999

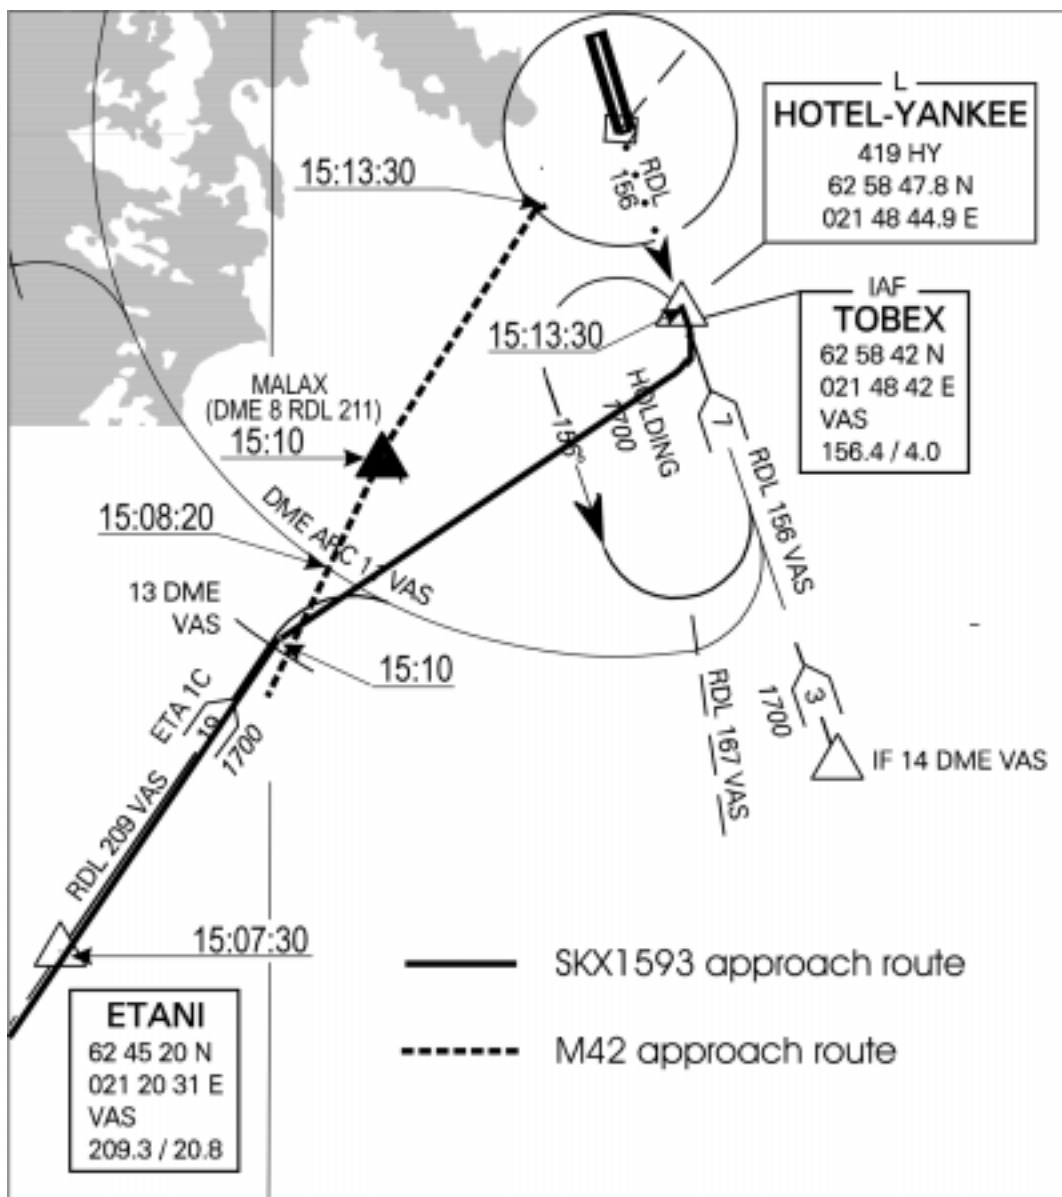
The approach routes of the aircraft are shown in picture 1.

Picture 1 The approach routes of the aircraft

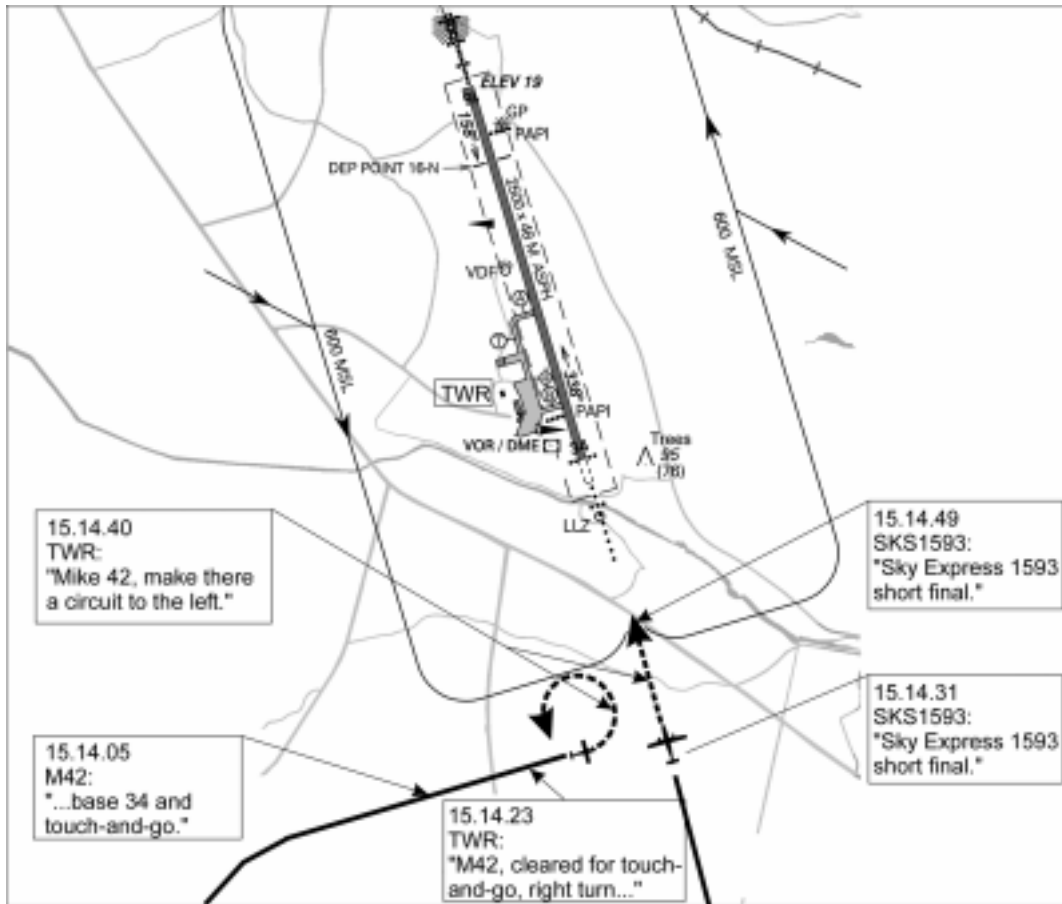
After receiving the touch-and-go clearance the M 42 pilot concentrated on turning to final approach leg. As he was not informed about the other traffic, he could not particularly look out for the airliner approaching from the right. After starting the left turn he saw the other aircraft flashing by below the nose of his aircraft as a dark figure, which he instinctively avoided by pulling the control stick. The aircraft turn steepened and the altitude increased. As the trainee pilot had rather little flight experience, the commission considers it possible that the actual technique of flying required quite a lot of his capacity. For this reason he may not have paid sufficient attention to the lookout and radio traffic not directly concerning his own flight. M 42 made two orbits to the left as ordered by the controller, but the pilot did not acknowledge the clearances. This had no effect on the course of events, but forgetting to acknowledge the clearances may indicate that the pilot was totally concentrated on controlling the aircraft.

The flight paths of the aircraft are shown in picture 2.

Picture 2 Flight paths of the aircraft on final to runway 34
