Aircraft incident at Helsinki-Vantaa airport on 12.10.2000

Micro-summary: Ground proximity incident between a taxiing MD-81 and departing airplane MD-83 taking off.

C 15/2000 L

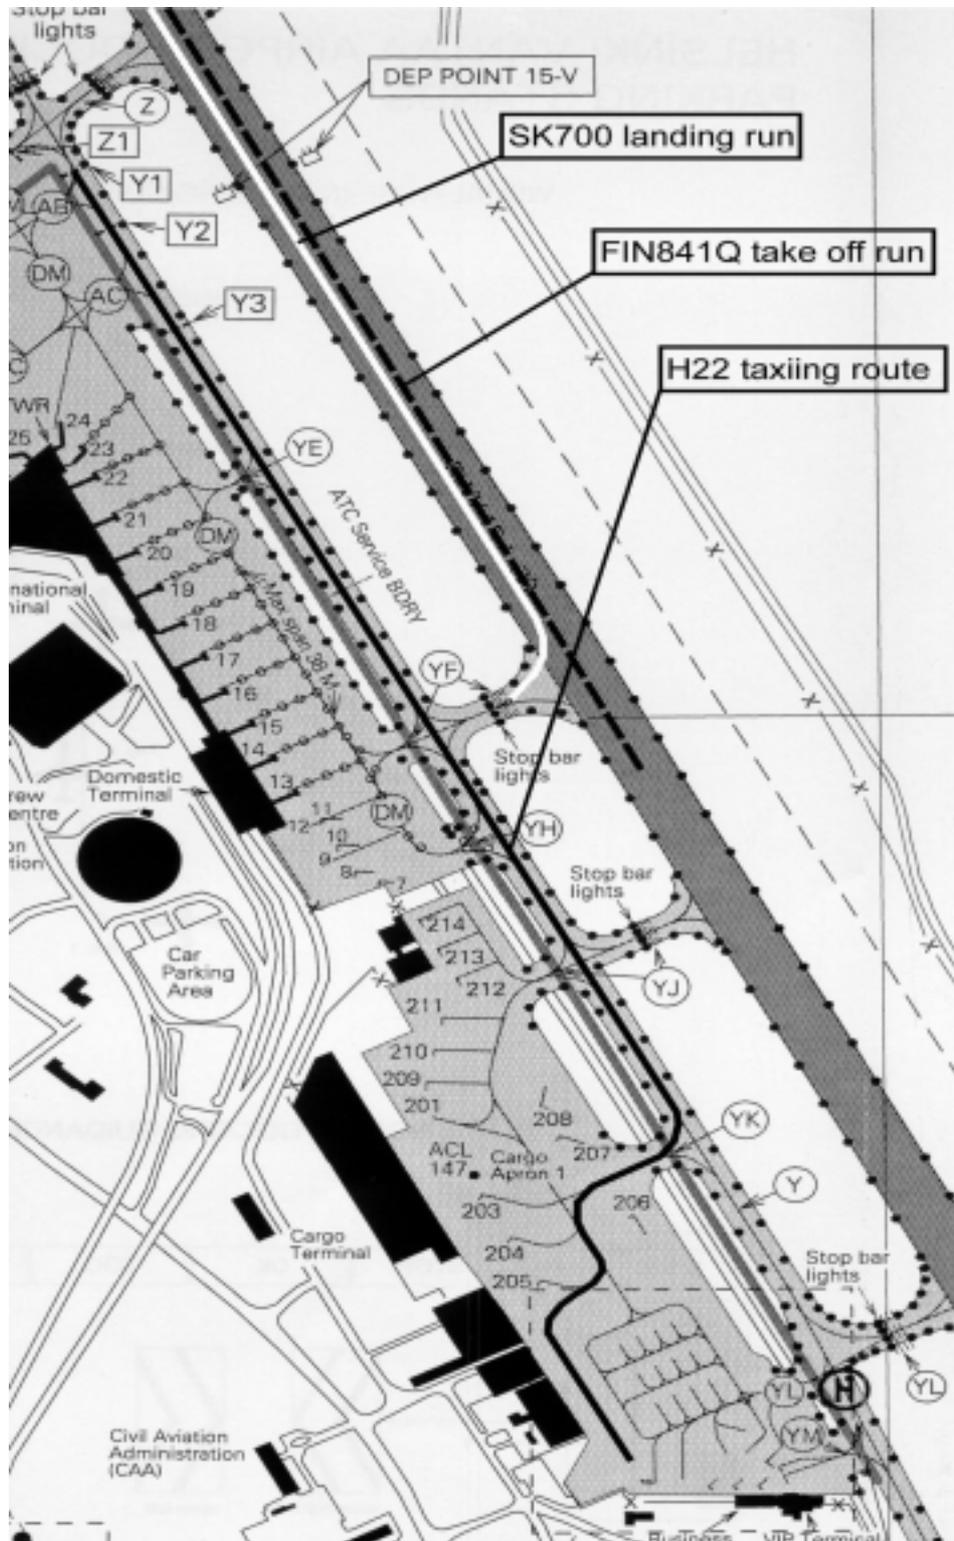
When SK700 had contacted Helsinki ground, the controller issued taxi clearance: "*Scandinavian 700, behind Fokker from left to right, taxi via Yankee and Alfa Charlie to stand 26*". SK700 acknowledged this clearance at 08.50.30. The Fokker mentioned in the clearance was F27 using Air Force call sign H22. It was taxiing on taxiway Y from the Business Flight Center to Y1. Compared to SK700 H22 was taxiing from left to right and was passing YH at a distance of about 150 m, when the arriving SK700 was turning off the runway. The H22 crew observed SK700 taxiing from right and slowed down their speed. According to the statement of H22 first officer SK700 was so far enough that there was no need for continuous look at the right wingtip of H22. During FIN841Q take-off SK700 was waiting for the passing H22 on YF.

Picture 1. Taxiing routes of the aircraft

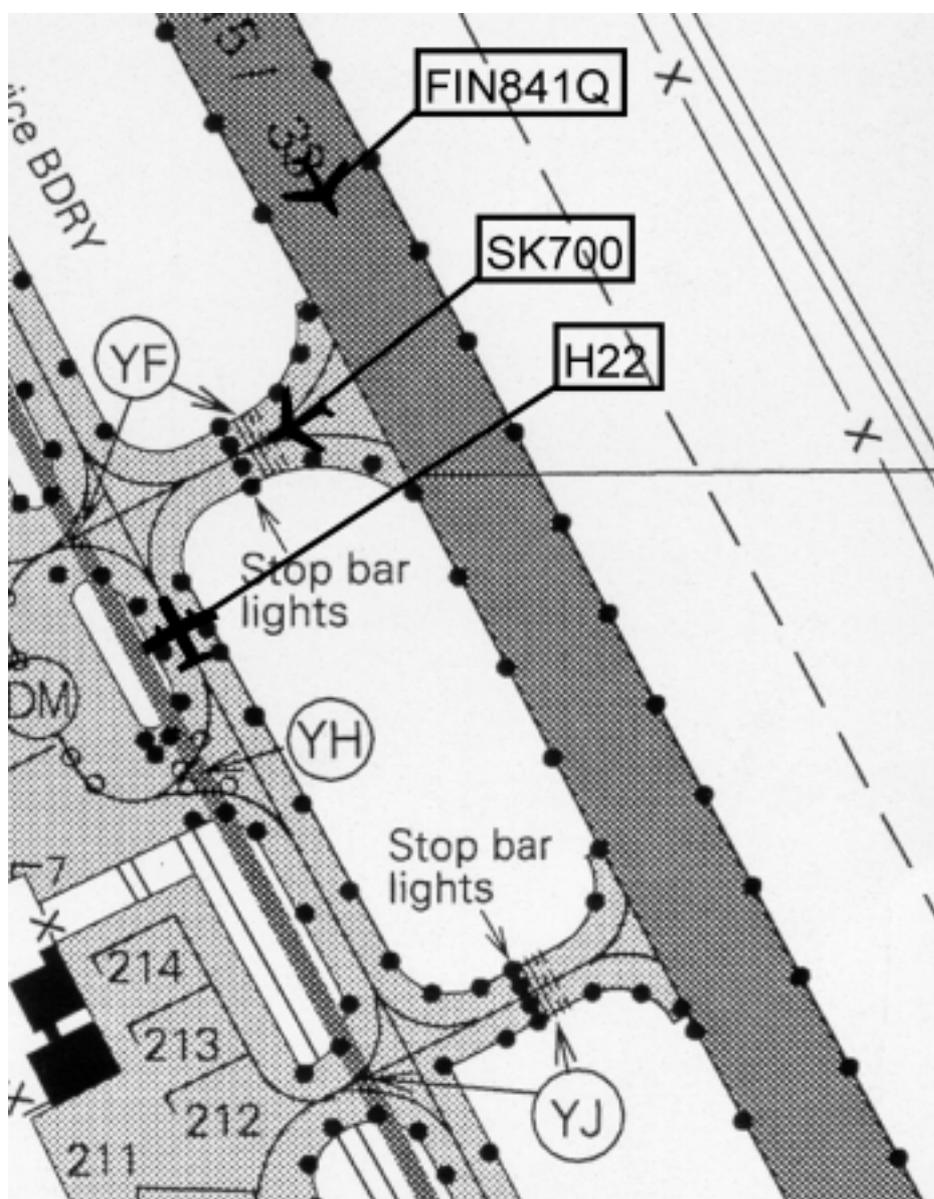
The pilots of FIN841Q had concentrated on their own takeoff and did not observe SK700 until in the short distance. They found out that they had space enough to pass SK700 without an evasive action. The commander of FIN841Q had no possibility to abort take-

off when he observed SK700 standing too close to the runway. In an aborted take-off FIN841Q should have passed SK700 anyway.

According to the co-operation letter of Helsinki-Vantaa airport the ground controller gets the strip of the landed aircraft from the tower controller when the aircraft has vacated the runway. When planning the control of taxiing traffic the ground controller have to follow landing traffic visually and from the radar display. This is the way the controller told he had acted also in this case. He did not however succeed in determining the taxiing order of his traffic correctly, because the landed SK700 had to stop on connecting taxiway YF to wait for taxiing of departing H22. Due to the short distance of runway 15/33 and taxiway Y SK700 stopped at the runway area.

Picture 2: Position of the aircraft while FIN841Q was taking off
