## Engine damage at Helsinki-Vantaa Airport on 17th October, 2000

B 3/2000 L

# Engine damage at Helsinki-Vantaa Airport on 17th October, 2000

OO-SSH  
Airbus A319

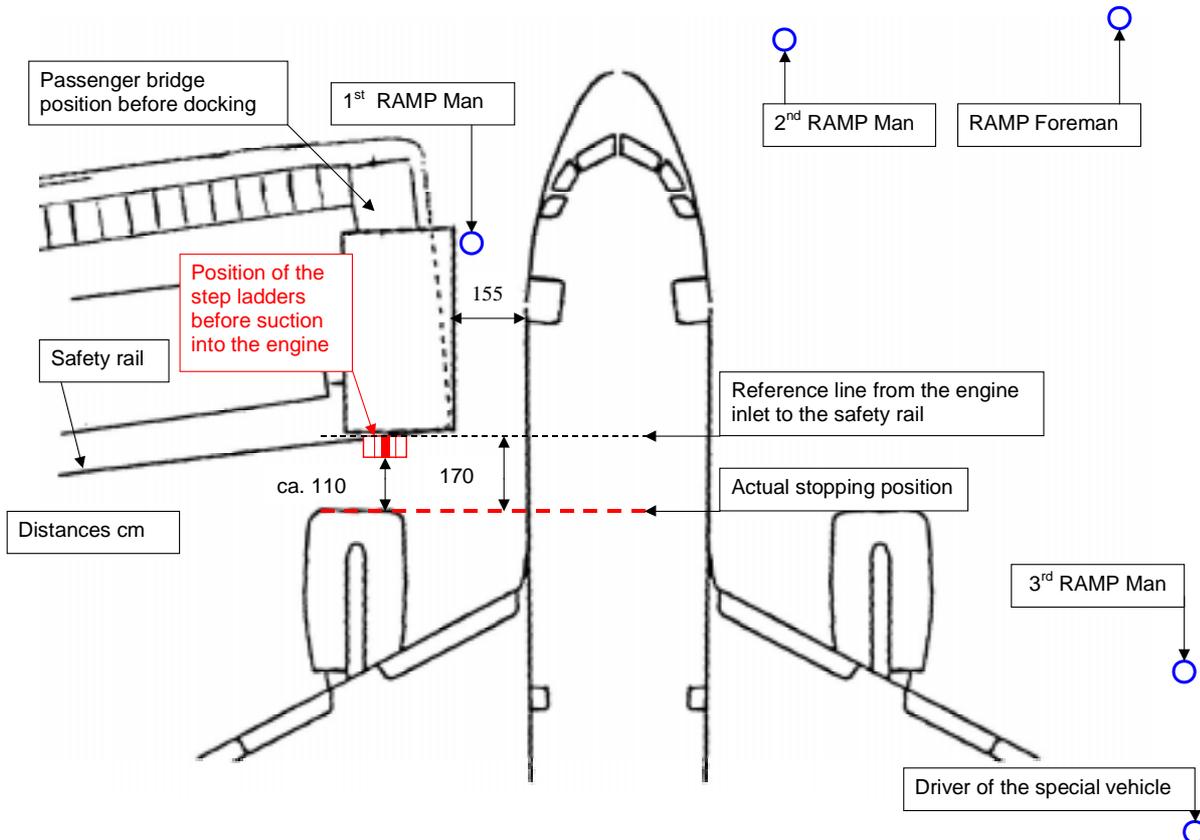
Picture 2. The parking of OO-SSH and the positions of RAMP group member's prior the maintenance stepladder is sucked into left engine of the aircraft

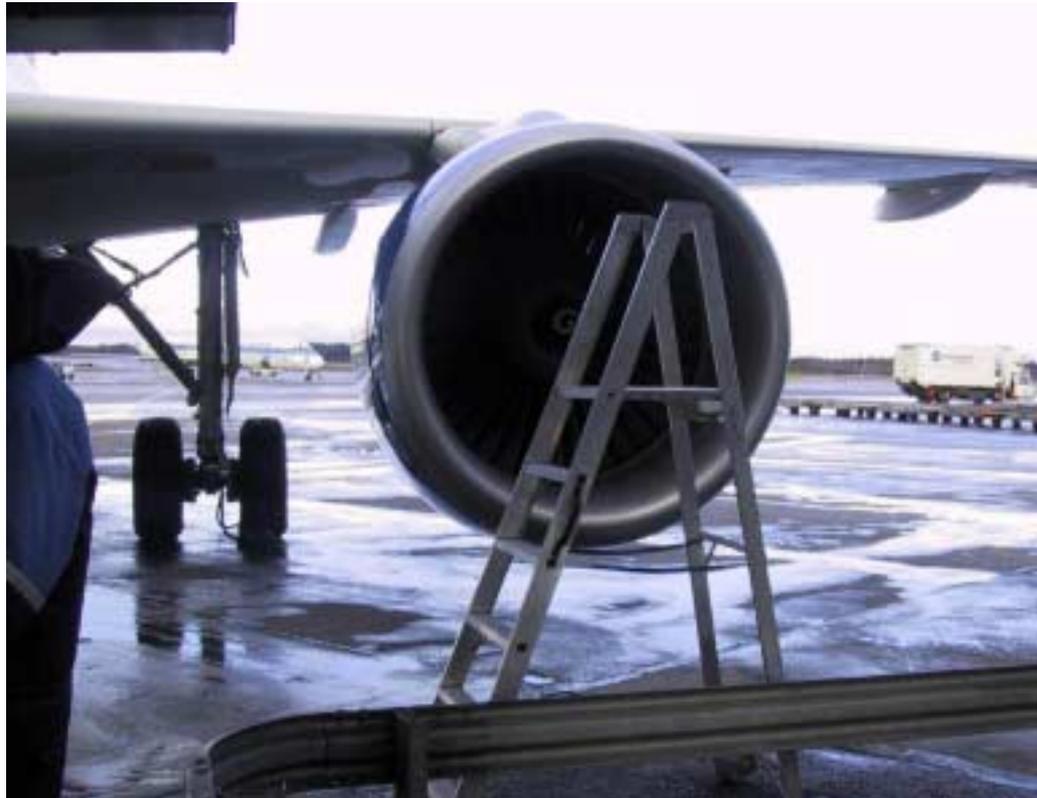
Picture 3. Simulated situation of the position of maintenance stepladder prior to damage

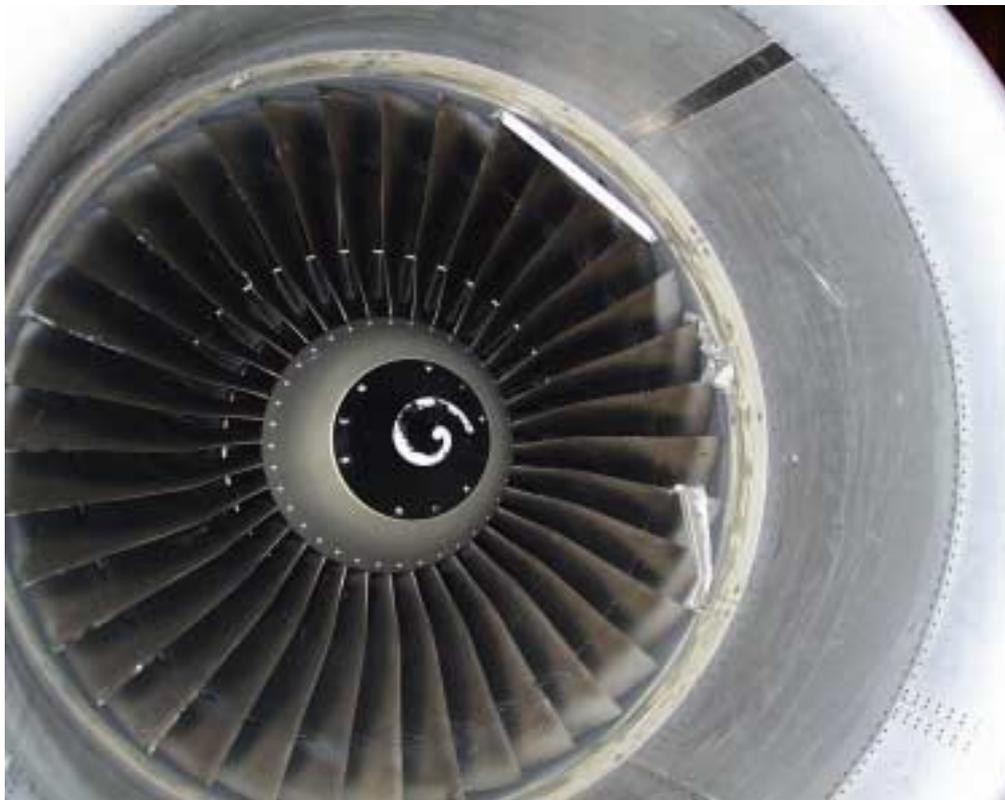
Ram air inlet case of the engine was damaged in various areas and sensor located in the ram air inlet which measures the temperature of air flow into the engine was destroyed. Fan blades and guide vanes of the bypass chamber had plenty of dents.

Sealing material by the compressor blades was damaged in several places, and the fan rotor did not rotate due to parts of the stepladder being in between blades and sealing material.

Picture 4. A general photo of the damaged engines air inlet and the parts of the maintenance stepladder in it

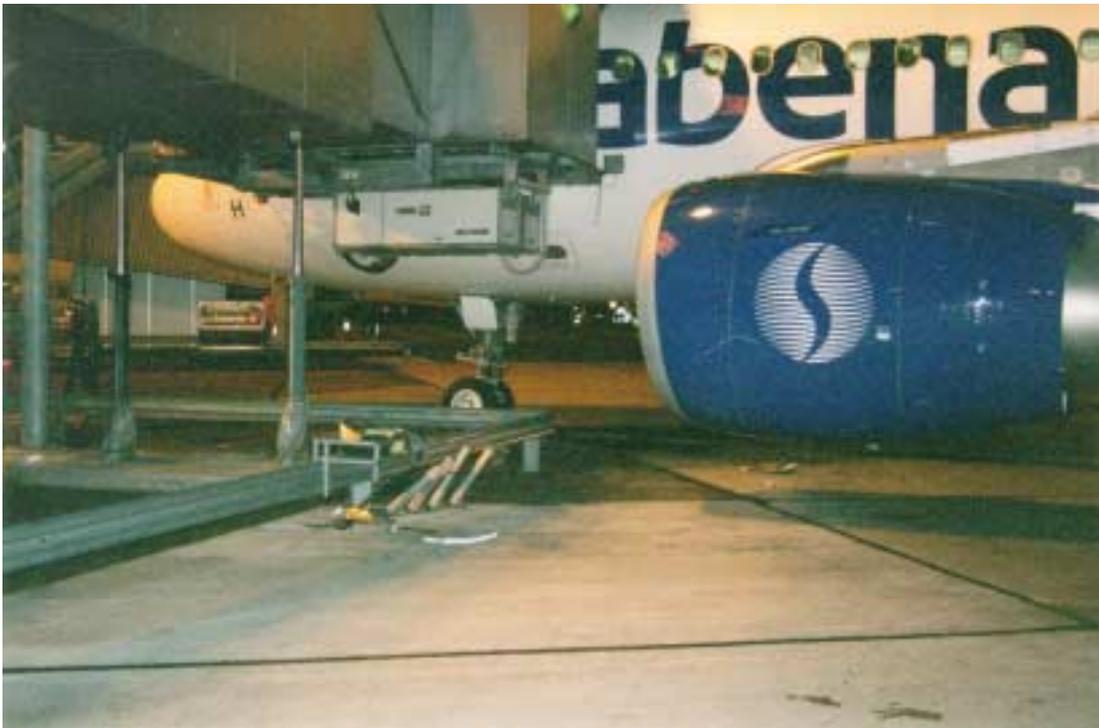
The stepladder causing the engine damage was destroyed and unusable.

Picture 5. The destroyed stepladder in front of the damaged engine (the stepladder has been removed away from its original position where the damage occurred)

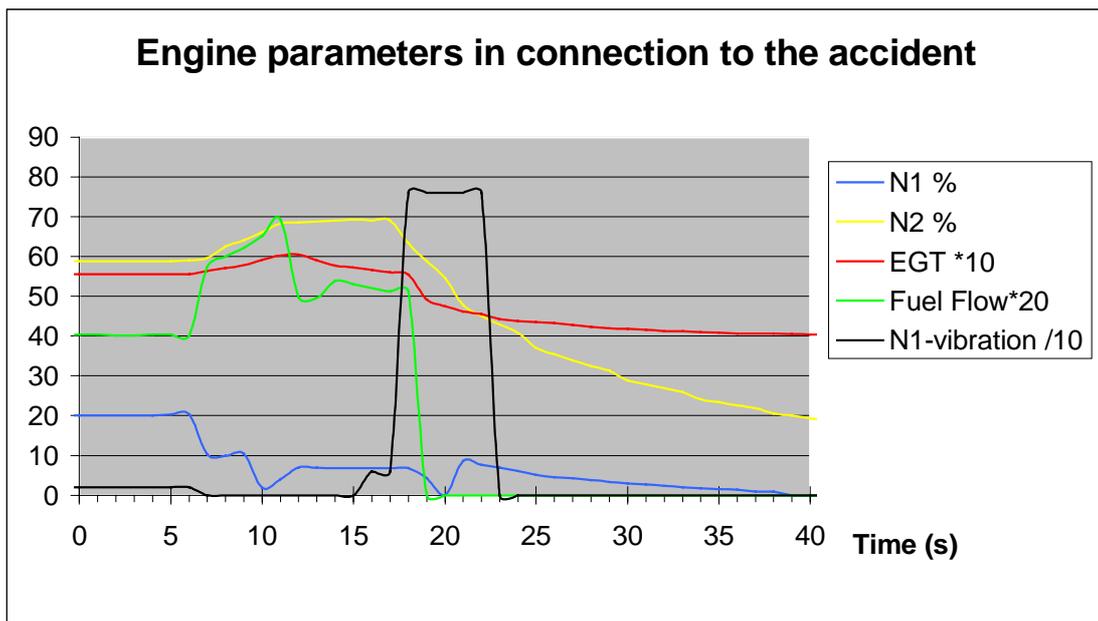
The diagram enclosed contains relevant engine parameters recorded into the DFDR starting from final portion of the taxiing approximately five seconds prior initiation of the damage. The power setting of engines was at minimum ground idle. When the step ladder was sucked against fan blades mechanical friction reduced  $N_1$  revolutions (blue graph), where at the engine's automatic power governor increased fuel flow (green graph) to maintain selected  $N_1$  power setting. Simultaneously  $N_2$  revolutions (yellow graph) and the exhaust gas temperature (EGT, red graph) increased.

The thrust of engine is created mainly by the fan. Therefore the power increased in the engine core did probably not add the forward directed thrust. There is no definite explanation to the high vibration value of  $N_1$  rotor presented in diagram (black dotted graph).

Picture 6. The flight recorder data of relevant engine parameters at time of occurrence

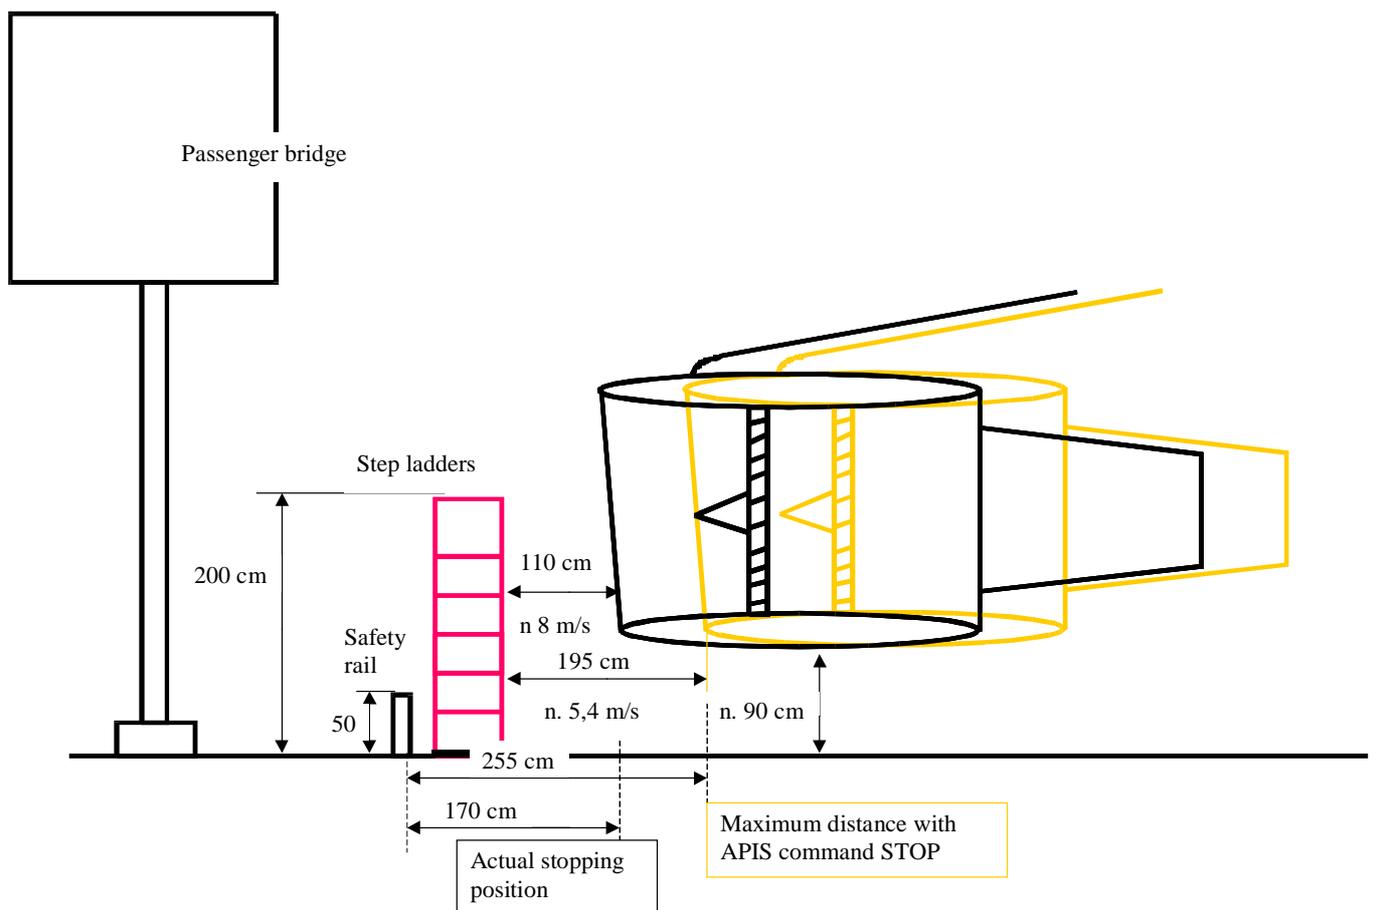
ble, that 205cm high stepladder could have hit the outer edge of the inlet opening when falling and slipped from there outside without ending up into the engine. Even though the speed of engines airflow changes significantly in relation to distance, suction of the engine would not likely have been able to lift on the ground located, 14.5 kg weighing stepladder into the engine. Velocity of the air flow by the leading edge of the engine is approximately 22.5 m/s, at a distance of 1.1 m approximately 8,0 m/s and at a distance of 1,95 m approximately 5,4 m/s.

The enclosed picture illustrates the position of the engine and the stepladder as well as the distances between them and the structures at the damage occurrence. The black drawing of the engine presents actual parking position of aircraft and yellow lineation the distance of the situation, if the aircraft would have stopped immediately after the STOP command indicated by the APIS system. In addition velocity of the inlet flow into engine is presented in the picture indicating the distances significant from the damage occurrence point of view.

Picture 10. Drawing presenting changes of the inlet airflow into the engine at damage occurrence

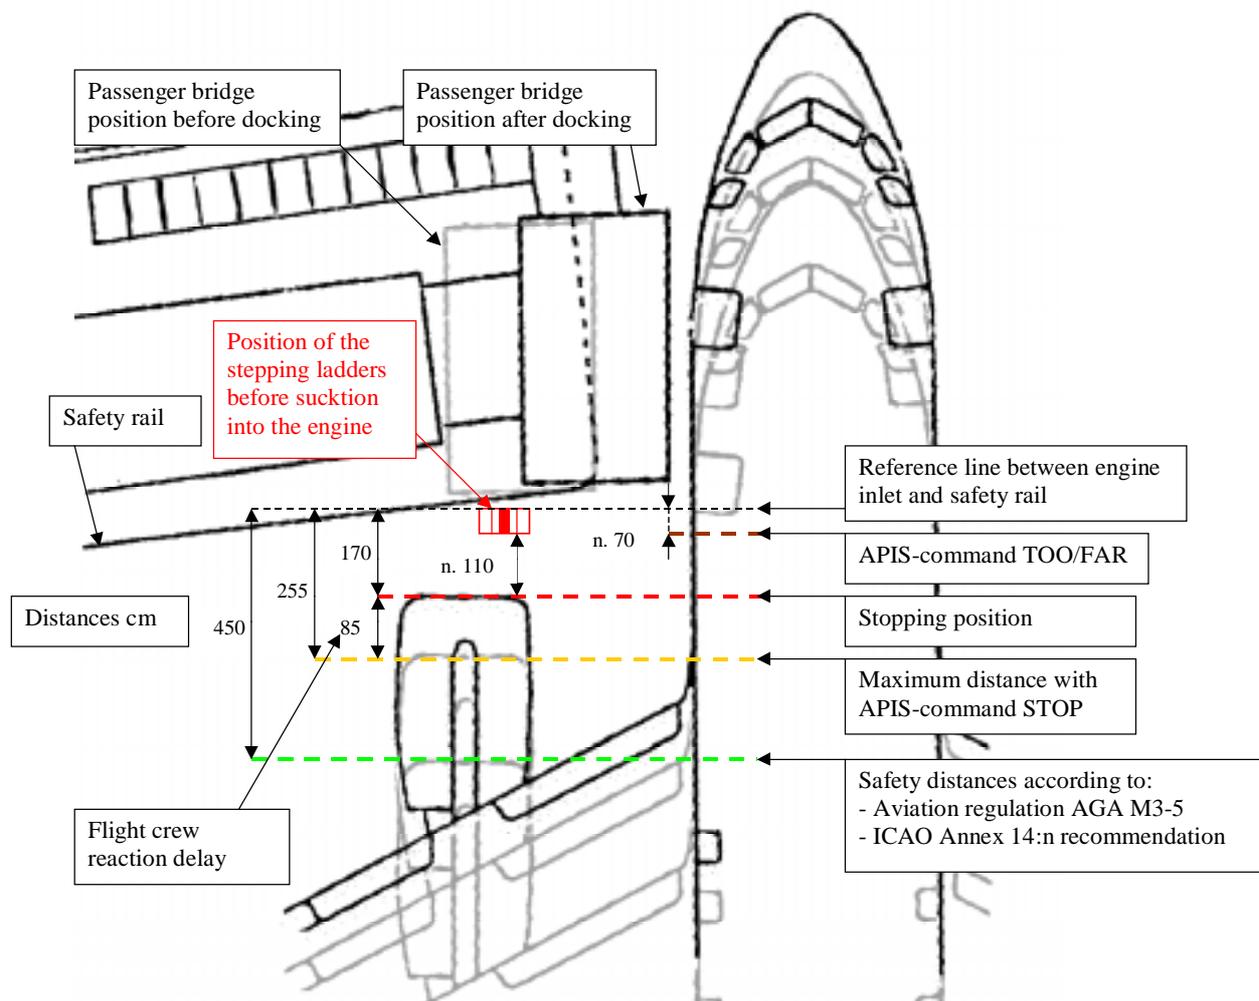
clearly fulfilled at aircraft stand number 25, though investigation commission finds the clearance in question relatively short on apron slipped by moisture or snow and ice.

Yellow dotted line indicates the APIS-systems STOP-command for the greatest safety distance of 255 cm from the passenger bridge and its safety rail, when aircraft is stopped immediately when STOP-command is lightened at parking stand number 25.

Picture 11. Safety distances according to instructions and regulations and the damage occurrences situational-distances at the Helsinki-Vantaa Airport aircraft stand number 25
