Loss of separation over Espoo on 15.12.2000, Disappearance of aircraft from ATC radar.

Aircraft Incident Report

C 19/2000 L

Loss of separation over Espoo on 15.12.2000 Disappearance of aircraft from ATC radar

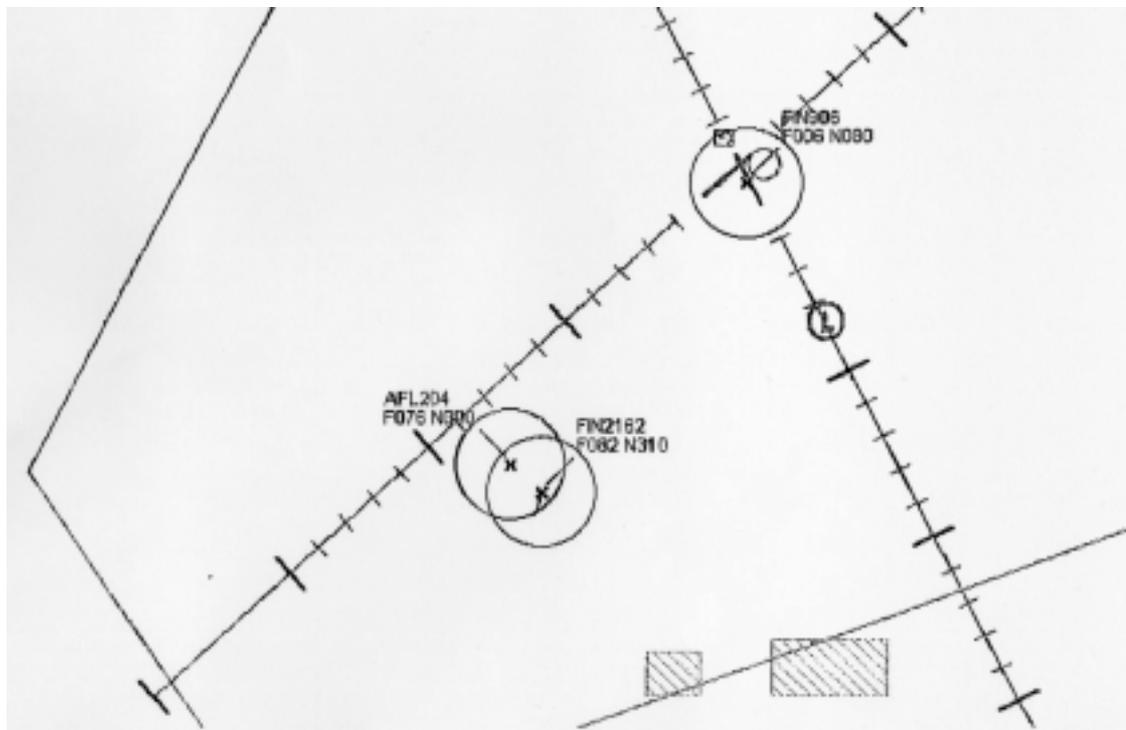
AFL204 became visible on Helsinki ATC radar screens at 16.45.56. It was then in front of FIN2162 about half a nautical mile on its front left side. The radar showed that AFL204 was flying at FL76. The tracks of FIN2162 and AFL204 intersected at an angle of almost 90°.

Figure 2. First radar observation of AFL204 at Helsinki ATC.

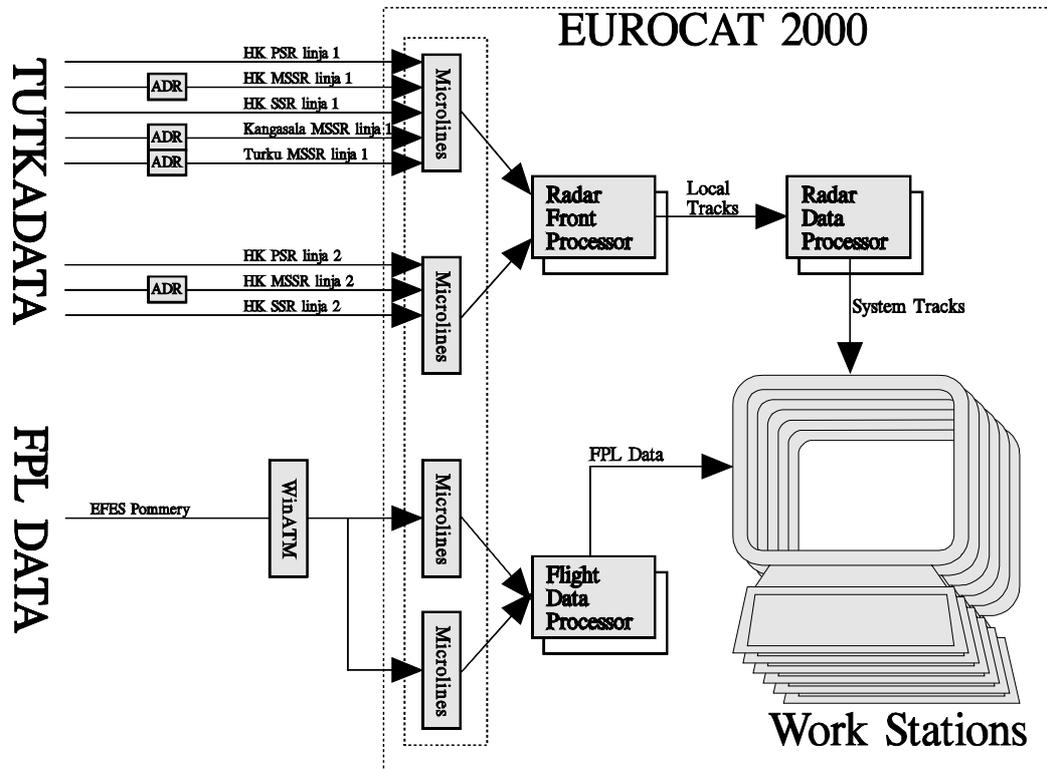
Figure 3. Eurocat 2000 radar display system used at Helsinki ATC.

Buildings in the airport area have caused occasional interference in the SSR. For this reason, ATC discontinued the use of SSR data in summer 2000, during which time the operations were based on MSSR alone. The SSR was connected back to the system on 15.10.2000.

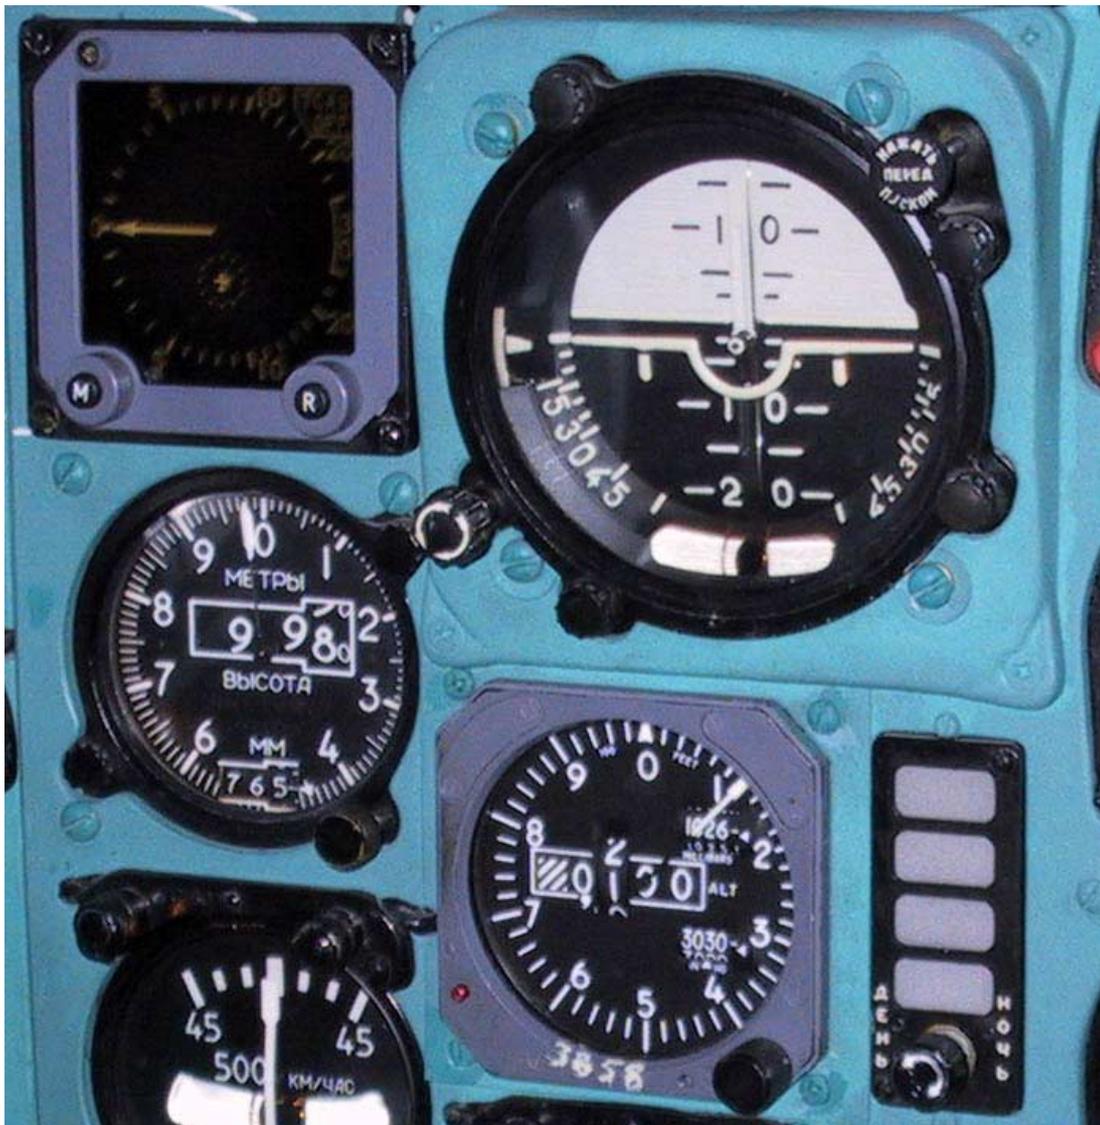
mean sea level. At the time of the incident, the difference between the actual barometric pressure QNH 994 hPa (mbar) and the standard pressure used above the transition altitude (1013.2 hPa) was about 520 ft. This means that FL50 was at 4480 ft, and the AFL204 should have changed altimeter setting before reaching this altitude since the crew reported passing through FL50. In his statement, the pilot-in-command of AFL204 told that the altimeter setting was changed at the *transition level*, though it should have been changed at the transition altitude, which is 5000 ft in all Finnish airspace. The adjustment of pressure setting in the metric altimeter is shown in the FDR recording provided by Aeroflot, but that of the altimeter showing feet is not recorded.

Figure 4. Altimeters available to the IL62M captain and TCAS display.

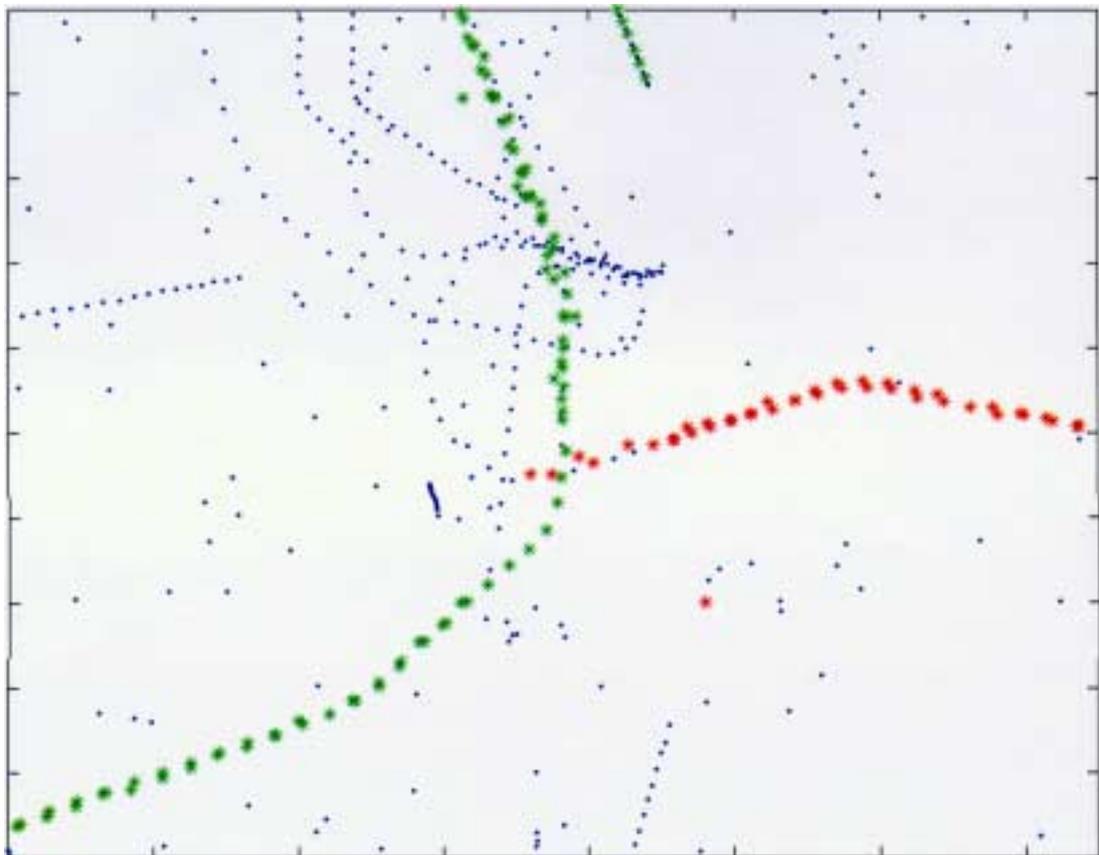
AFL204 reported reaching FL70 at 16.44.00. The label information of the aircraft was first displayed on radar screens at 16.45.56, at which time it was shown to be on FL76. FIN2162 received a TCAS resolution advisory about the aircraft at the same time. AFL204 was simultaneously detected by two radars at Helsinki-Vantaa ATC, three

Considering the technical rounding used in radar systems, the difference between FL70 and FL76 is the same as the difference between the QNH and standard barometric pressure converted into altitude. It is therefore probable that the altimeter indicating feet was on QNH setting above the transition altitude, although the crew thought it to be on the standard setting. They flew at the 7000 ft altitude indicated by the altimeter and believed to be at FL70, but were actually at FL76. In his statement, the pilot-in-command told that the flight had been normal and the crew had not noticed anything unusual.

Figure 5. Aircraft tracks from the Finnish Air Force radar recording
Blue points are primary radar returns.
Red stars are secondary radar returns for AFL204.
Green stars are secondary radar returns for FIN2162.

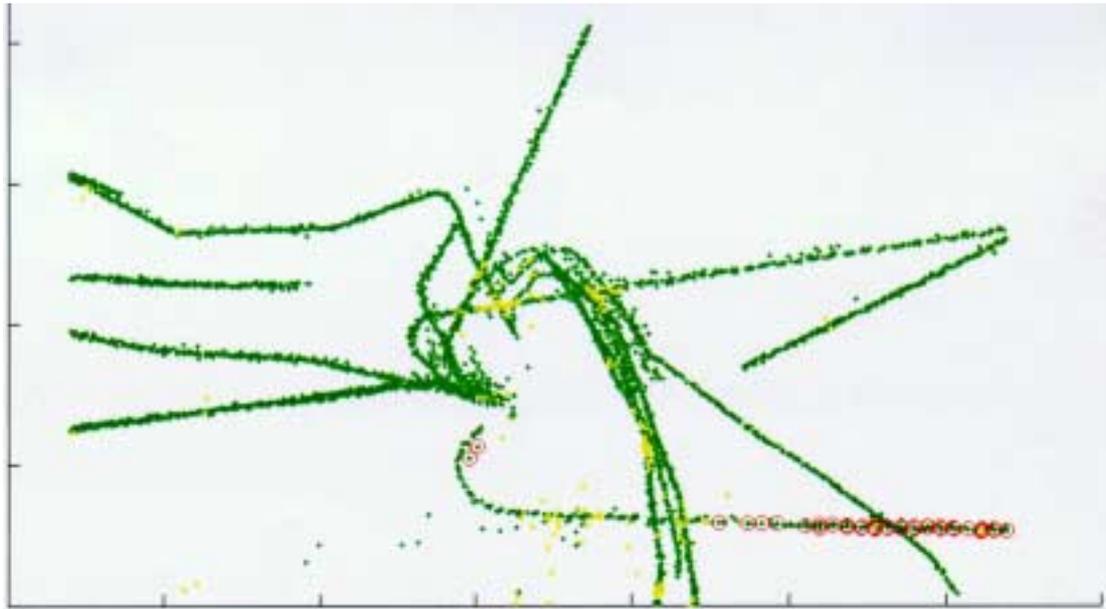
Figure 6. Radar recording by the Finnish Air Forces. An example of poor radar contact, showing PLK632 after take-off on 15.11.2000. The green spots indicate primary radar returns and the red circles transponder replies accepted by the secondary radar. The aircraft was not visible on secondary radar screen at Helsinki-Vantaa either.

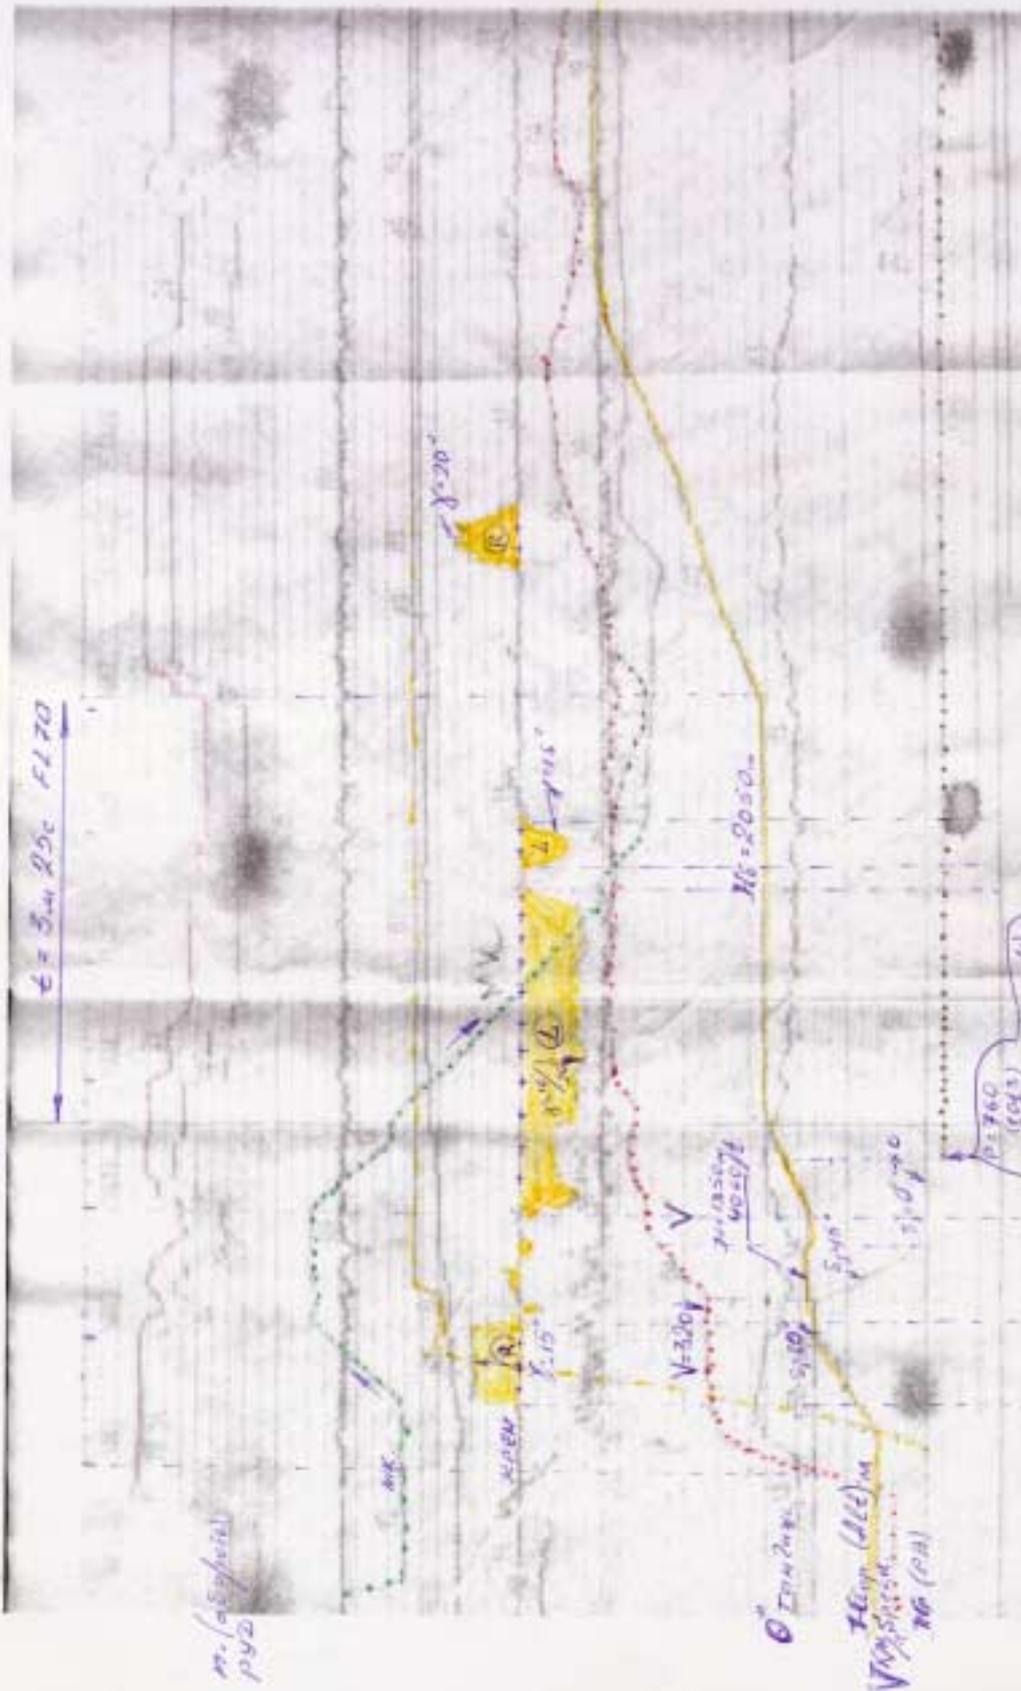
Copy of FDR express-analysis - take-off, AFL-204 flight, IL-62, Reg.№ 86532, 15.12.2000
