Aircraft damage in hailstorm west of Helsinki on 21.7.2001

Investigation report

B 5/2001 L

LN-RMT

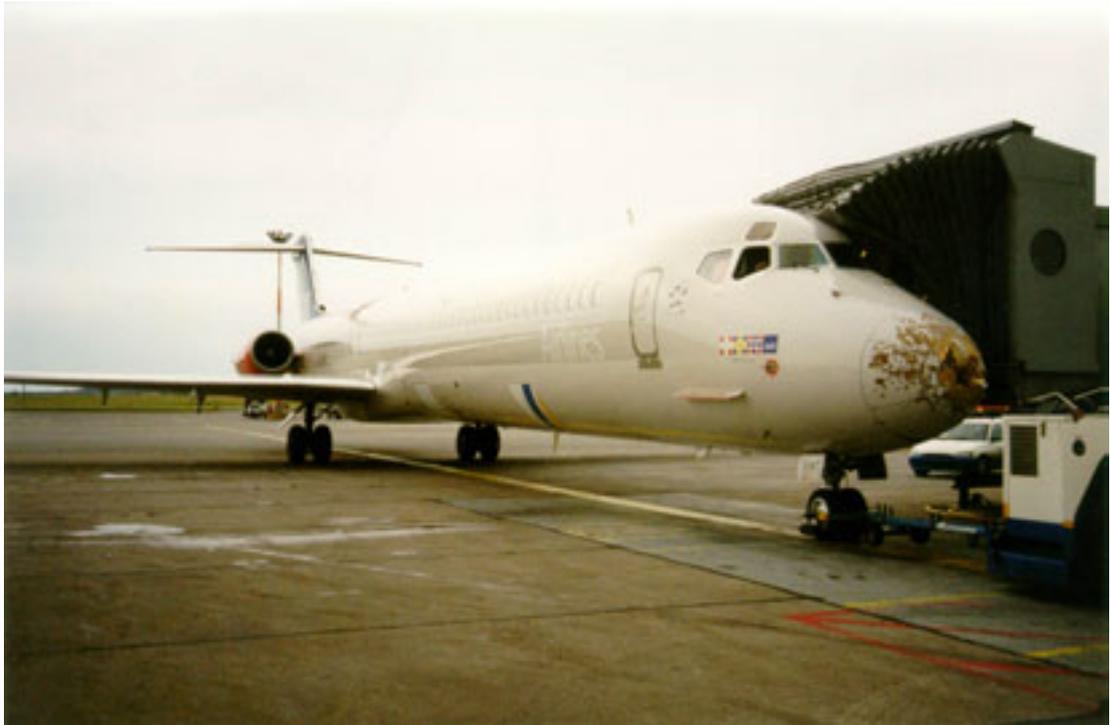
Figure 1. SAS1700, MD81 after the incident

The slat panels on wing leading edges were dented by hail, as were the leading edges of horizontal and vertical stabilisers and engine inlet cowls. A hole was torn in the radome, as a result of which the radar antenna surface was also dented. The outer surfaces of windshields in front of the captain and co-pilot were cracked. The aircraft structures or engines were not damaged.

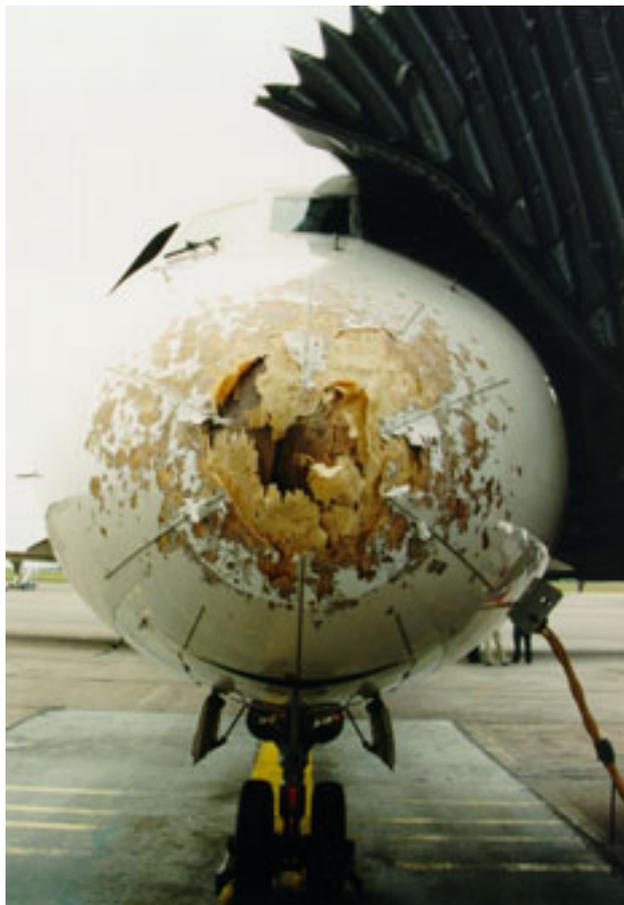
A hole of about 50 cm in diameter was torn in the radome, as a result of which the radar antenna surface was also dented by hail.

Figure 5. The damaged radome

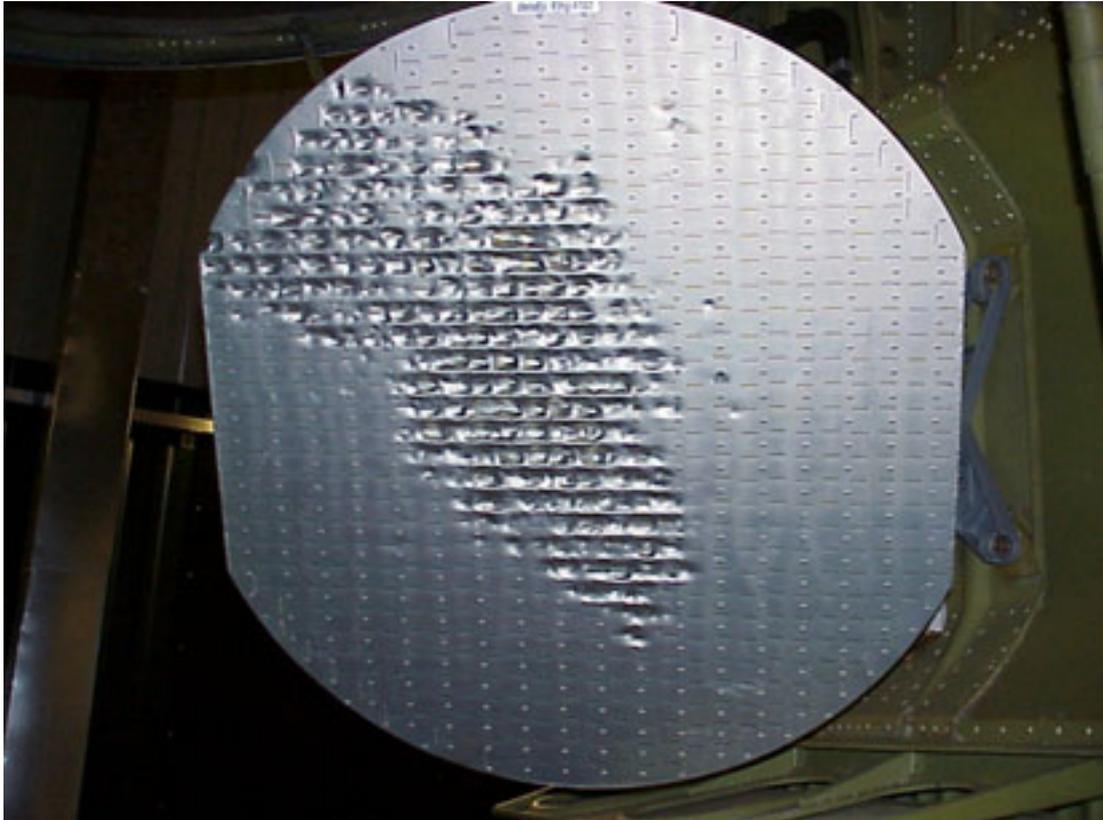
Figure 6. Dented radar antenna surface

The weather radar receiver/transmitter unit was removed from the aircraft and sent to Finnair Avionics Department for testing and read-out of fault memory. The unit was found to be serviceable. The fault list recorded showed that the malfunction in flight had been caused by antenna stoppage. The stoppage was simulated during the test.

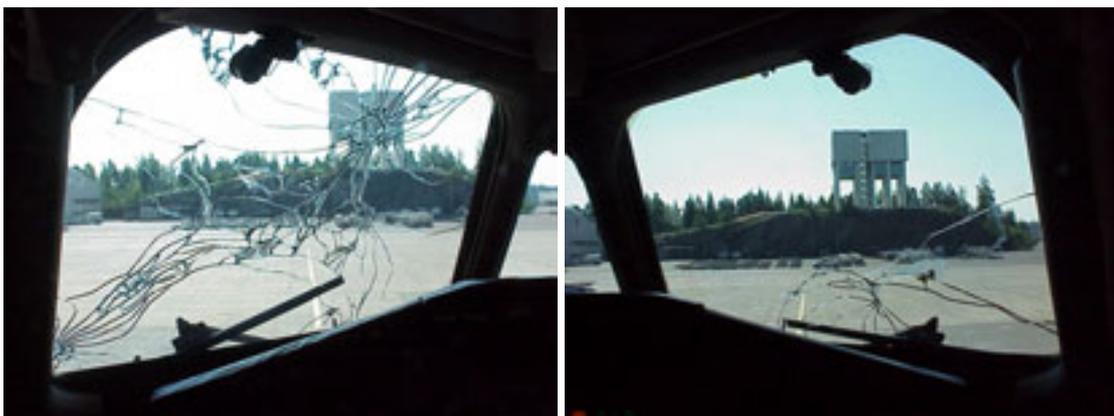
The outer surfaces of windshields in front of the captain and co-pilot were cracked. However, cracks in outer surface do not affect structural integrity of the windshield.

Figure 7. Left and right cockpit windshields as seen from the inside

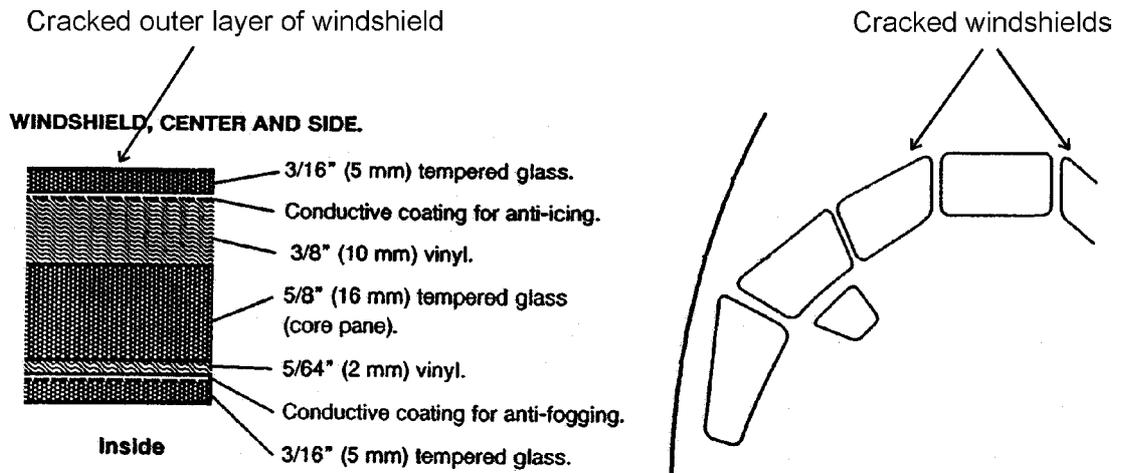
Figure 8. Windshield structure and location of the cracked windshields

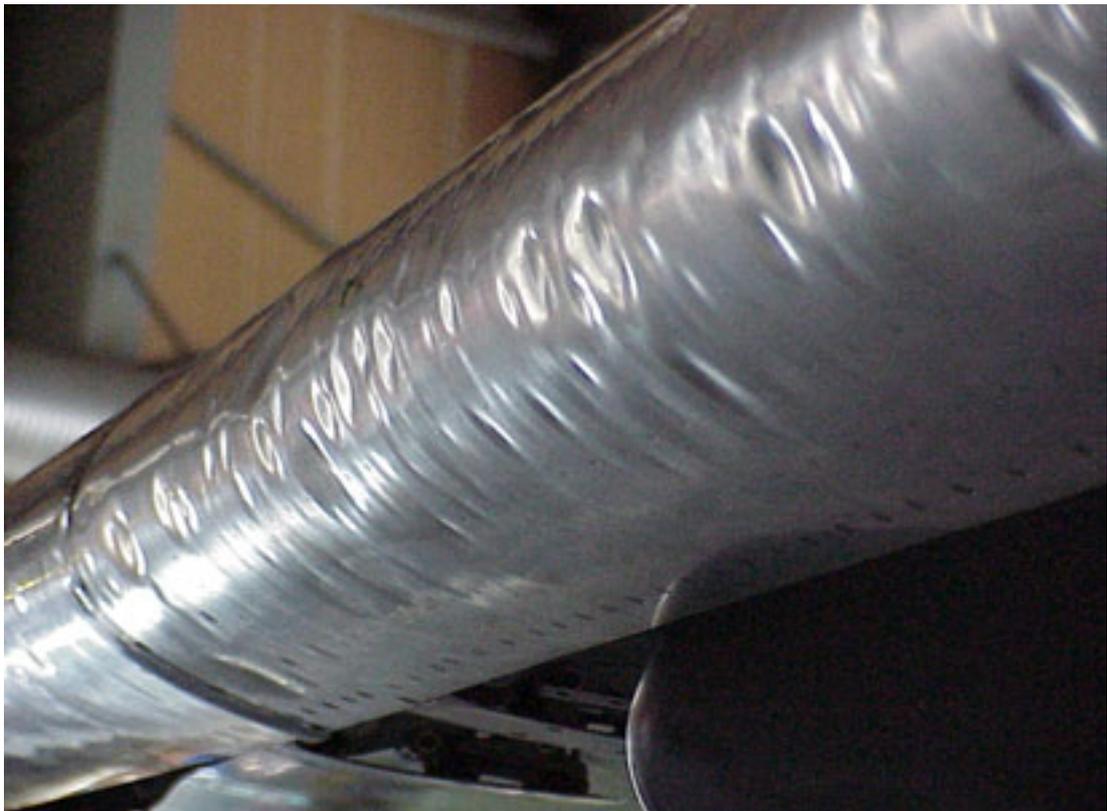
The slat panels on wing leading edges were dented by hail, as were the leading edges of horizontal and vertical stabilisers. The worst dents in both wings were found on slat panel no. 1 (the second panel from wing root). Both panels had about 120 dents in total. The largest dents were 70 x 50 mm² in diameter and 5 mm deep.

Figure 9. Right wing leading edge slat panel no. 1

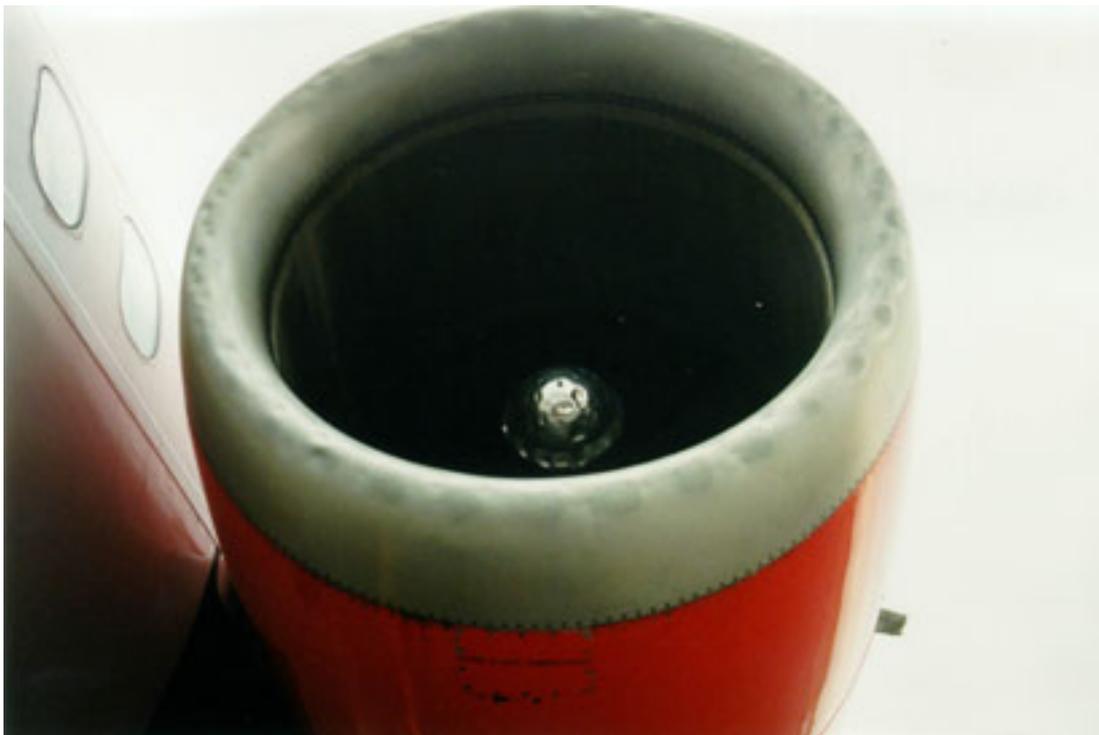
Moreover, the engine inlet cowls and the bullet in the centre of the compressor were dented in a similar way as the wings and stabilisers. The engines sustained no other visible damage.

Figure 10. Left engine inlet cowl

SAS made a boroscope inspection and test run to the engines. The inspections or test run did not reveal any internal damage or changes in performance.
